MEMORANDUM

DATE: January 16, 2018

SUBJECT: Weekly Environmental Conditions for Systems Operations

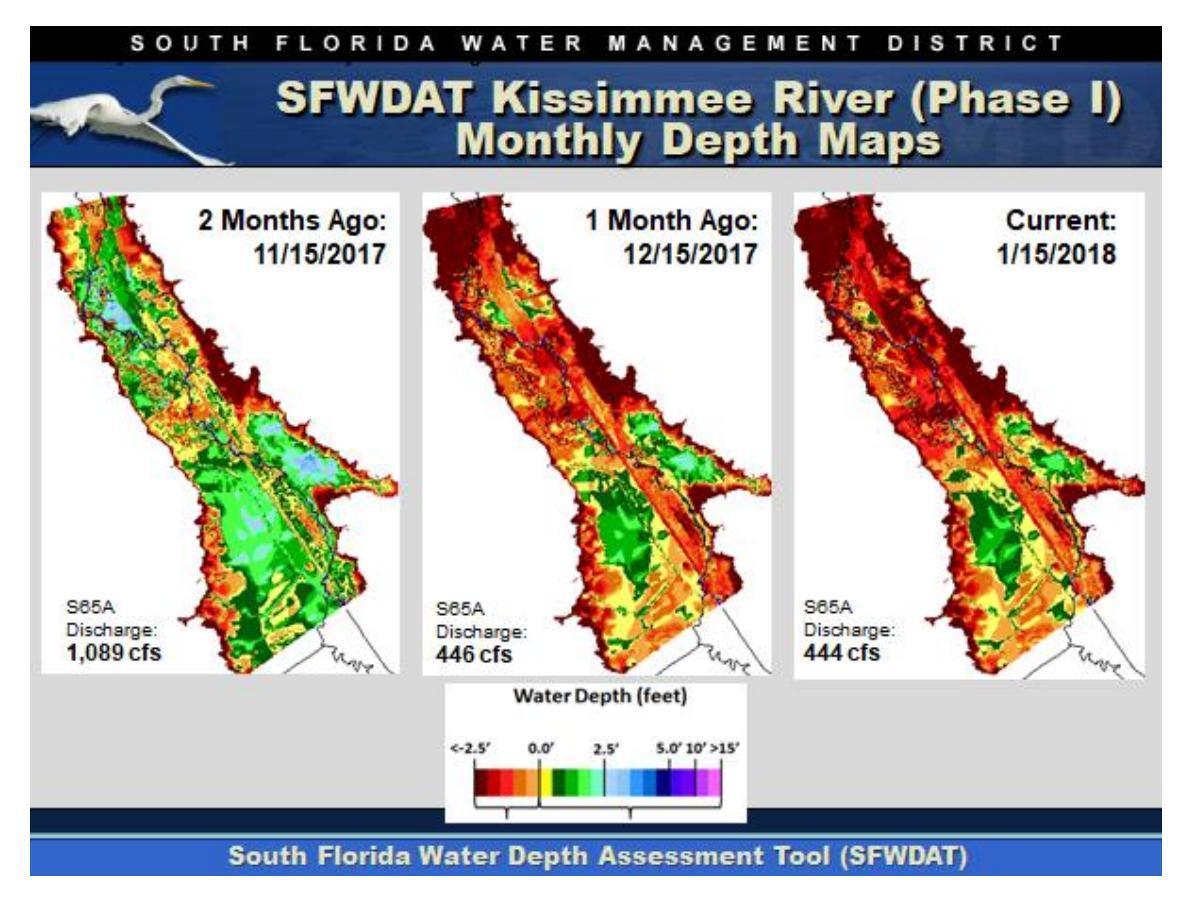
Figure 8. Phase I area floodplain water depths for this week, one month ago, and two months ago. Note that the WDAT color-coding has been modified to accommodate greater water depths; these maps are not directly comparable to Kissimmee Basin WDAT maps published prior to January 16, 2012.

Discharges at Lower Basin structures are shown in Table 2. SFWDAT depth maps for the Phase I restoration area are shown in Figure 8. Kissimmee River floodplain stages at selected stations are shown in Figure 9.

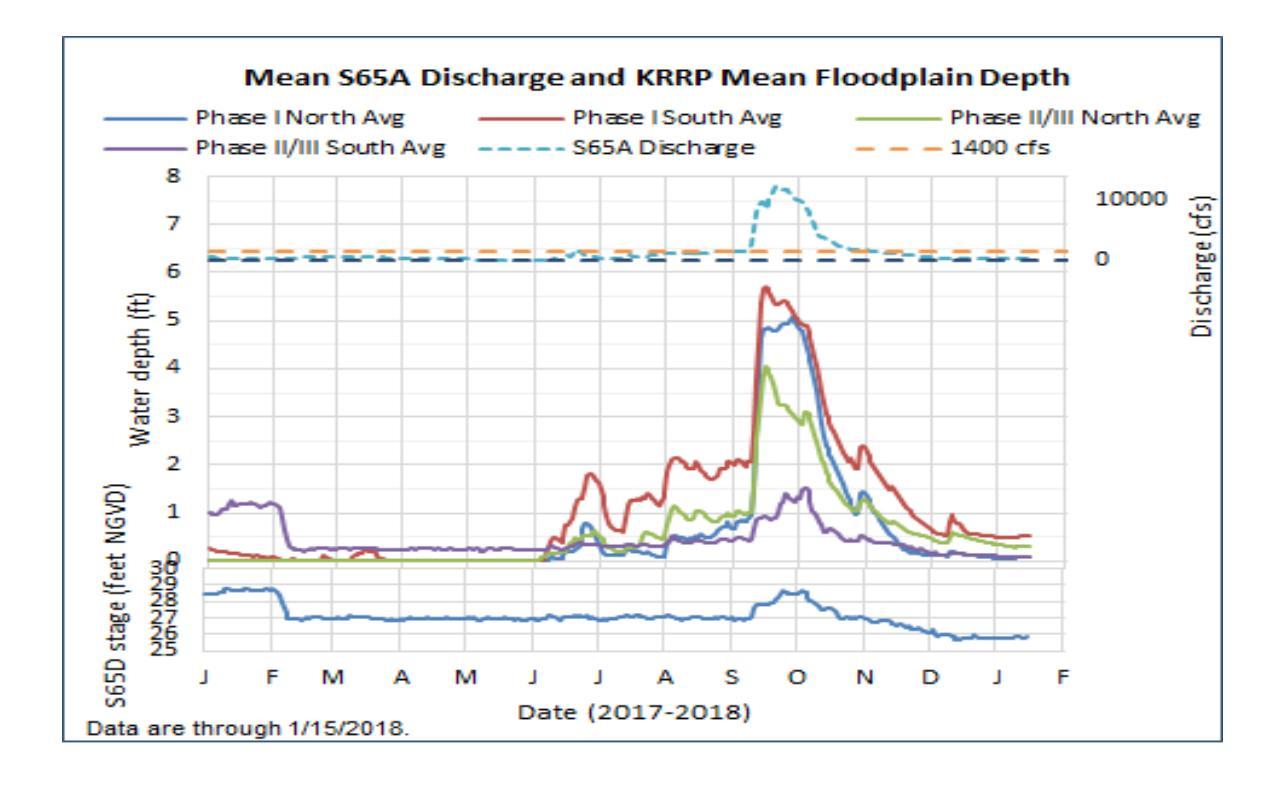
Figure 9. Mean water depth in the northern Phase I, southern Phase I, northern Phase II/III, and southern Phase II areas in relation to the S65A discharge and S65D headwater stage.

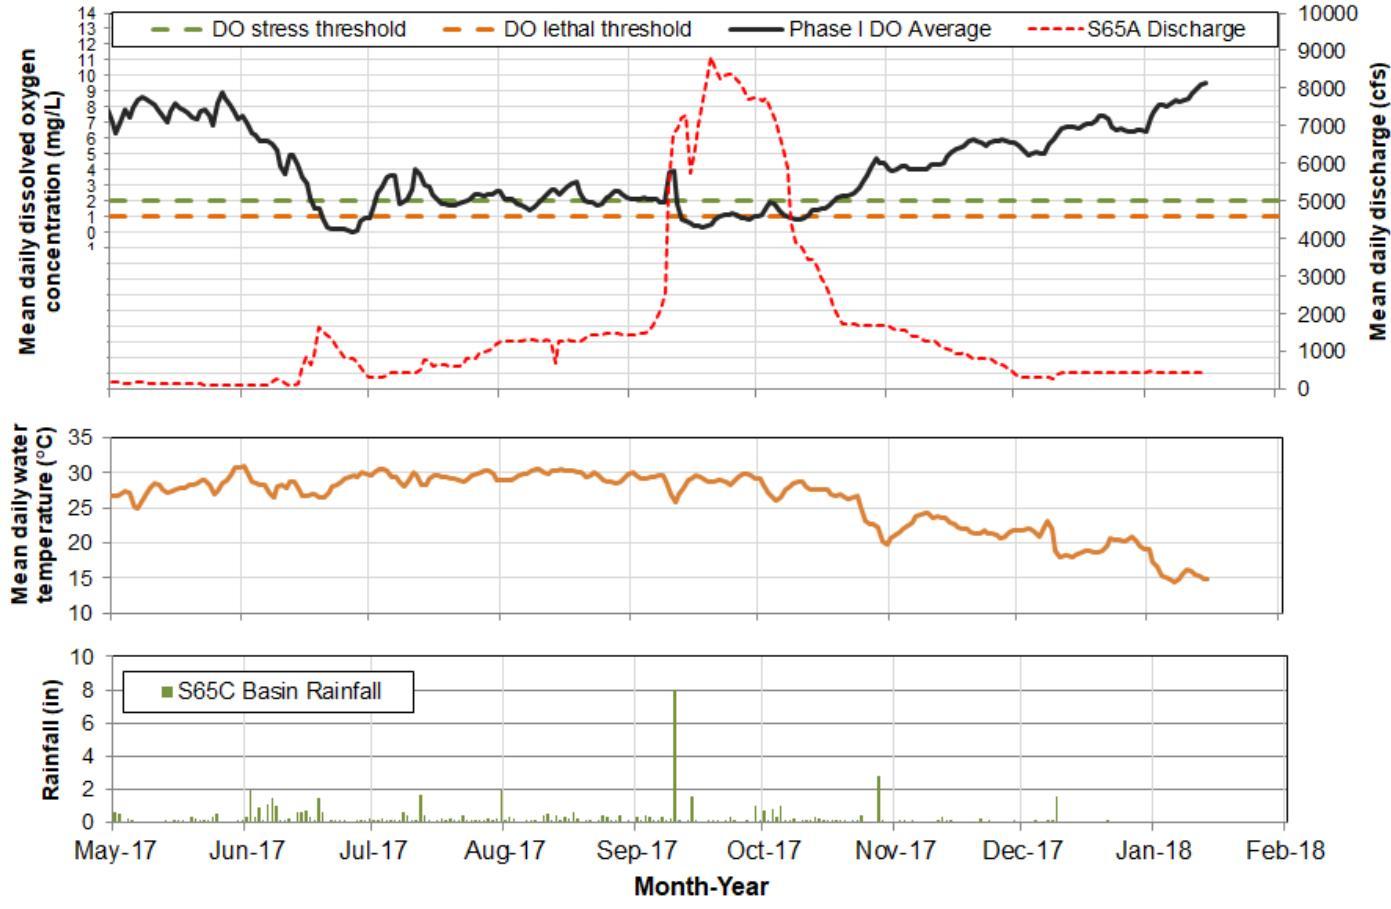
Figure 10. Mean daily dissolved oxygen, discharge, temperature and rainfall in the Phase I river channel.

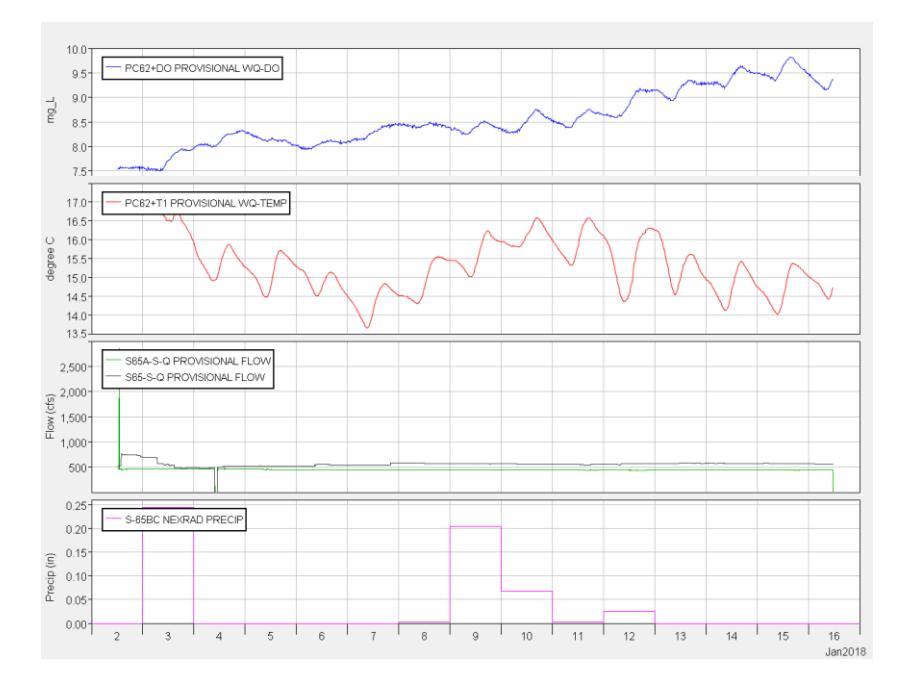
Figure 11. Phase I river channel dissolved oxygen and water temperature (measured at 15 minute intervals) and Pool BC daily rainfall.

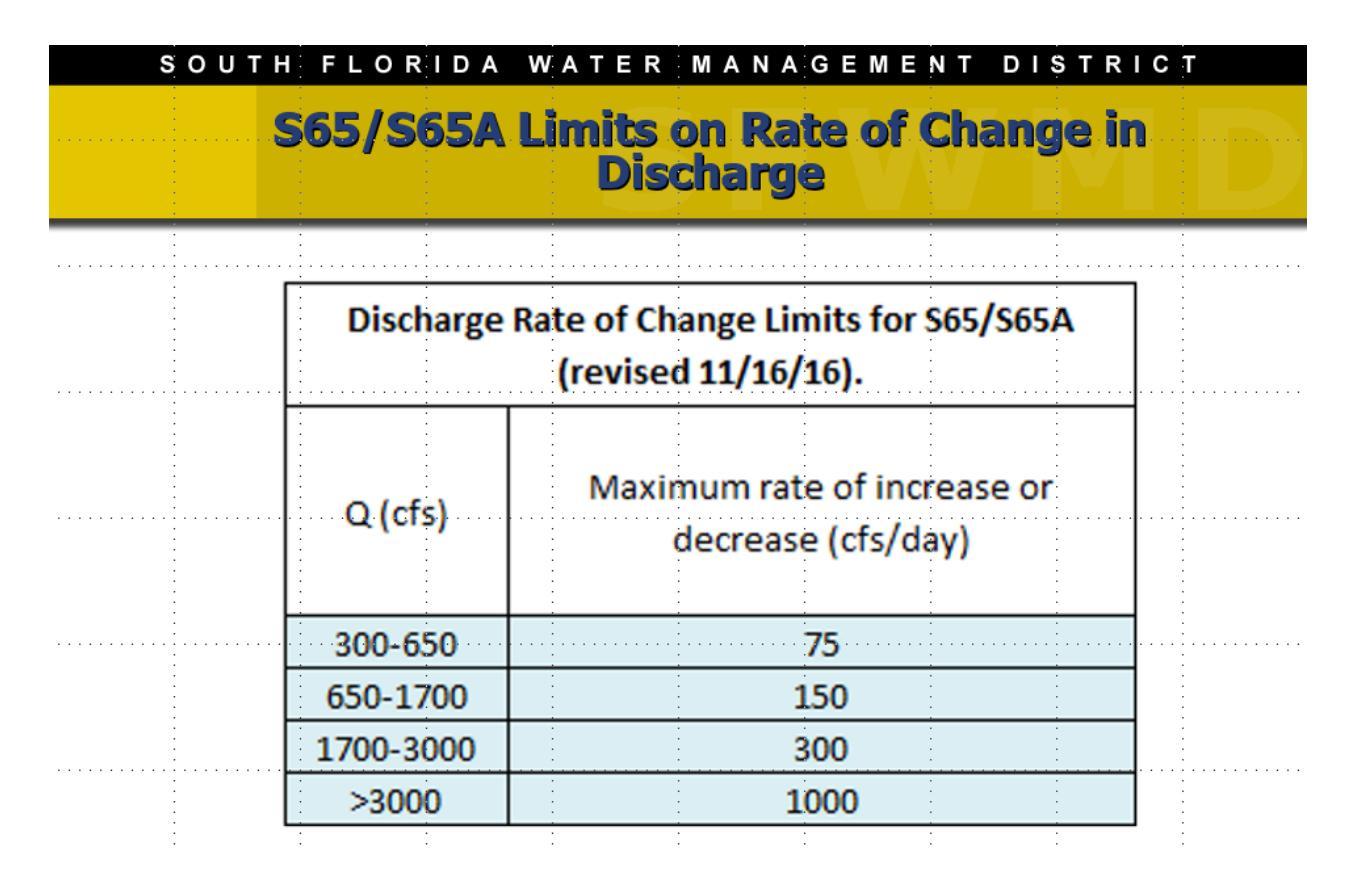
Figure 12. Limits on rate of discharge change at S65/S65A starting with the 2016-2017 Dry Season.

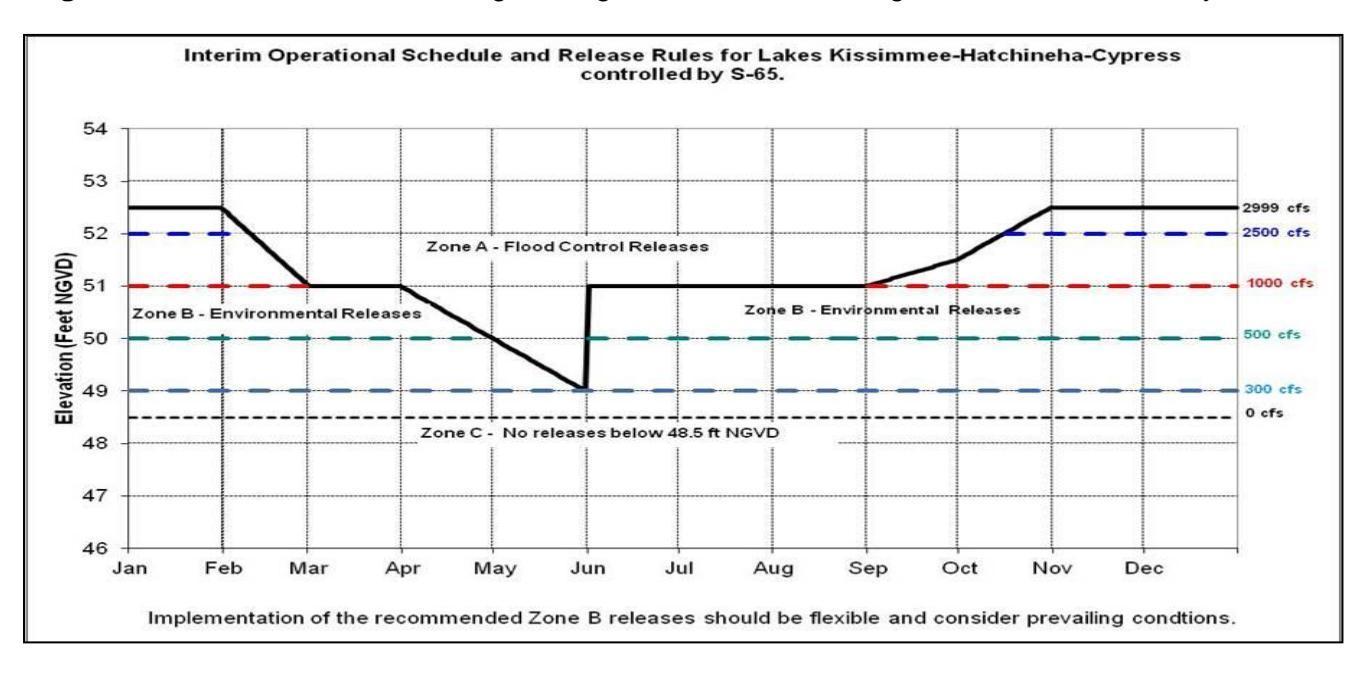
Figure 13. Interim operations schedule for S-65. The discharge schedule shown to the right has not been used in recent years.

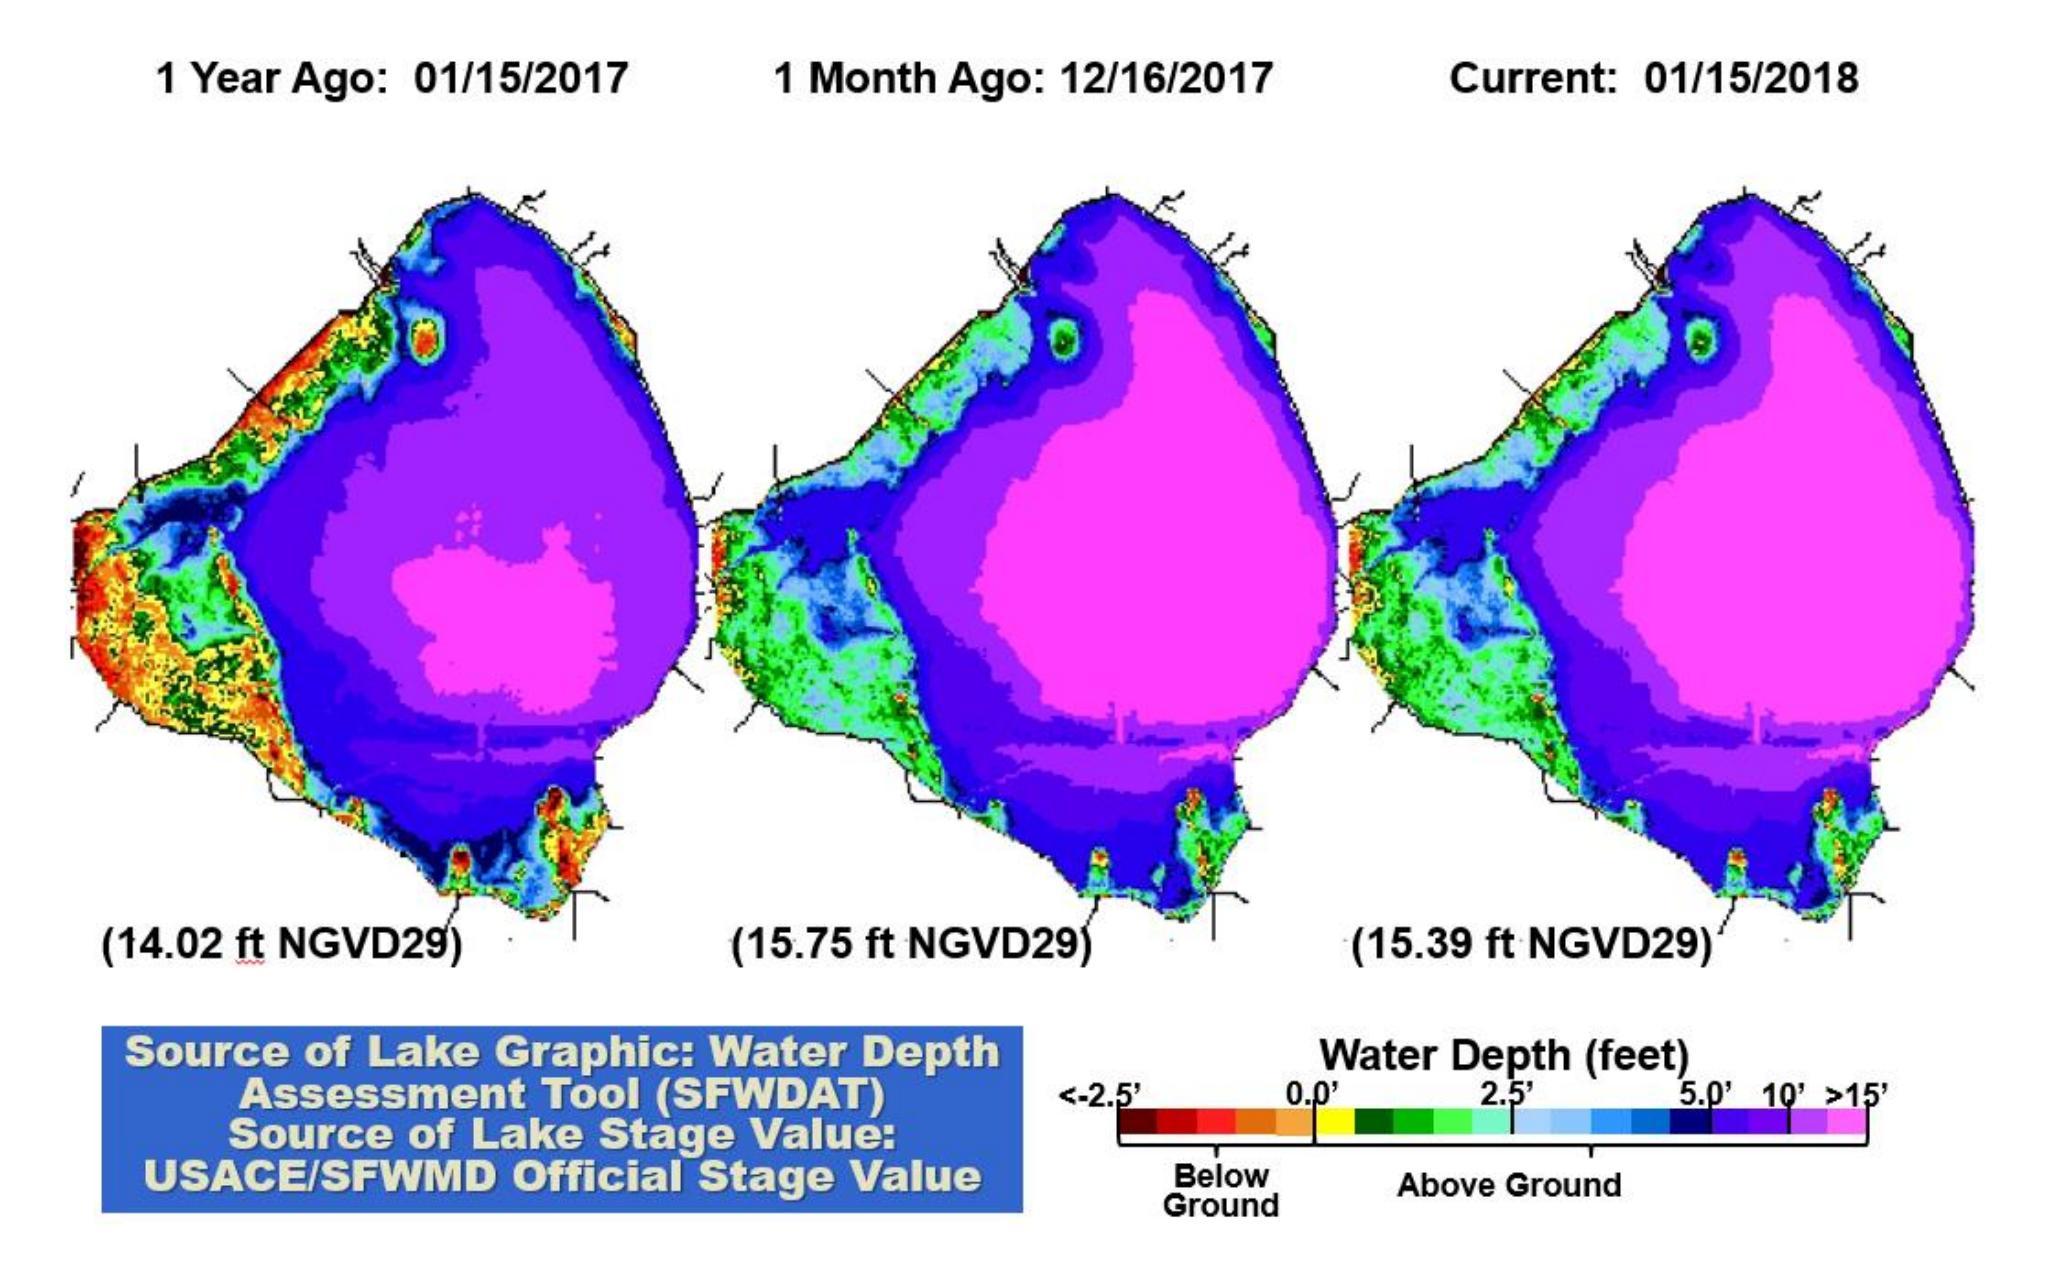
Figure 1. Water depth estimates on Lake Okeechobee based on the South Florida Water Depth Assessment Tool.

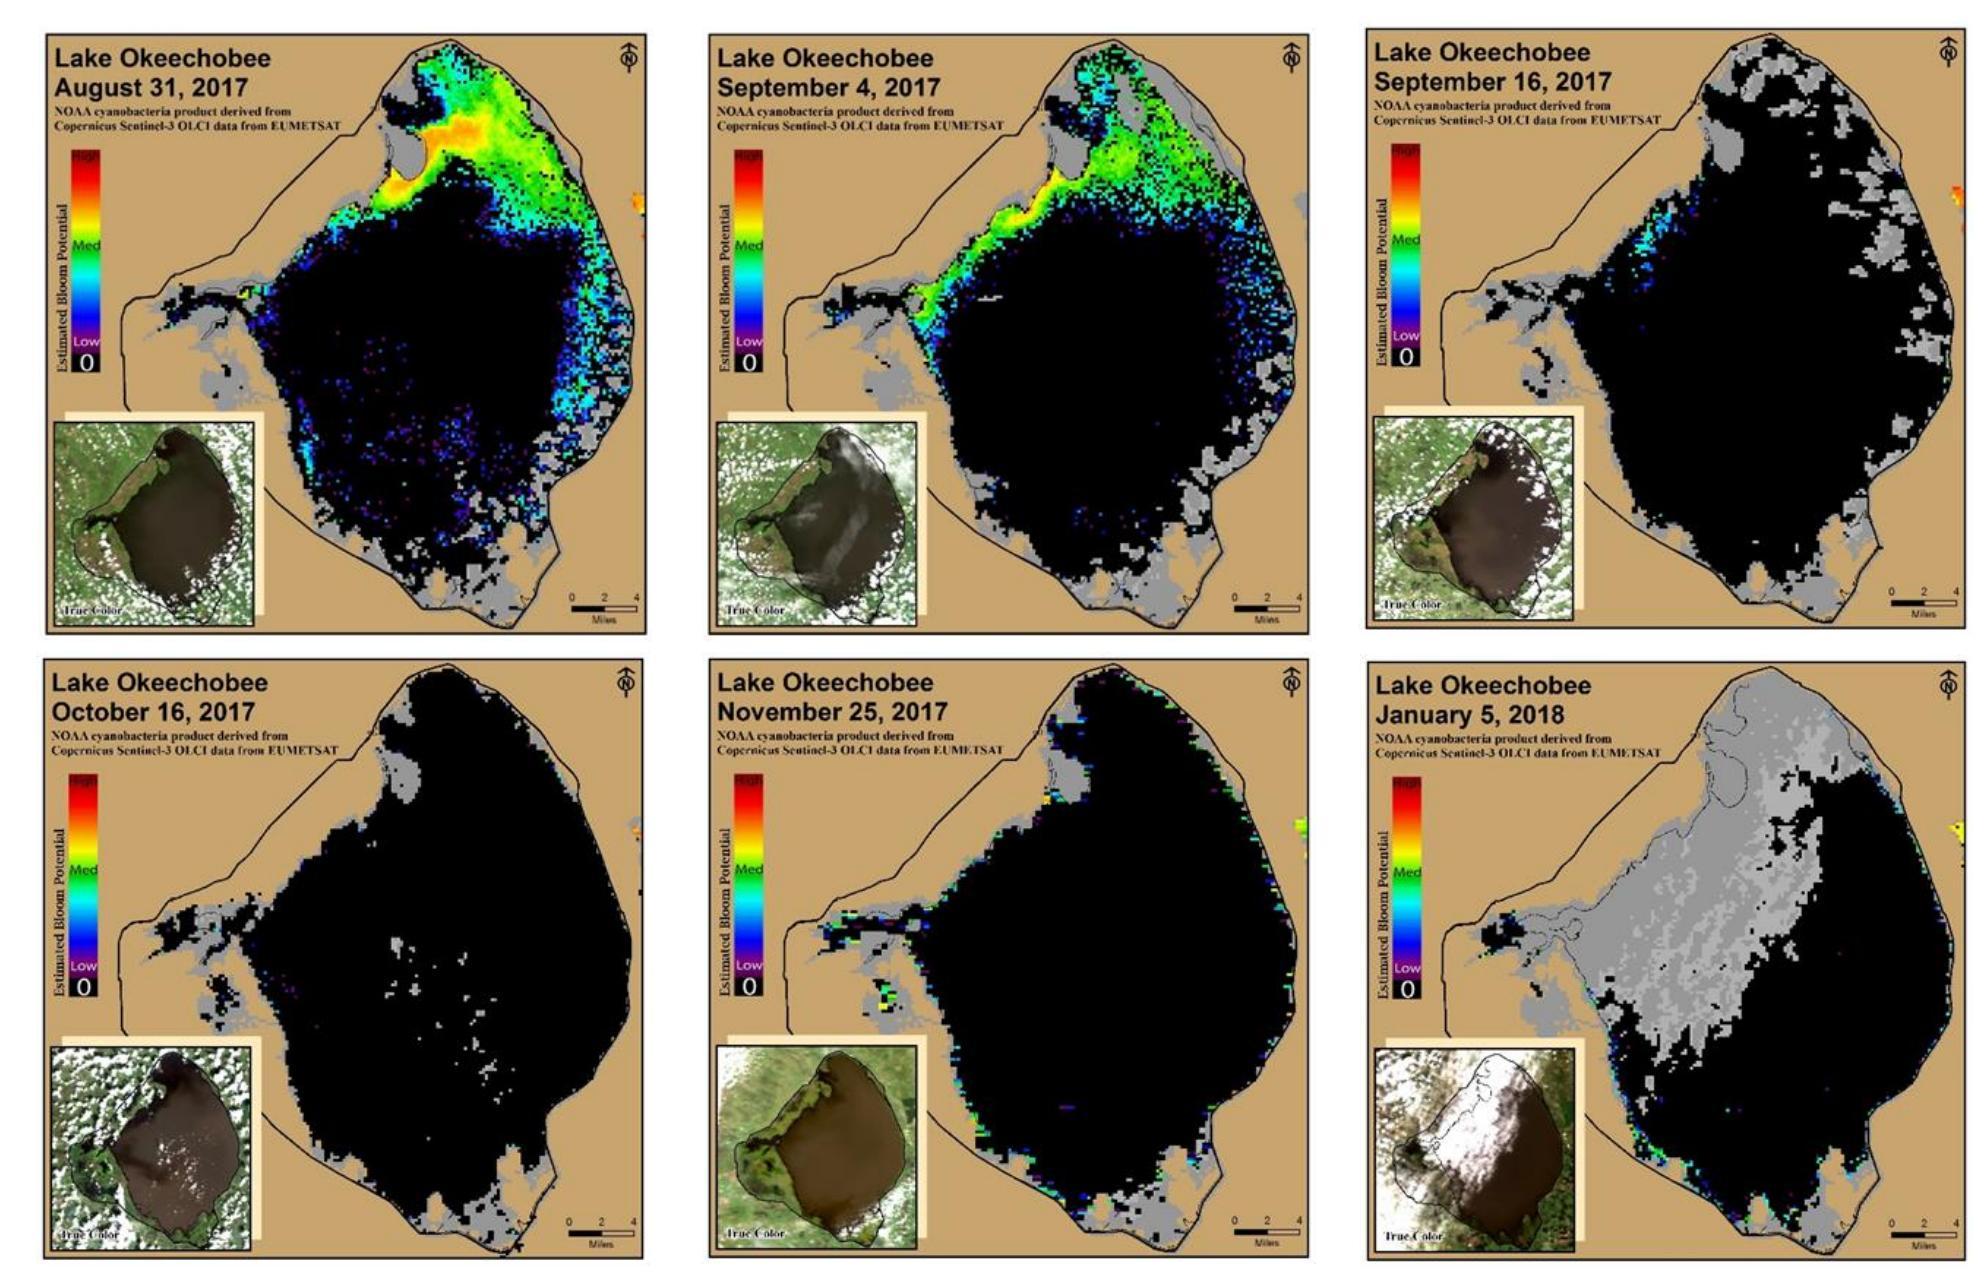
Figure 5. Potential for cyanobacterial blooms on Lake Okeechobee based on NOAA's harmful algal bloom monitoring system derived from Copernicus Sentinel-3 OLCI data from EUMETSAT.

Satellite imagery indicates that algal bloom potential has remained very low over the past four months, based on NOAA's cyanobacteria monitoring product derived from the OLCI satellite sensor. Potential for elevated cyanobacterial levels were last observed in the northern portion of the Lake in early September 2017 (Figure 5). Along with decreasing temperatures, high winds from Hurricane Irma may have further reduced bloom potential on the Lake by increasing turbidity, but elevated TP levels from high inflows and resuspended Lake sediment are expected to produce high bloom potentials next year as turbidity continues to decline and temperatures increase.

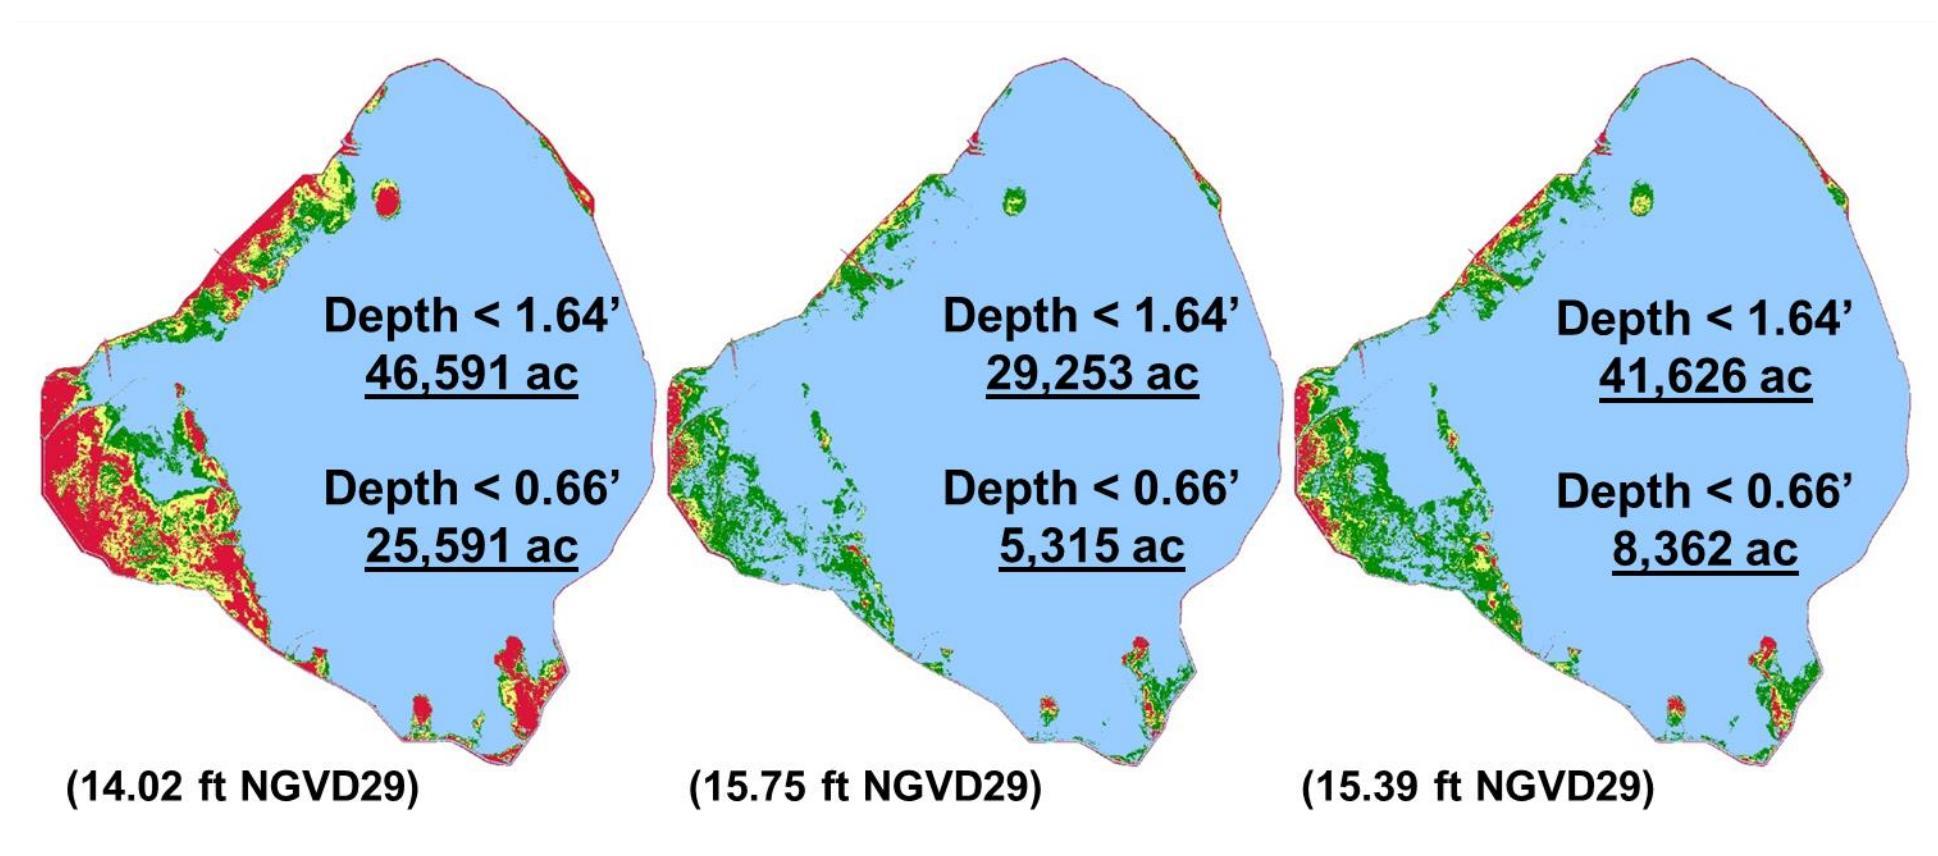
Figure 6. Wading bird habitat suitability index for Lake Okeechobee based on the South Florida Water Depth Assessment Tool.

Based on the Lake Okeechobee wading bird habitat suitability index, there are approximately 41,626 acres of suitable foraging habitat for long-legged birds and 8,362 acres for long and short legged birds on the Lake (Figure 6).

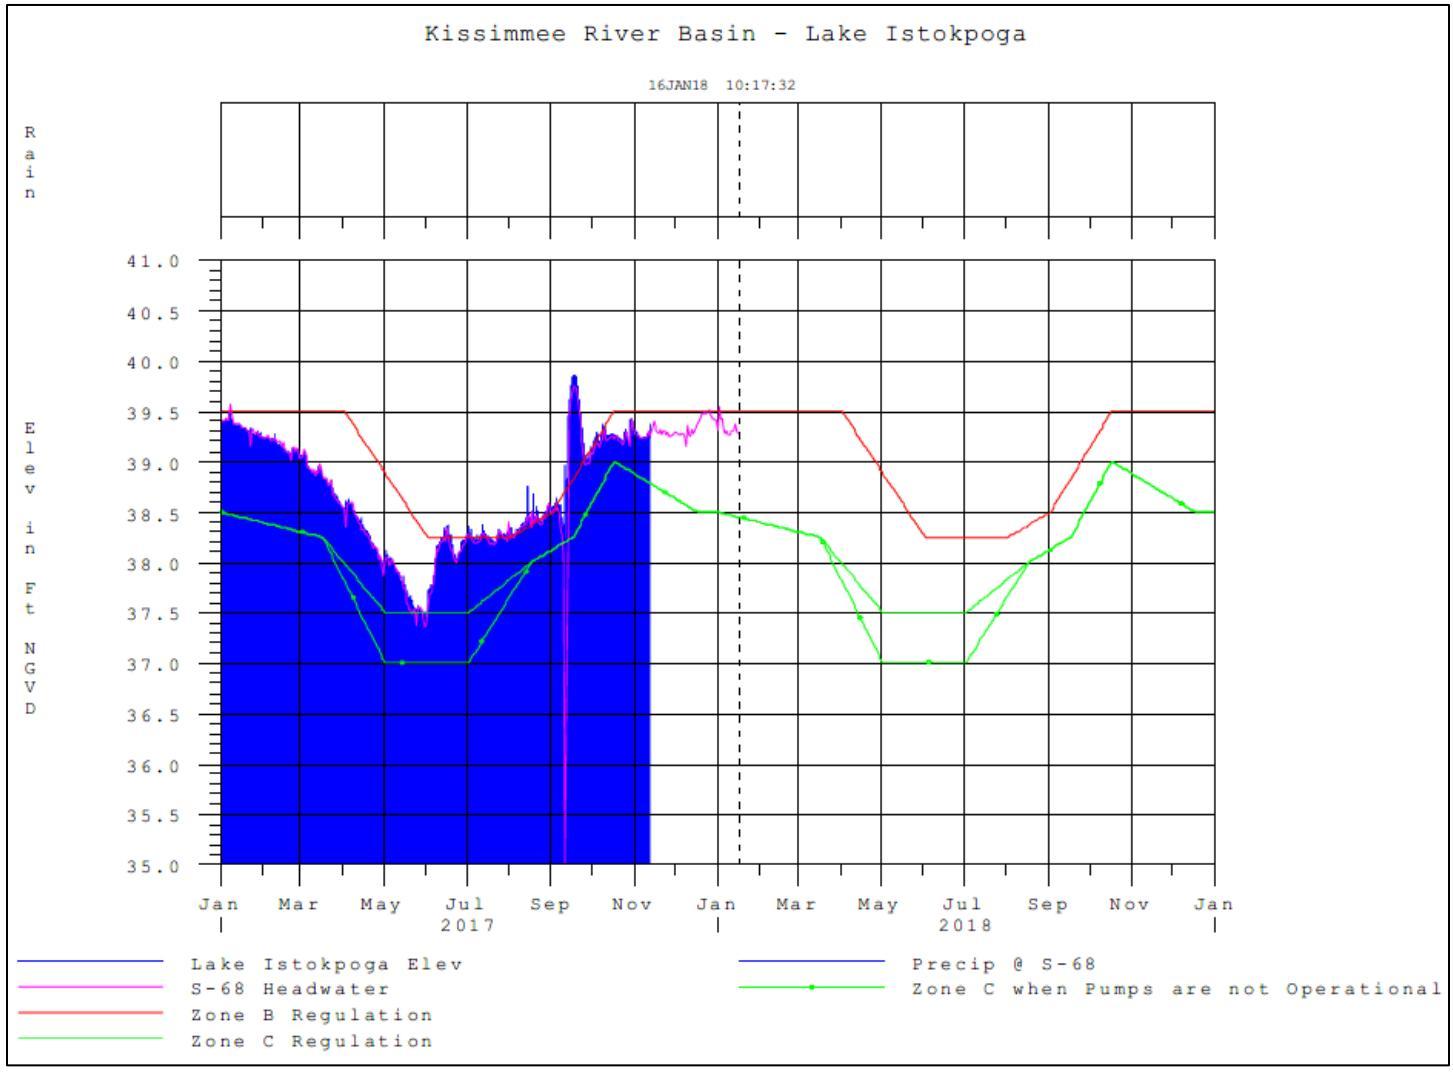
Figure 7. Recent stages on Lake Istokpoga.

Lake Istokpoga stage is 39.22 feet NGVD as of midnight January 15, 2018 and is currently 0.28 feet below its regulation schedule to accommodate construction on downstream structures (Figure 7). Average daily flows into the lake from Josephine Creek for the week January 9, 2018 – January 15, 2018 were the same as the previous week, at 48 cfs. No data have been reported for Arbuckle Creek since July 4, 2017 as the gauge is being recalibrated after construction in the area. Average daily discharge from S68 and S68X over the past week decreased to 168 cfs from 325 cfs the week prior. According to RAINDAR, only 0.3 inches of rain fell in the Lake Istokpoga basin over the past week.

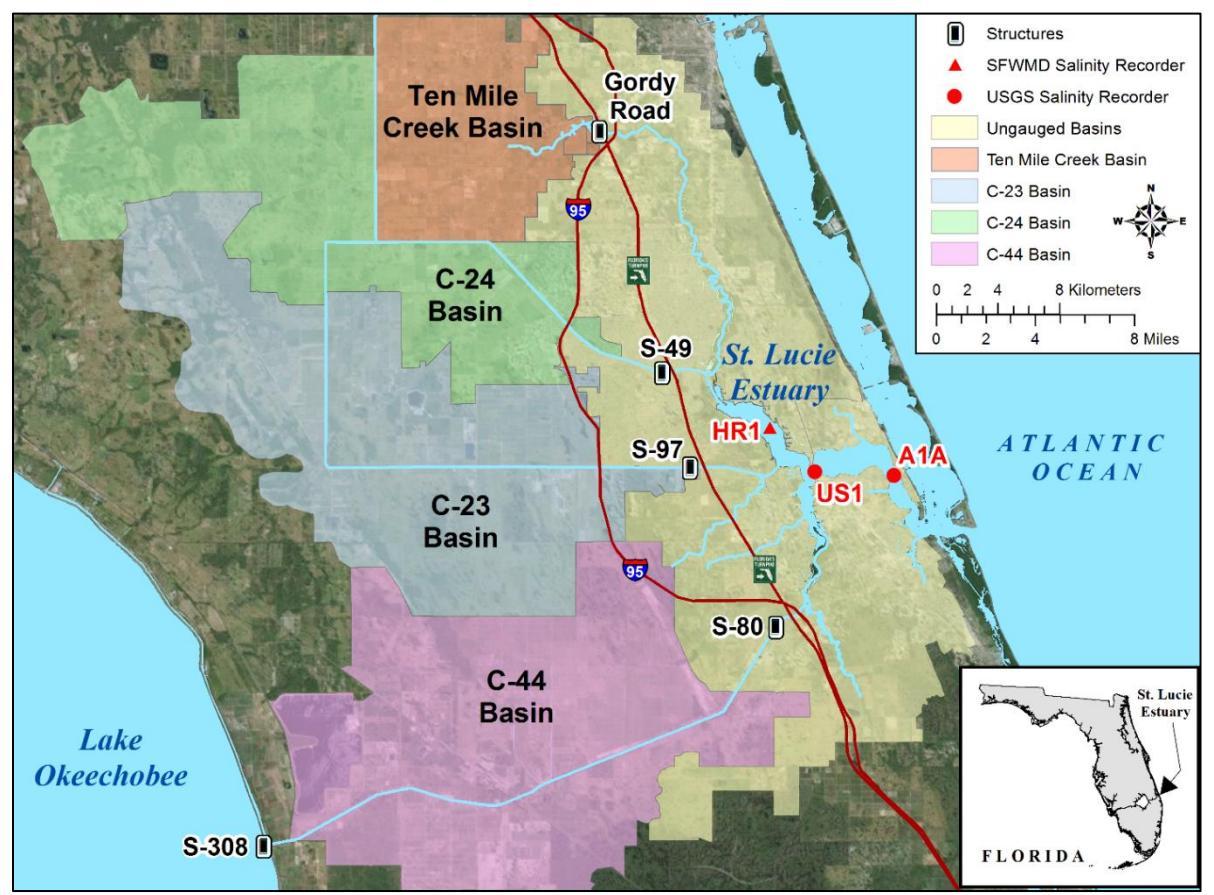
Figure 1. Basins, water control structures, and salinity monitoring for the St. Lucie Estuary.

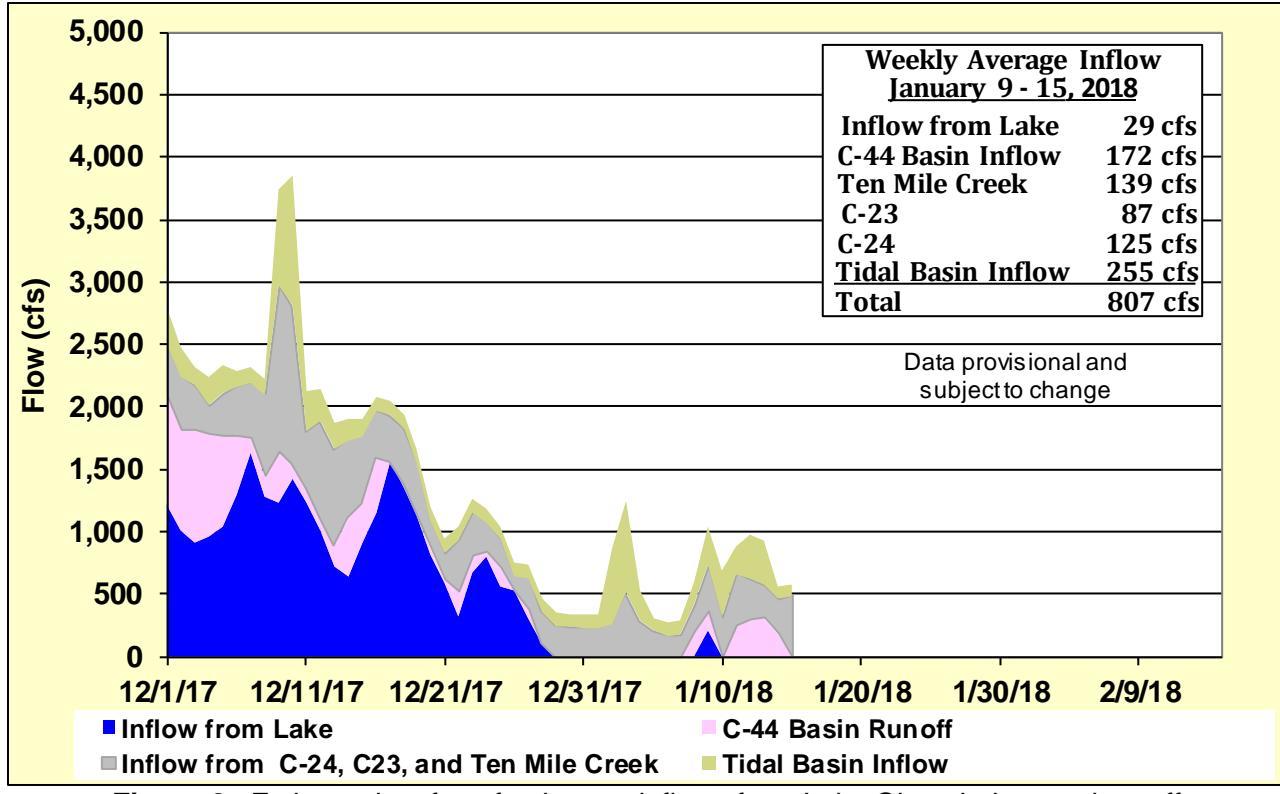
Figure 2. Estimated surface freshwater inflows from Lake Okeechobee and runoff from the C-44, C-23, C-24, Ten Mile Creek, and tidal basins into the St. Lucie Estuary.

Last week total inflow into the St. Lucie Estuary averaged about 807 cfs (Figures 1 and 2) and last month inflow averaged about 846 cfs. Last week's provisional averaged inflows from the tidal basin and the structures are shown in Table 1.

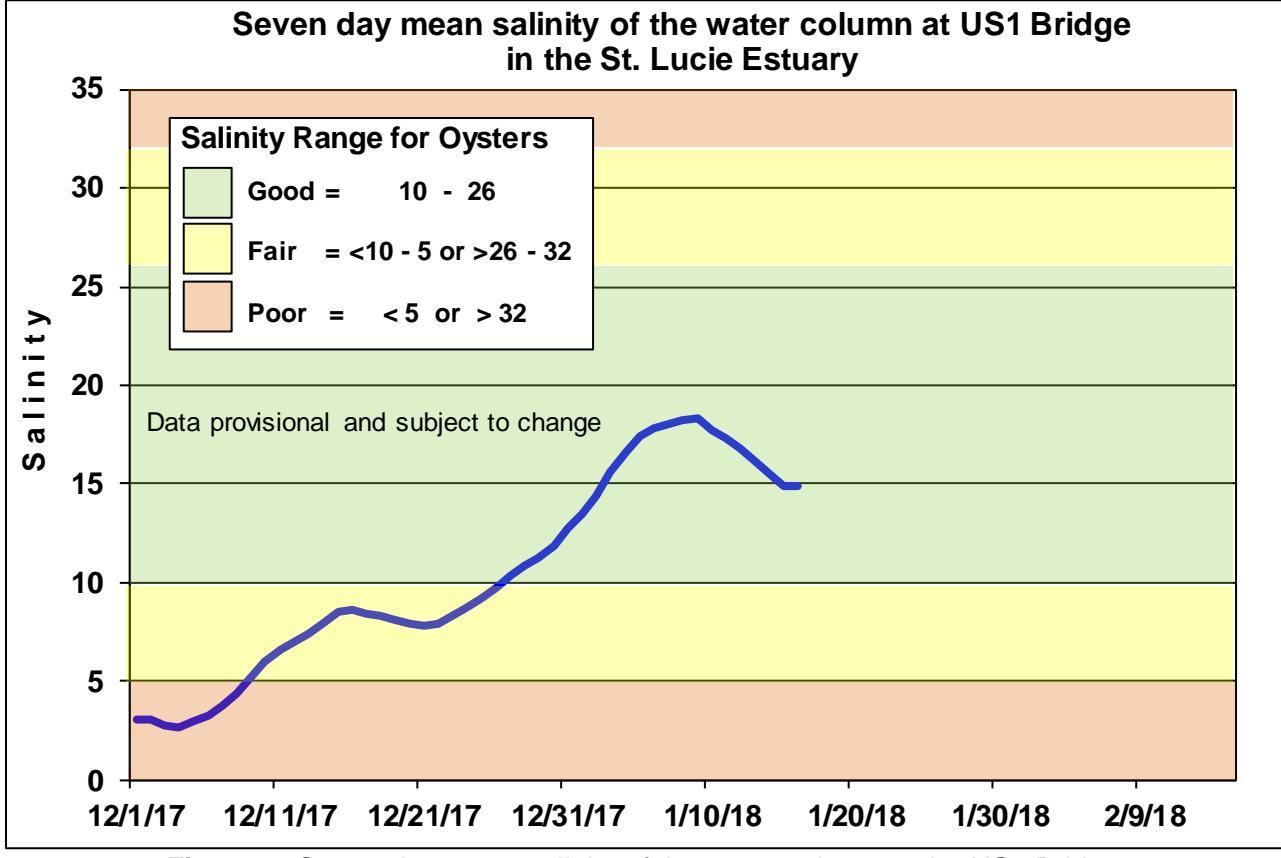
Figure 3. Seven-day mean salinity of the water column at the US1 Bridge.

Over the past week, salinity decreased throughout the estuary (Table 2, Figures 3 and 4). The sevenday moving average salinity of the water column (an average of the surface and bottom salinity) at the US1 Bridge is 14.9. Salinity conditions in the middle estuary are in the good range for adult eastern oysters (Figure 3).

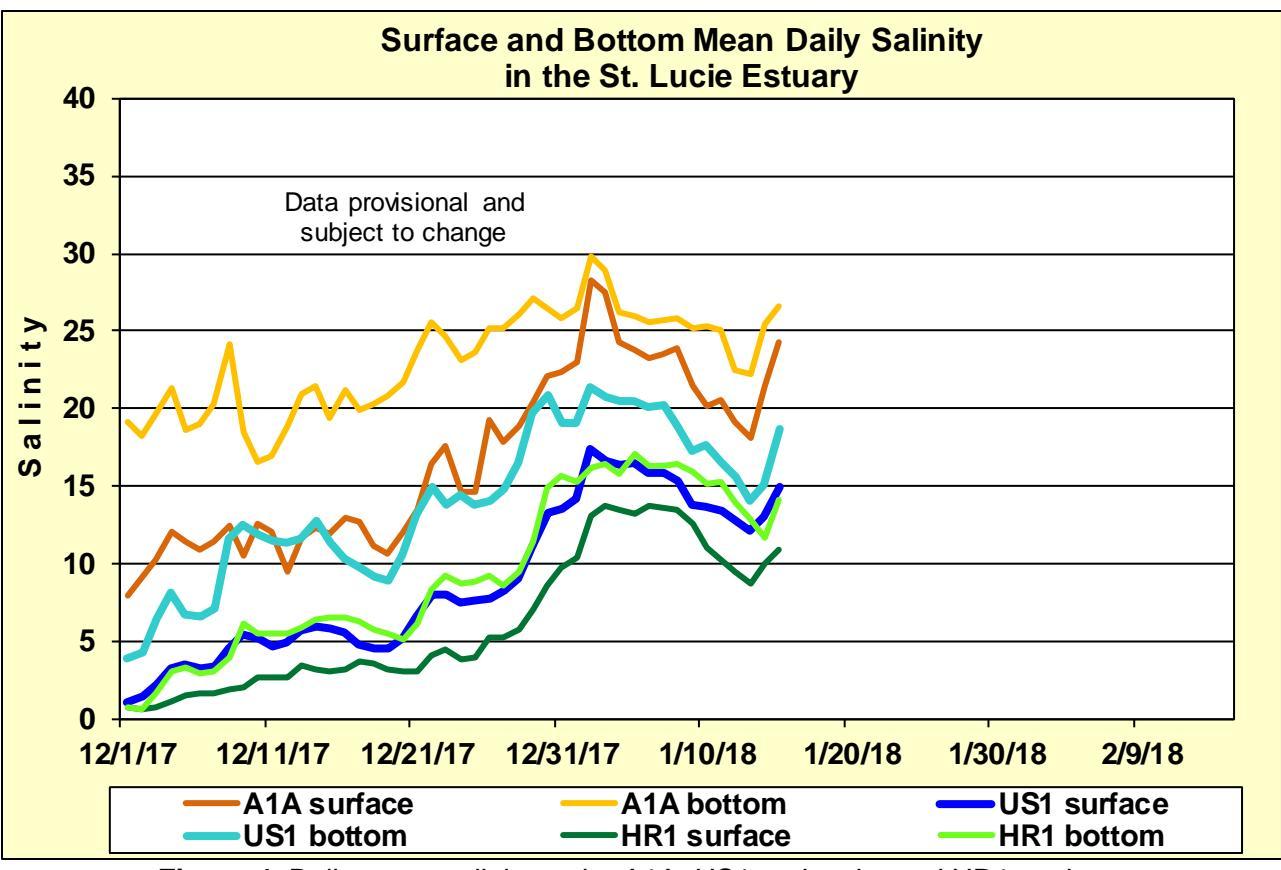
Figure 4. Daily mean salinity at the A1A, US1 and estimated HR1 stations.

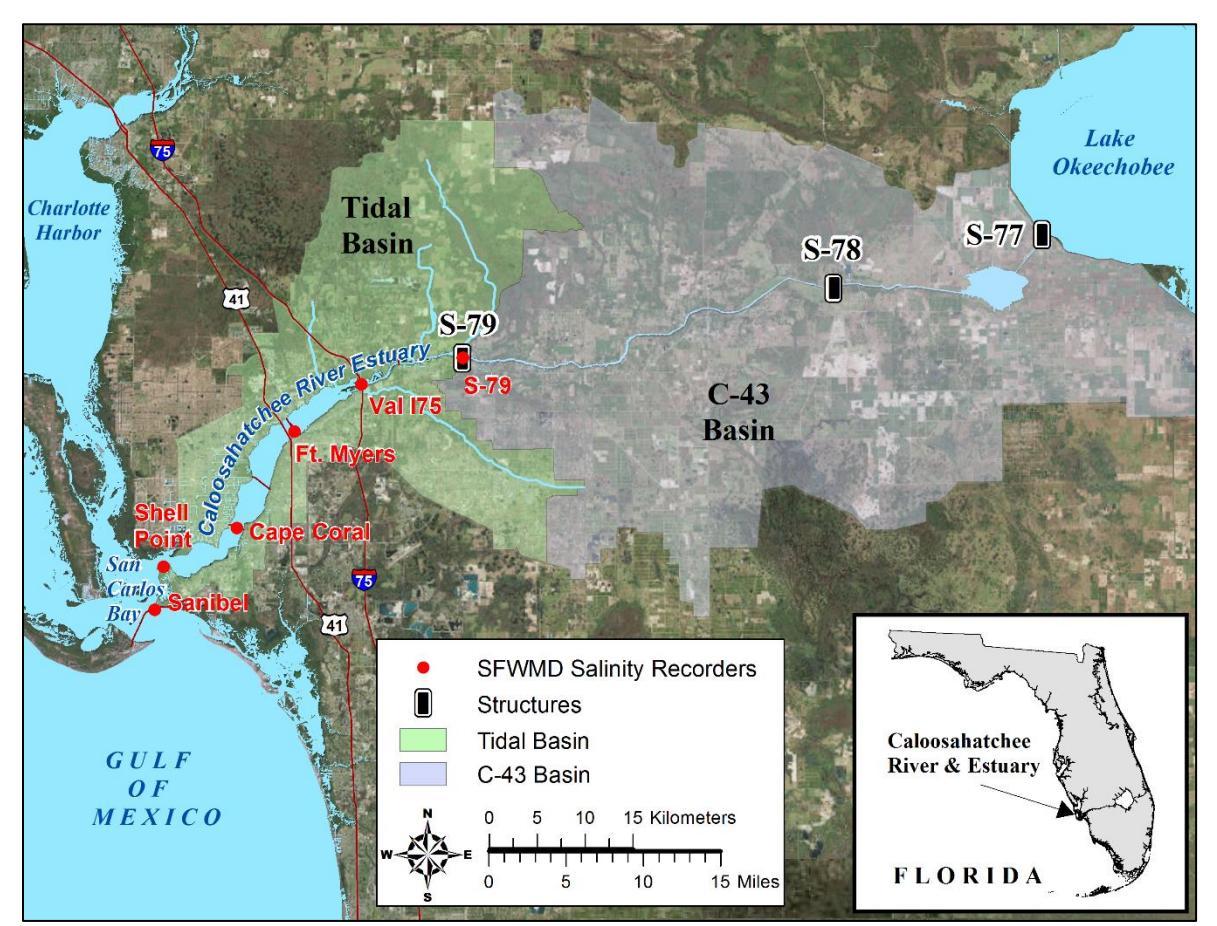
Figure 5. Basins, water control structures, and salinity monitoring for the Caloosahatchee Estuary.

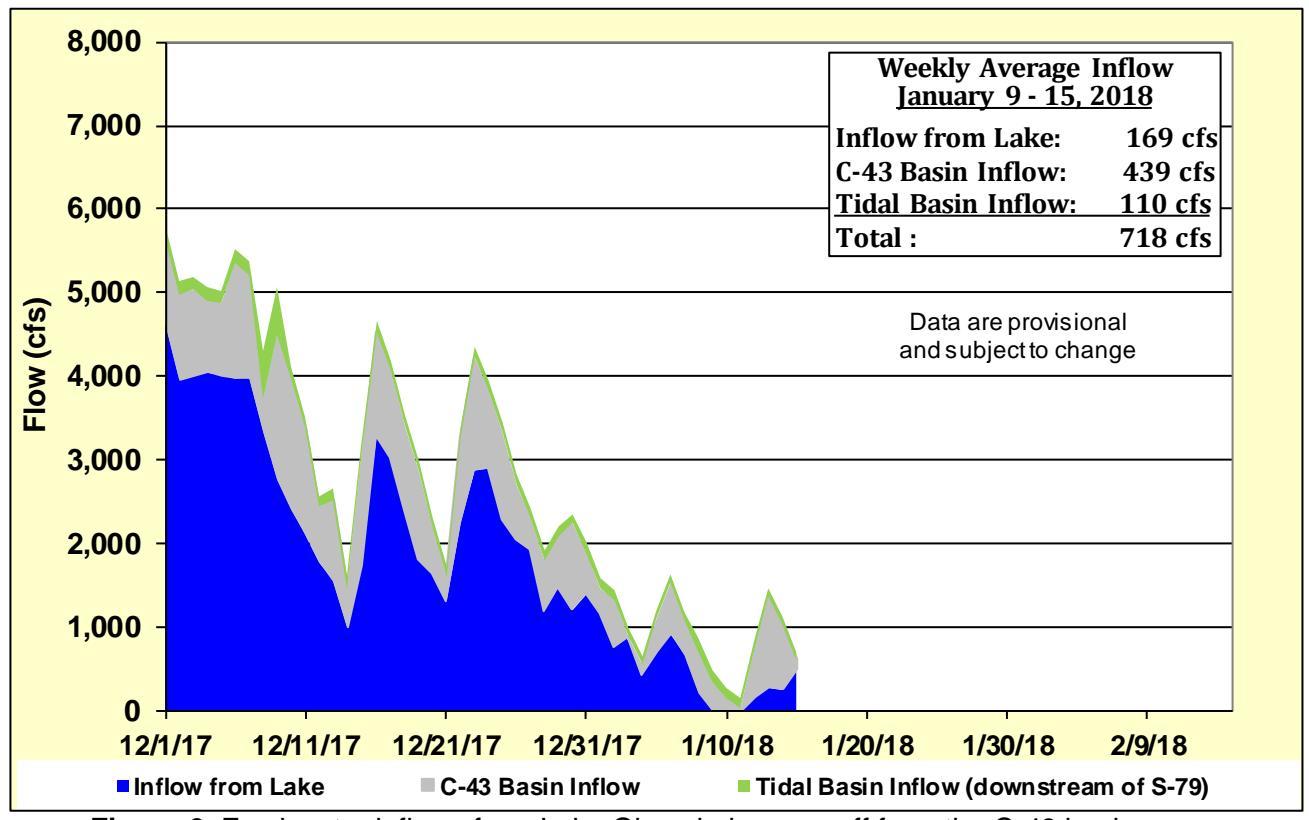
Figure 6. Freshwater inflows from Lake Okeechobee, runoff from the C-43 basin, and tributaries in the tidal basin into the Caloosahatchee River Estuary.

Last week total inflow into the Caloosahatchee Estuary averaged about 718 cfs (Figures 5 and 6) and last month inflow averaged about 1,939 cfs. Last week's provisional averaged inflows from the structures are shown in Table 4.
