MEMORANDUM

DATE: January 16, 2018

SUBJECT: Weekly Environmental Conditions for Systems Operations

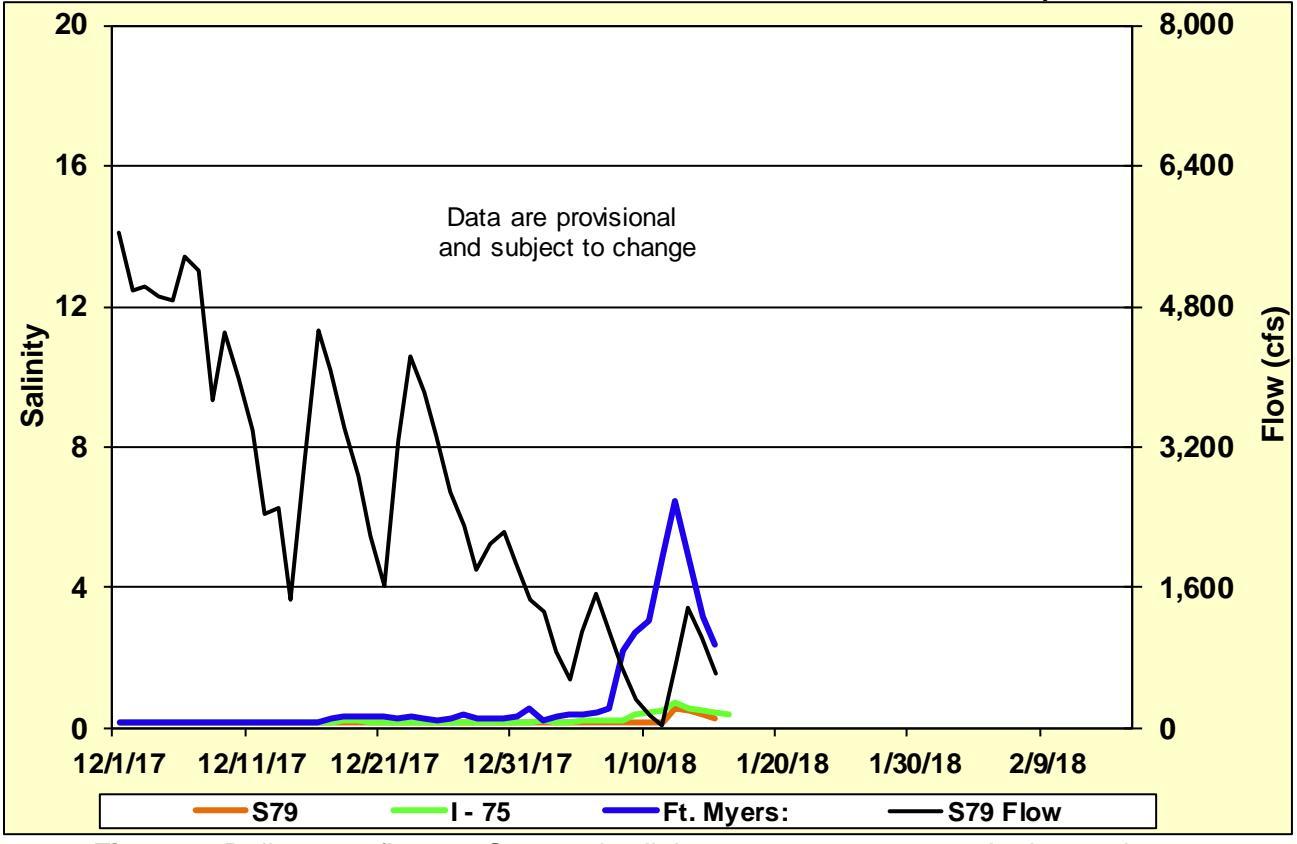
Figure 7. Daily mean flows at S-79 and salinity at upper estuary monitoring stations.

Over the past week, salinity increased throughout the estuary (Table 5, Figures 7 & 8). The seven-day average salinity values are within the good range for adult eastern oysters at Cape Coral and at Shell Point (Figure 9). Salinity data were not available at Sanibel. The 30-day moving average surface salinity is 0.3 at Val I-75 and 1.3 at Ft. Myers. With no flow through S-79, daily salinity at Val I-75 is forecast in two weeks to be 4.1, and the 30-day moving average is forecast to be 1.5 (Figure 10). Salinity conditions between Val I-75 and Ft. Myers are good for tape grass.

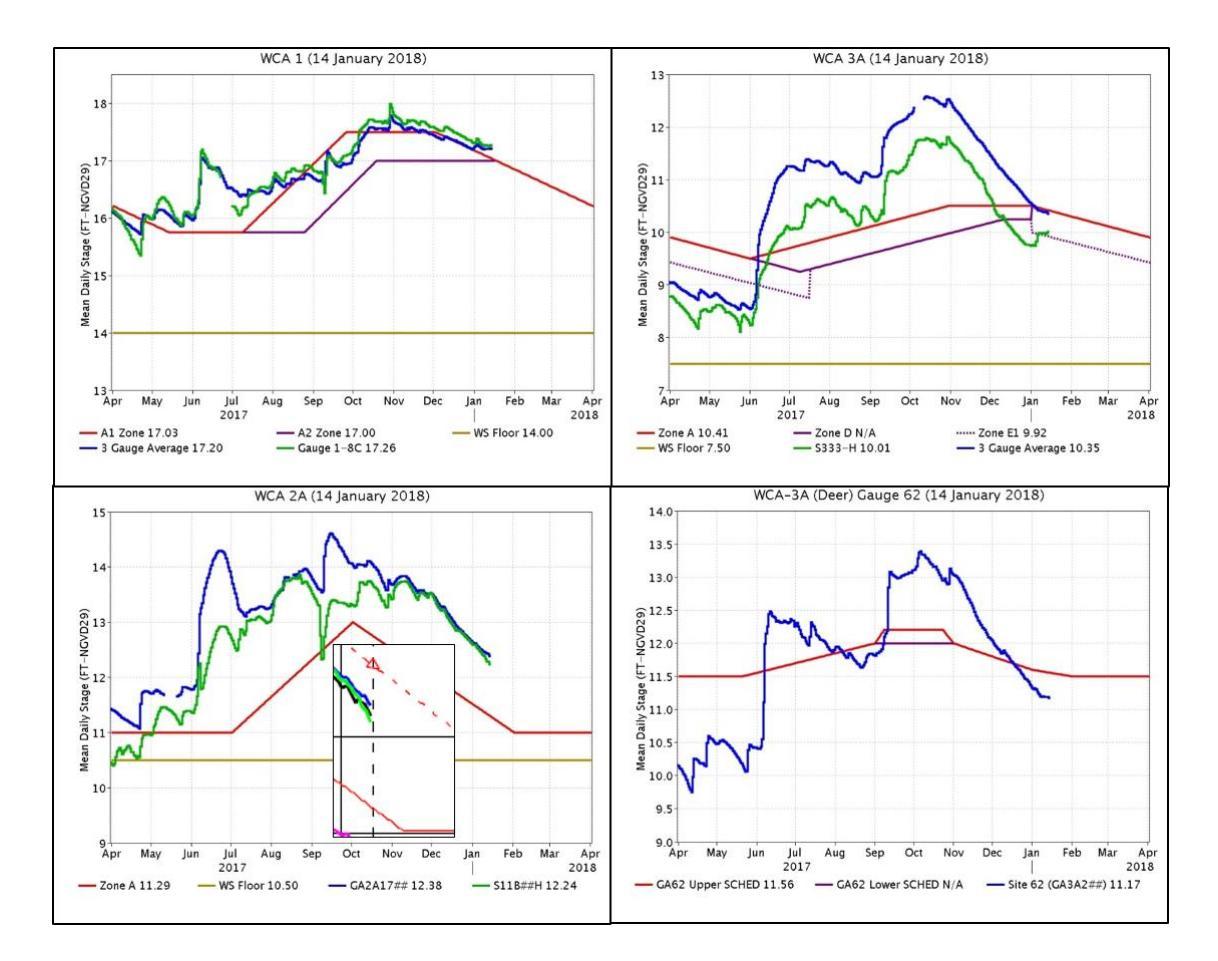
Water Depths and Changes: The WDAT tool for spatial interpolation of depth indicates a range from a low of 0.0 feet to 0.5 feet along the northern perimeter of WCA-3A and northern WCA-2A, to a high of 3.5 feet to 4.0 feet along the northern L-67A canal in southern WCA-3A. Comparing WDAT water levels from present, water depths over the last week fell across the entire Everglades, with the exception being the northeastern and southwestern regions of WCA-1. Looking back one month, stages in all the WCAs are lower, with a majority of WCA-3A and 2A being significantly lower. Pan evaporation was estimated at 0.77 inches over the last week.

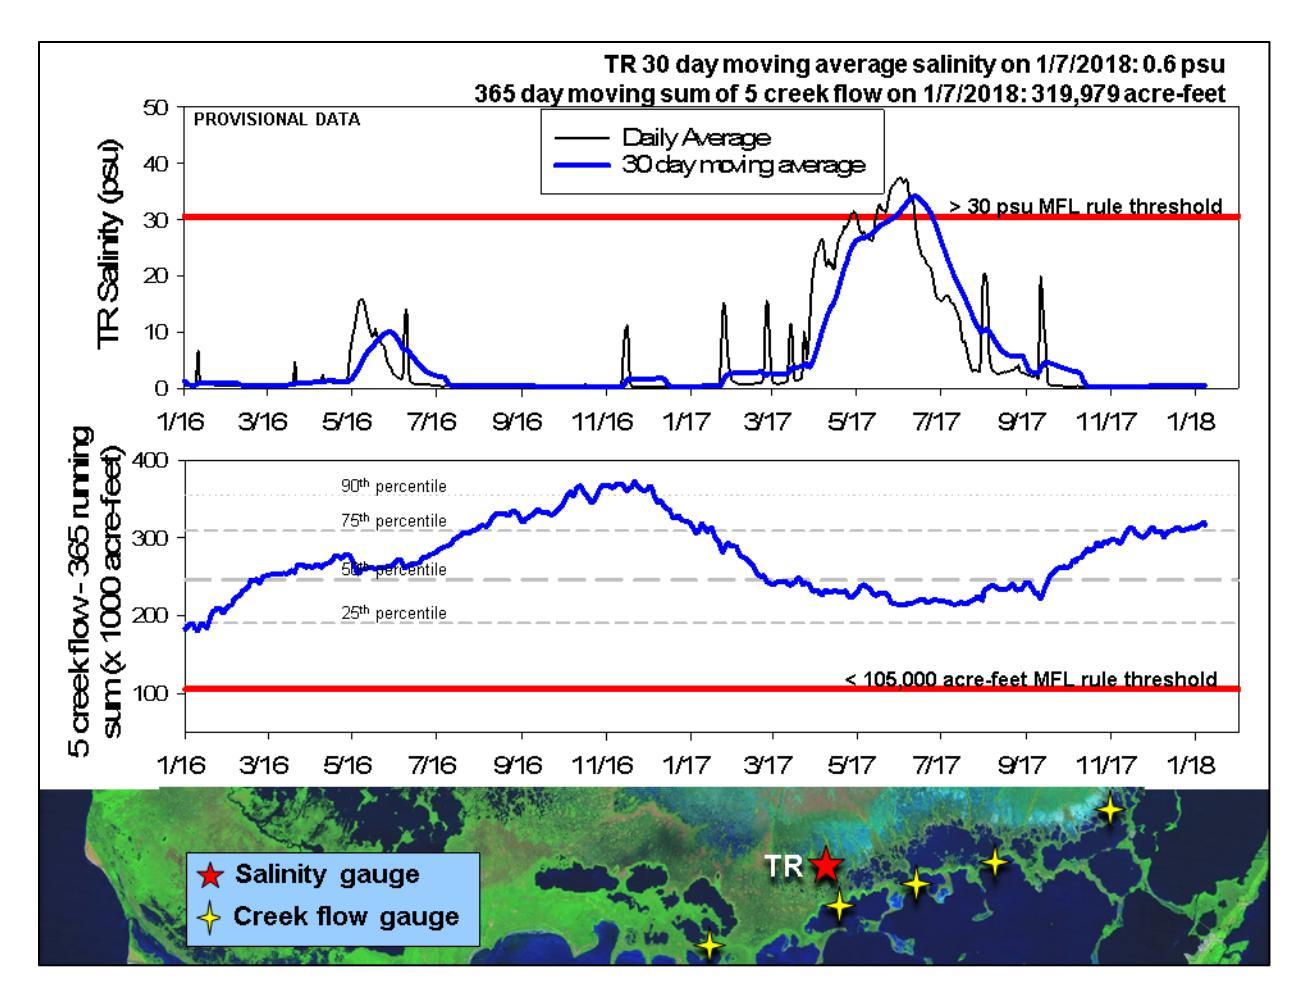
Florida Bay MFL: Mangrove zone daily average salinity remains near fresh at 0.6 psu and has started to slowly increase. The 30-day moving average is 0.6 psu. The weekly cumulative flow from the five creeks denoted by yellow stars on the map decreased by about 2,000 acre-feet over the last week to end at just under 4,500 acre-feet. This is double the historical average for this time of year. Flows are expected to decrease as the dry season progresses. The 365-day moving sum of flow from the five creeks identified by yellow stars on the map decreased about 1,700 acre-feet over the last week to end at 318,262 acre-feet (still greater than the long-term average of 257,628 acre-feet). Creek flow is provisional data from the USGS and is highly variable.
