# MEMORANDUM

**DATE:** June 26, 2019

SUBJECT: Weekly Environmental Conditions for Systems Operations

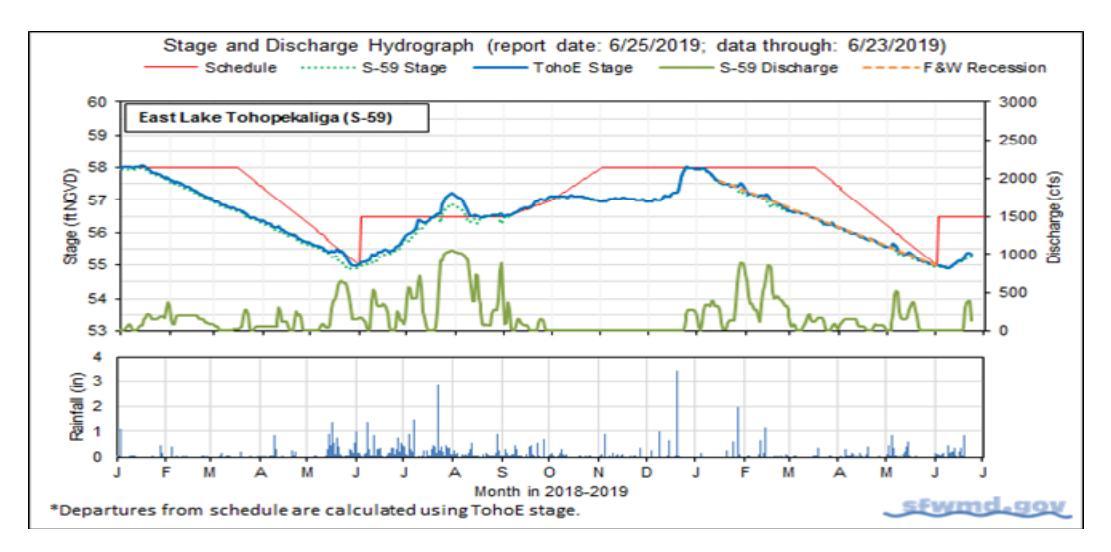
Figure 1.

Stages and departures in the Kissimmee Chain of Lakes (KCOL) are shown in **Table 1**. KCOL stage hydrographs with respective regulation schedules and rainfall are shown in Figures 1-7.

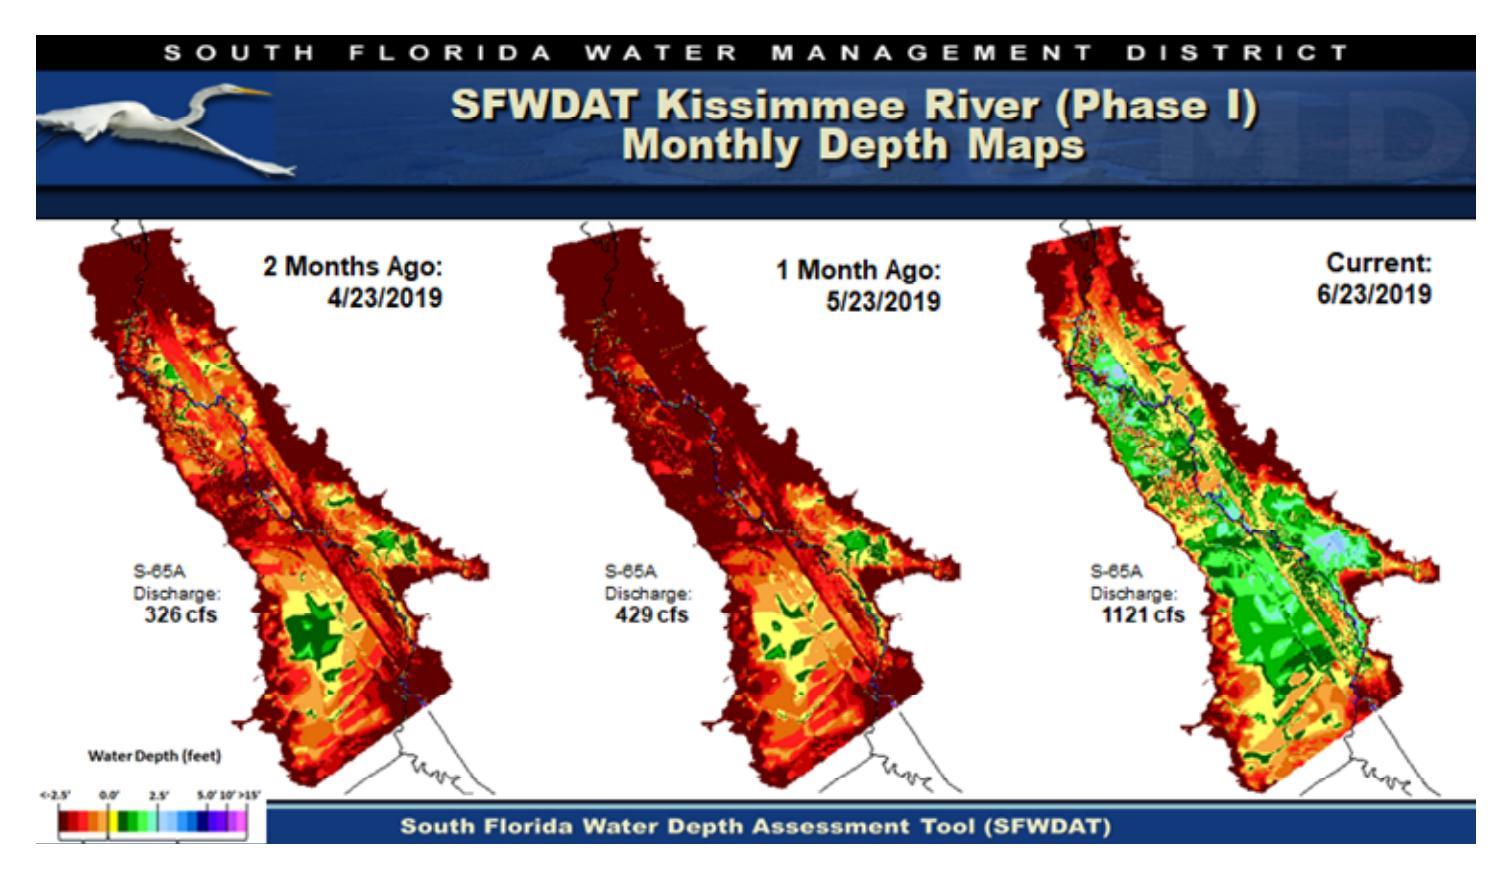
**Figure 8.** Phase I area floodplain water depths for this week, one month ago, and two months ago. Note that the WDAT color-coding has been modified to accommodate greater water depths; these maps are not directly comparable to Kissimmee Basin WDAT maps published prior to January 16, 2012.

Discharges at Lower Basin structures are shown in Table 2. SFWDAT depth maps for the Phase I restoration area are shown in Figure 8. Kissimmee River floodplain stages at selected stations are shown in Figure 9.

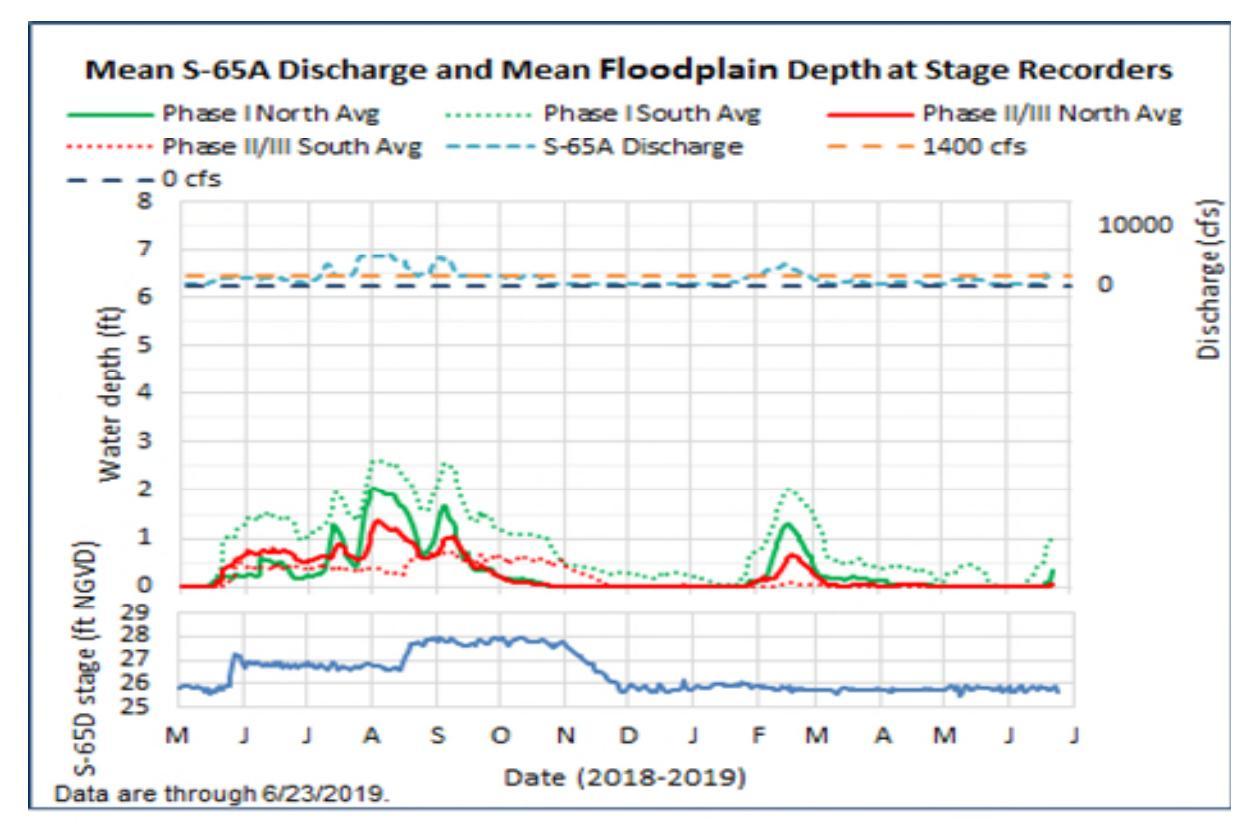
Figure 9. Mean water depth at stage recorders in the northern Phase I, southern Phase I, northern Phase II/III, and southern Phase II/III areas in relation to the S-65A discharge and S-65D headwater stage.

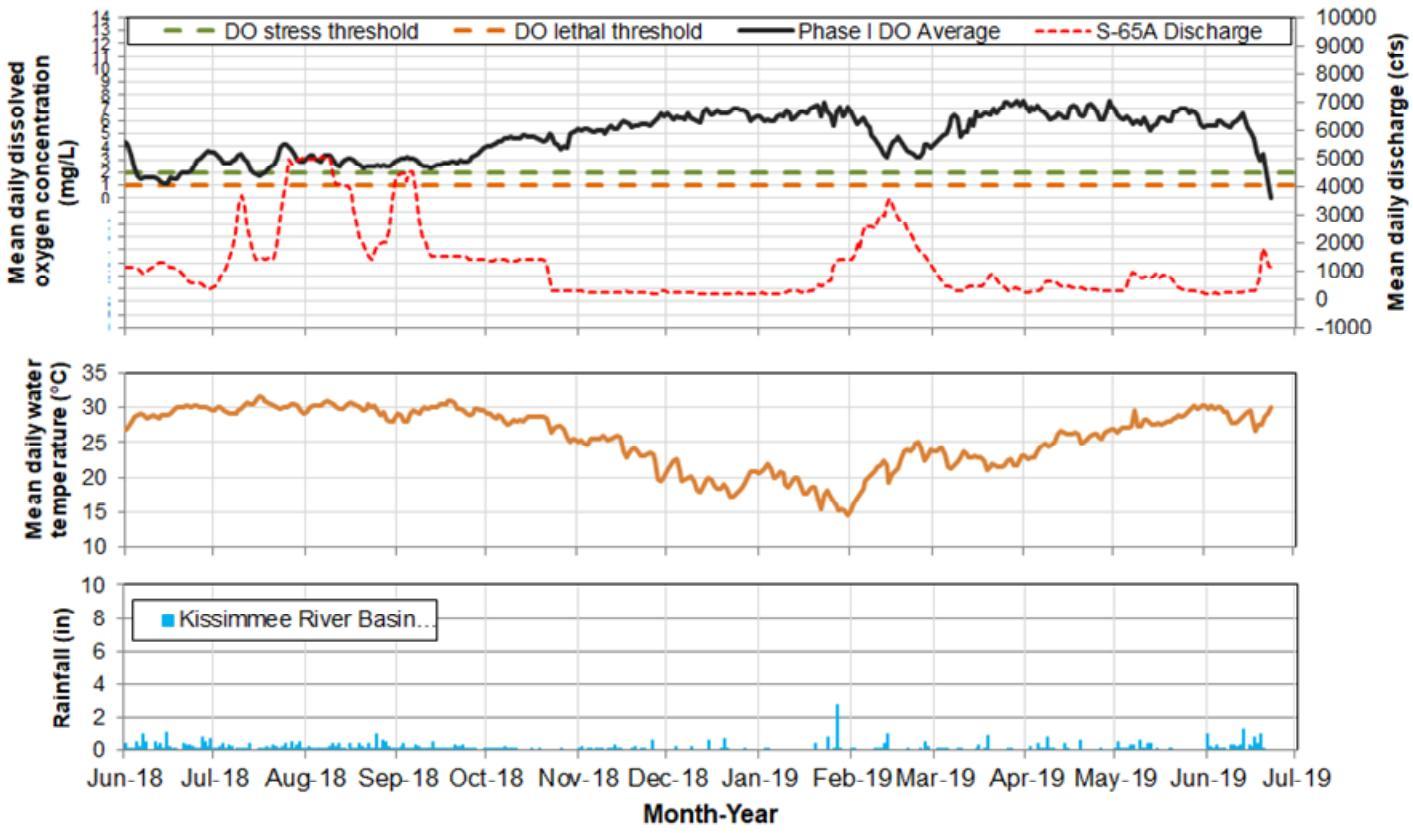
Figure 10. Mean daily dissolved oxygen, discharge, temperature and rainfall in the Phase I river channel.

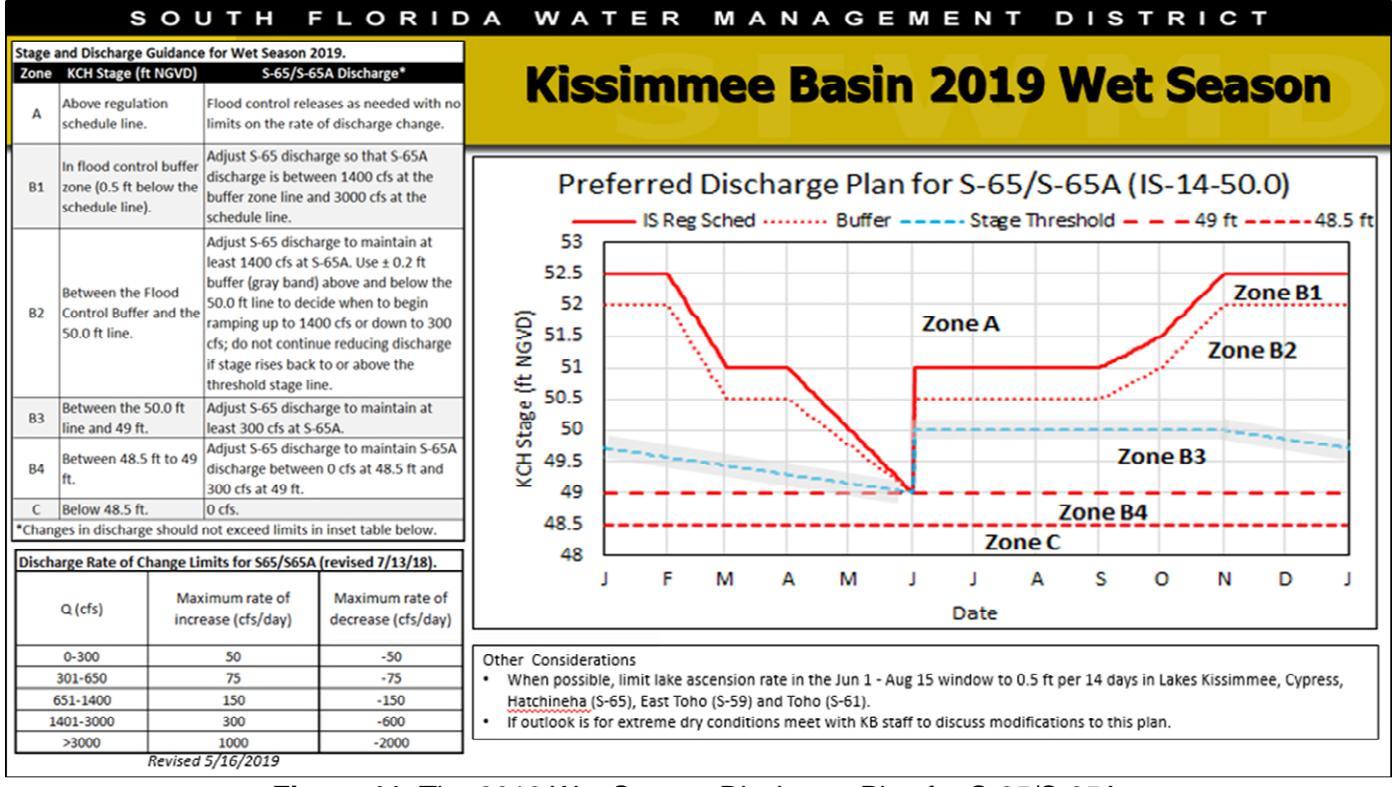
Figure 11. The 2019 Wet Season Discharge Plan for S-65/S-65A.

6/1/2019	Begin implementation of the 2019 Wet Season Discharge Plan for S-65/S-65A (see figure).	Provide variable flow from S-65/S-65A to balance Kissimmee River and Headwaters Lakes objectives, including Kissimmee River floodplain inundation, moderate rates of change in discharge, and controlled rate of stage rise in the lakes.	Planned	KB Ops	6/11/2019
5/31/2019	Reduce S-65 flow by 100 cfs over 2 days (5/31 and 6/1) to about 280 cfs.	Slow rate of stage decline in KCH while sustaining about 150 cfs at S-65A. (Note: Unexpected rainfall late on 6/1 allowed S-65A discharge to be returned to about 220 cfs on 6/2).	Implemented	KB Ops/SFWMD Water Management	6/4/2019
5/28/2019	No new recommendations.		N/A		5/28/2019
5/20/2019	No new recommendations.		N/A		5/21/2019
5/13/2019	No new recommendations.		N/A		5/14/2019
5/6/2019	Due to the rainfall, increase S65-A to 1000 cfs today in two increments and increase flow at S-65 accordingly. We will reassess the rise in KCH stage tomorrow 5/7.	Short-term goals: try to keep S65-A discharge at or below 1000 cfs for KR fish sampling this week and next, while keeping the reversal in KCH less than about 0.4 ft.	Implemented	KB Ops	5/7/2019

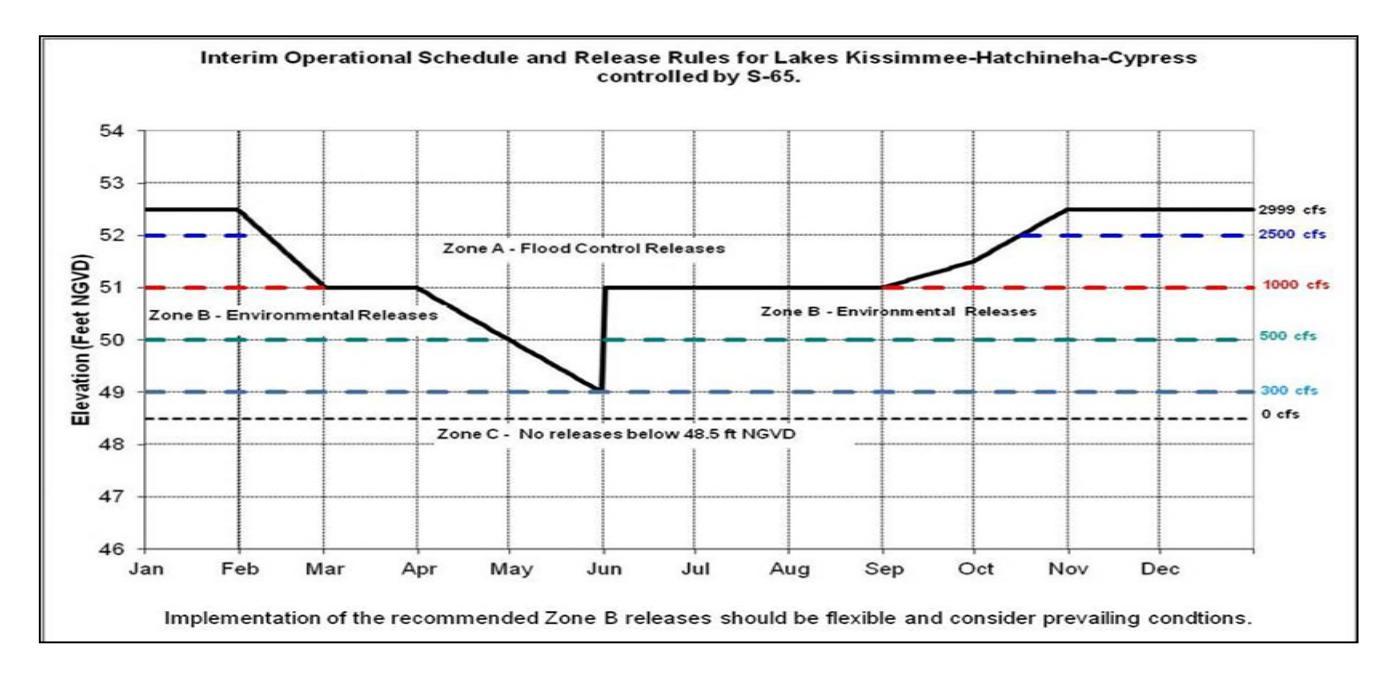
Figure 12. Interim operations schedule for S-65. The discharge schedule shown to the right has not been used in recent years.

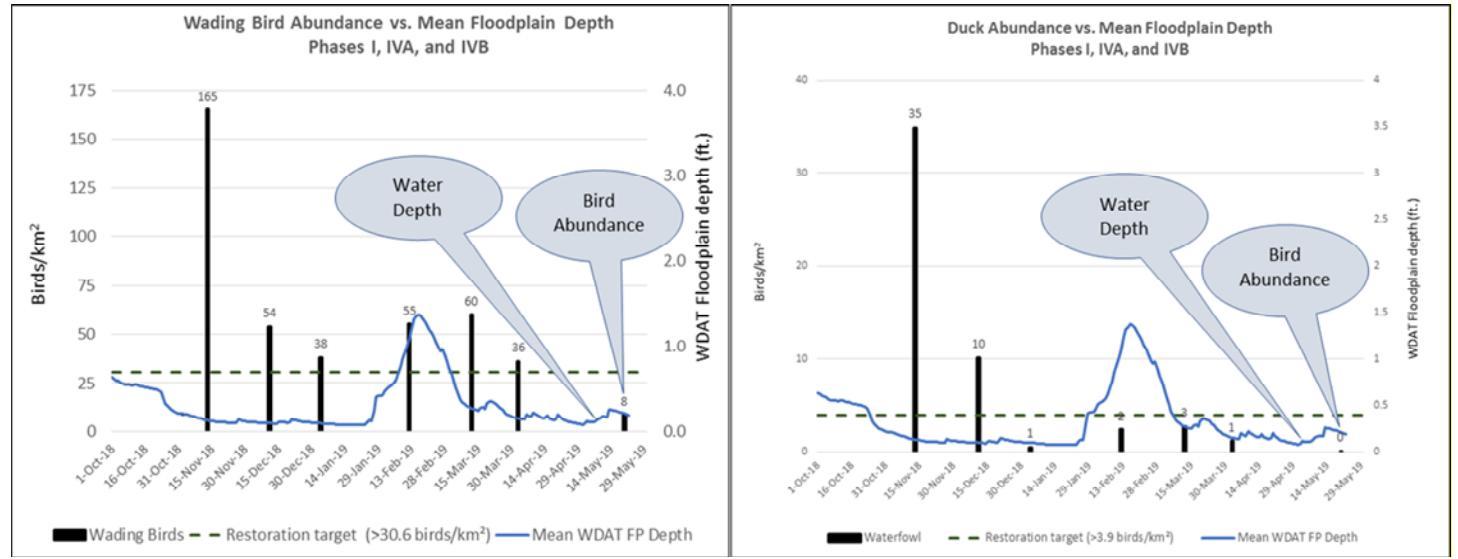
Figure 13. Kissimmee River Wading Bird and Waterfowl Surveys from November 2018 to May 2019.

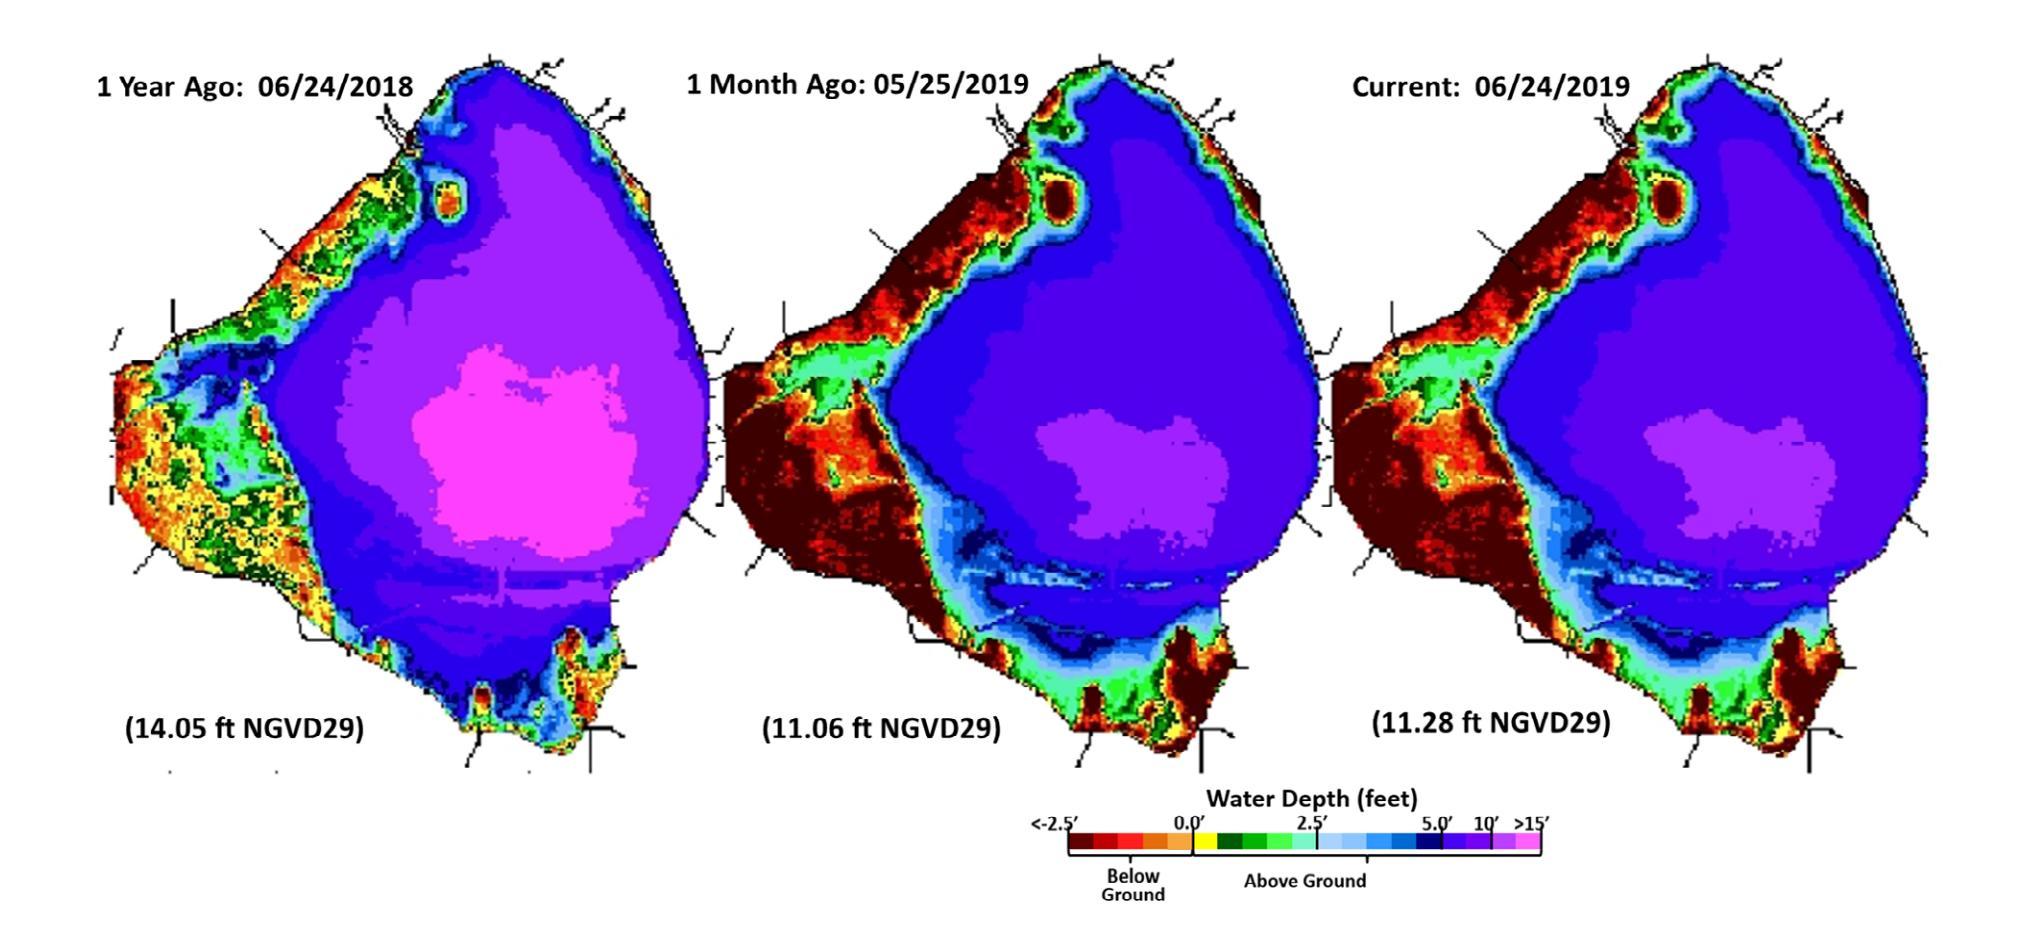
Figure 1. Water depth estimates on Lake Okeechobee based on the South Florida Water Depth Assessment Tool.

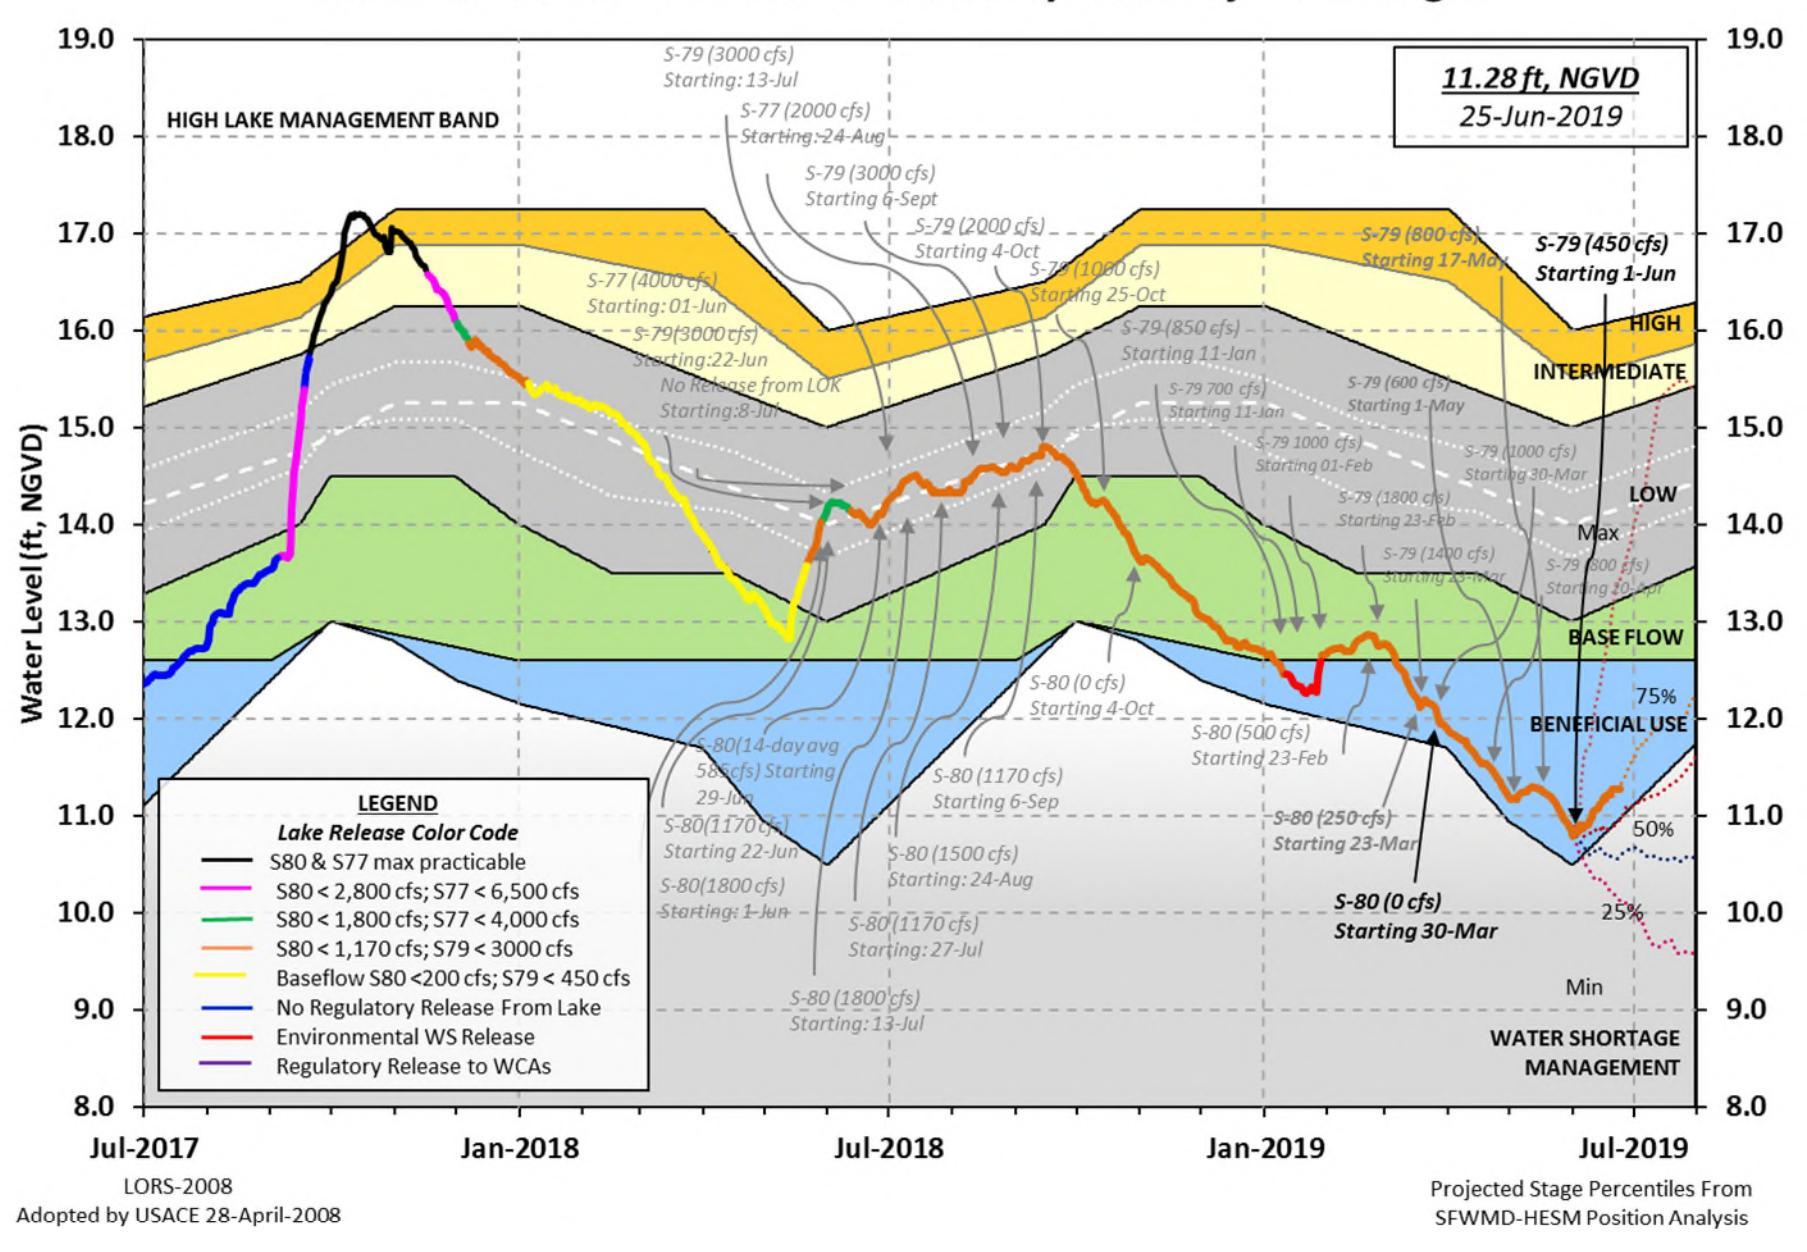
Figure 2. Recent Lake Okeechobee stage and releases, with projected stages based on a dynamic position analysis.

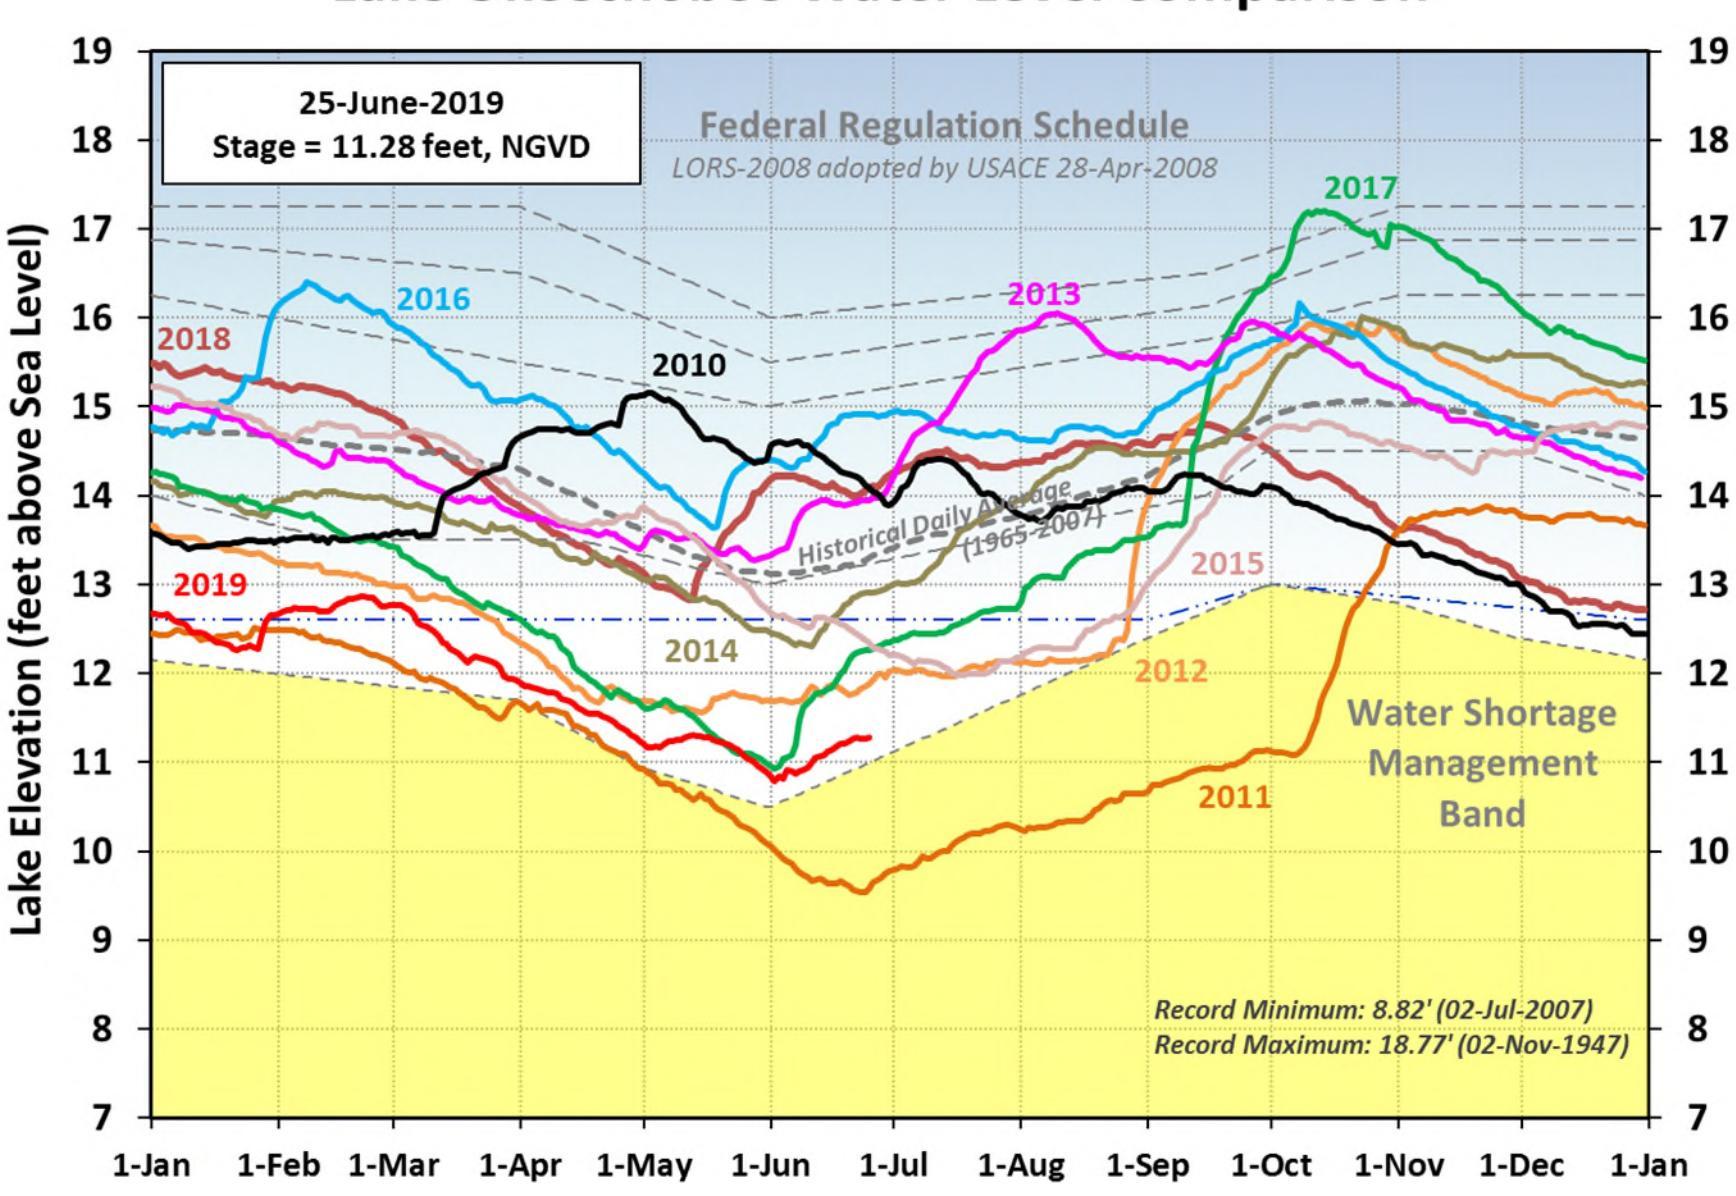
Figure 3. Select annual stage hydrographs for Lake Okeechobee from 2010 – 2019.

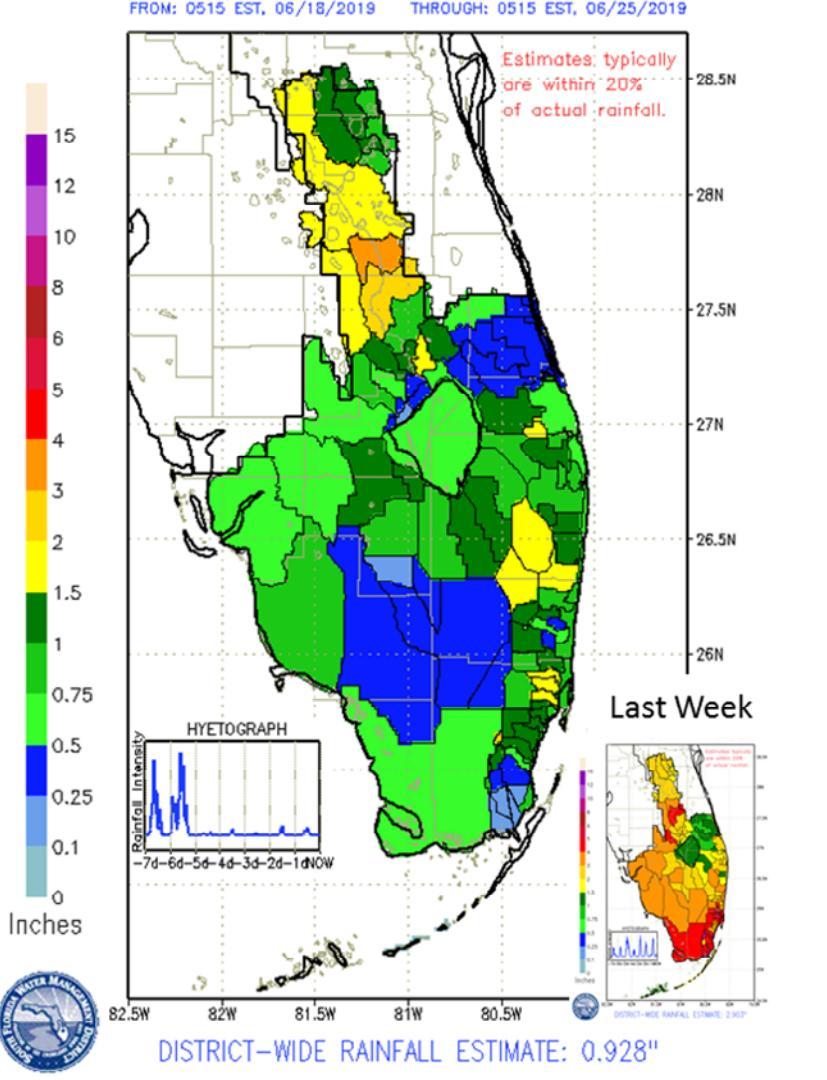
SFWMD PROVISIONAL RAINDAR 7-DAY BASIN RAINFALL ESTIMATES FROM: 0515 EST, 06/18/2019 THROUGH: 0515 EST, 06/25/2019

Figure 4. Rainfall estimates by basin.

According to the USACE web site, Lake Okeechobee average daily lake stage is at 11.28 feet NGVD for June 24, 2019 increasing 0.07 feet from the previous week. This value is based on the use of four interior lake stations (L001, L005, L006 and LZ40) and three perimeter stations (S-308, S-4 and S-133). The Lake is now 0.22 feet higher than a month ago and 2.77 feet lower than a year ago when stages were roughly a foot higher than the top of the preferred ecological envelope (Figure 1). The Lake dropped into the Beneficial Use sub-band on March 7, 2019 and is currently 0.3 feet above the Water Shortage sub-band but running parallel to it over the past few weeks (Figure 2). Lake stage is currently at the lowest levels for this time of year since 2011 (Figure 3). According to RAINDAR, during the week of June 18 to June 24, 2019, 0.66 inches of rain fell directly over the Lake, compared to 1.49 inches the previous week. Most of the watershed experienced similar rainfall except the Kissimmee Basins, most of which received between 1.5 - 4 inches (Figure 4).

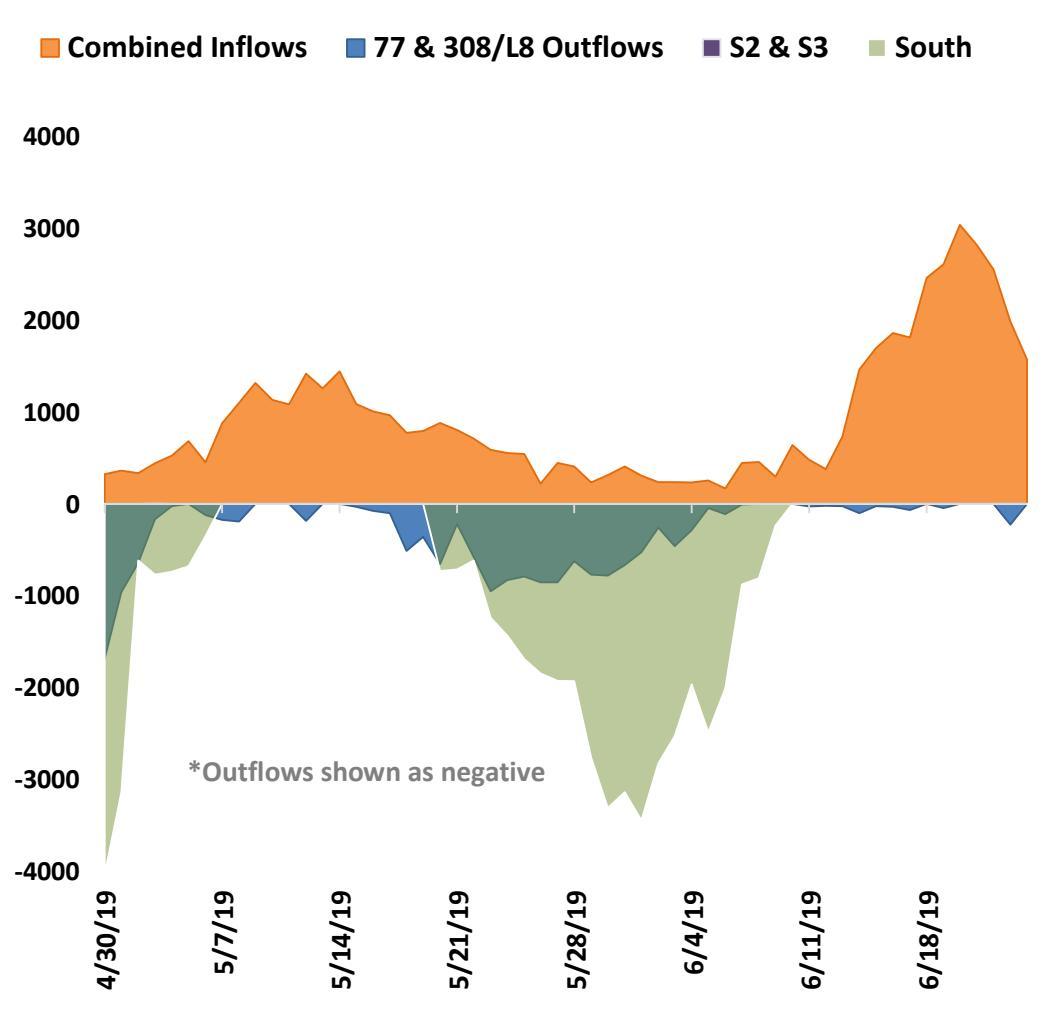
**Figure 5.** Major inflows (orange) and outflows (blue) of Lake Okeechobee, including the S-350 structures designated as South (green). The L-8 Canal flows through Culvert 10A are included as outflows when positive, and as inflows when backflowing into the lake. All inflows and outflows are shown as positive and negative, respectively, for visual purposes.

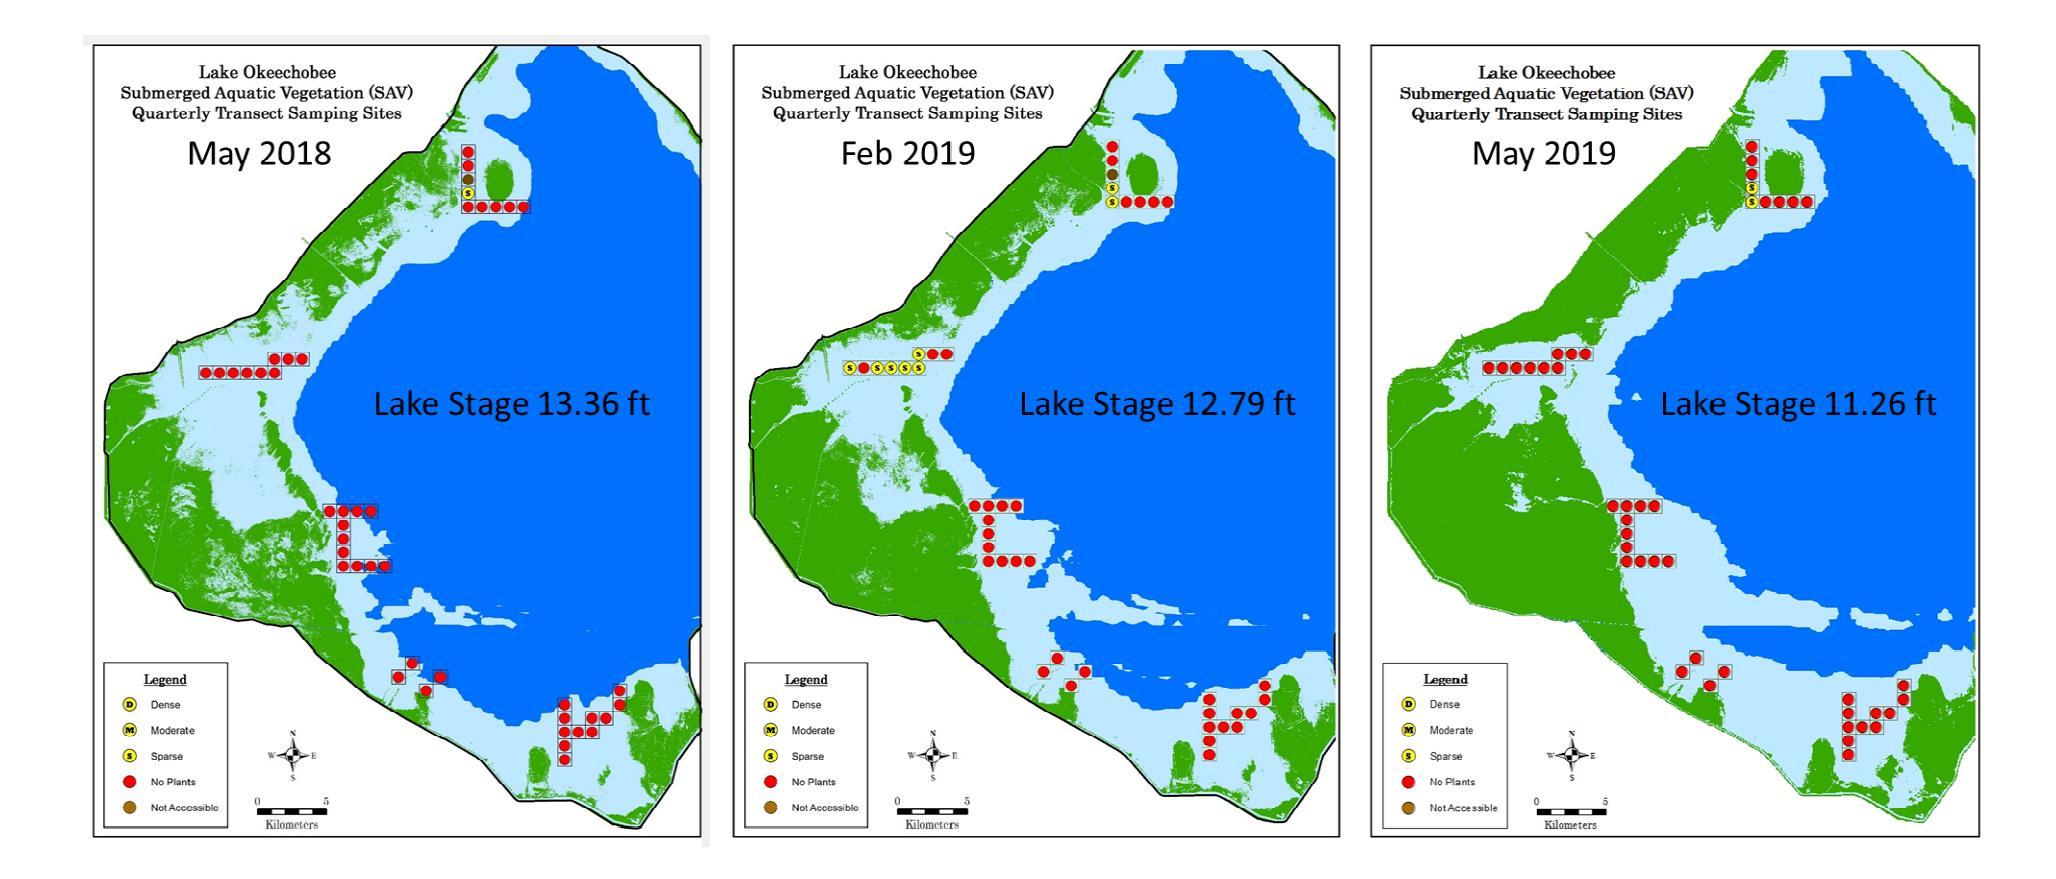
Figure 6. Submerged aquatic vegetation (SAV) samples from permanent transects monitored on a quarterly basis. Red indicates no SAV while yellow indicates presence.

Submerged Aquatic Vegetation (SAV) is sampled quarterly from a subset of permanent monitoring stations on the Lake, and May 2019 survey results showed a decrease in presence from February 2019 (Figure 6). Fisheating Bay had very small, very sparse plants in February that were not observed in May, though such sparse coverage is difficult to detect. Other SAV transect monitoring in April and May that's done at a higher spatial resolution and in shallower water did find small plants growing in Fisheating Bay. However, the May 2019 quarterly results do show that widespread recovery is in its very early stages, if that.

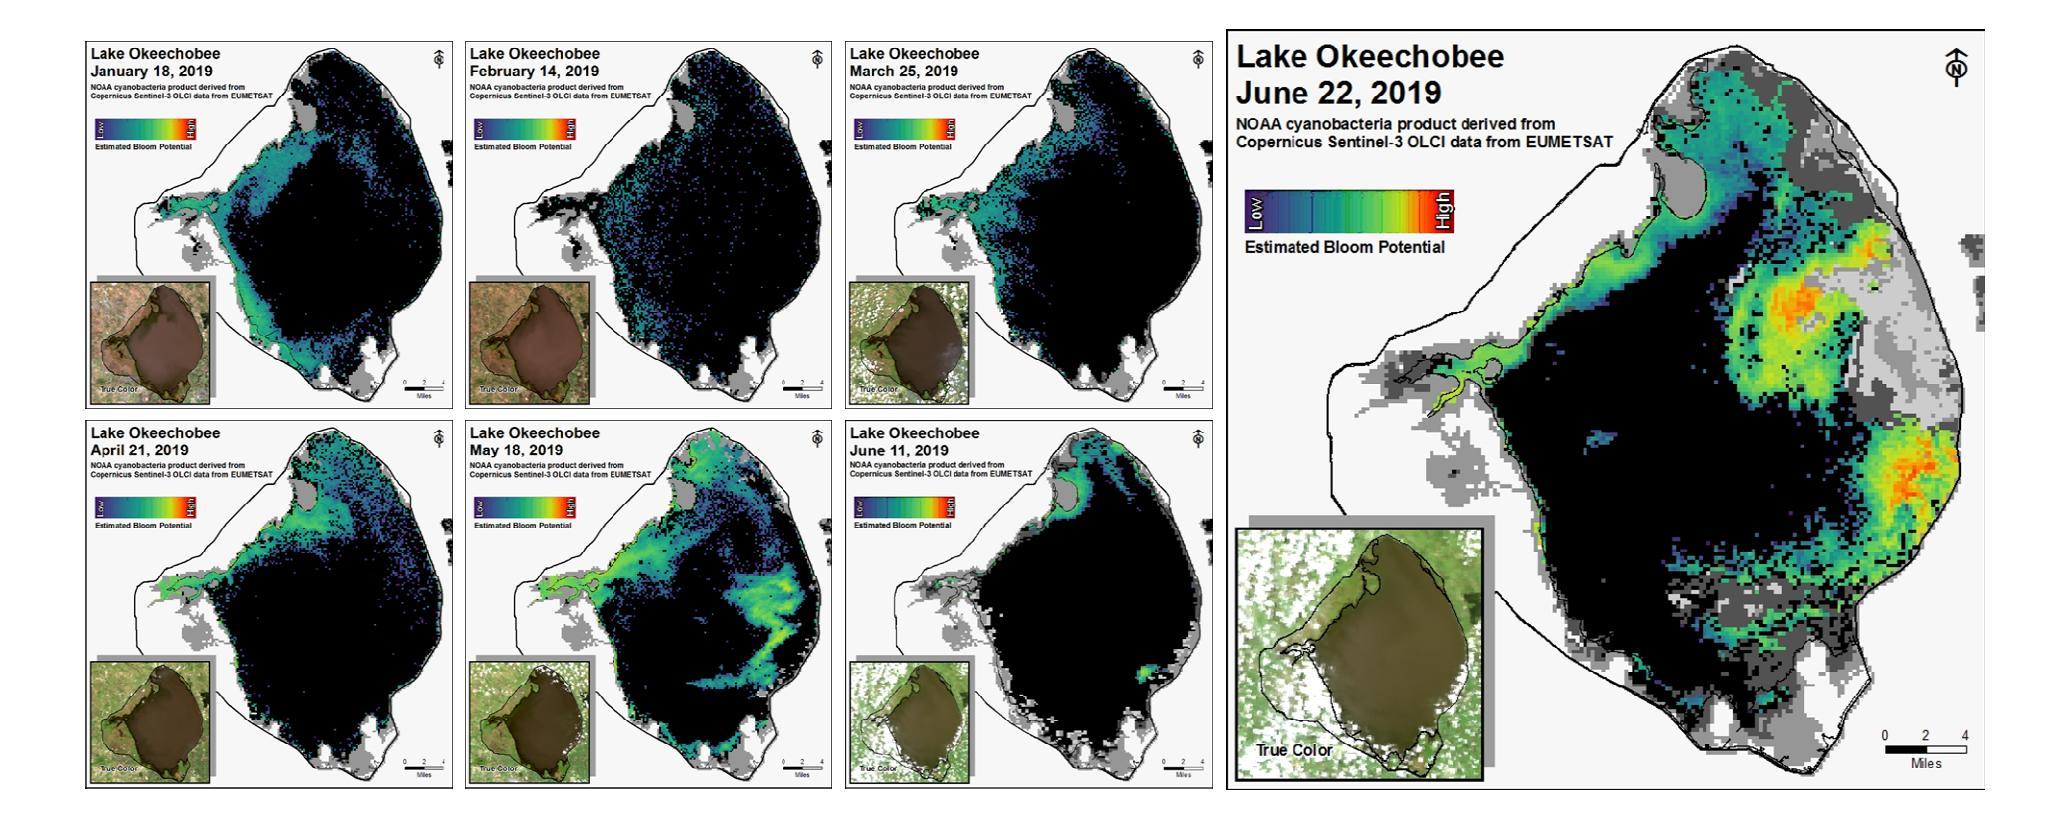
Figure 7. Potential for cyanobacterial blooms on Lake Okeechobee based on NOAA's harmful algal bloom monitoring system derived from Copernicus Sentinel-3 OLCI data from EUMETSAT. Gray indicates cloud cover.

The most recent viable satellite imagery (June 22, 2019) using NOAA's cyanobacteria monitoring product derived from EUMETSAT's Sentinel OLCI sensor data showed that the abatement of rainstorms over the latter portion of the week increased bloom coverage in the center/east portions of the lake (Figure 7). The Environmental Protection Agency has developed a mobile app to monitor cyanobacteria blooms across the nation using this satellite data, and conditions on the Lake can be monitored as well (Figure 8). More information on the product is available at <a href="https://www.epa.gov/water-research/cyanobacteria-assessment-network-mobile-application-cyan-app">https://www.epa.gov/water-research/cyanobacteria-assessment-network-mobile-application-cyan-app</a>.

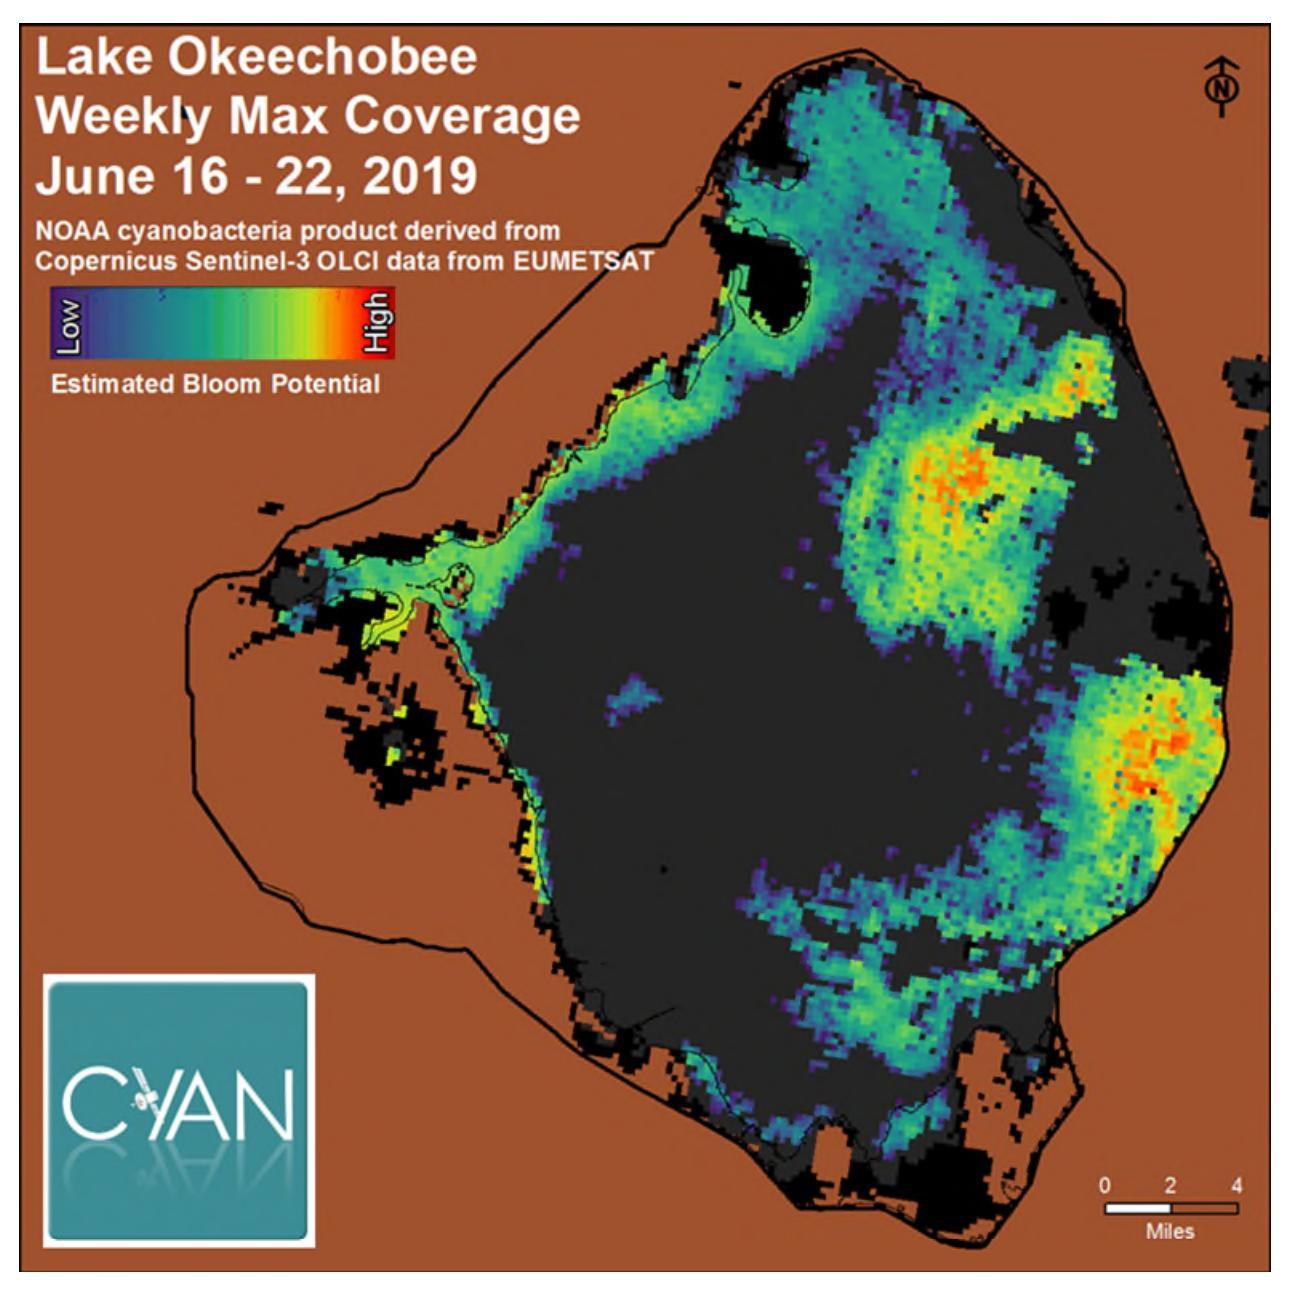
**Figure 8.** The weekly maximum coverage of cyanobacteria blooms on Lake Okeechobee. Modified from EPA's CyAN mobile application, which is based primarily on Copernicus Sentinel-3 OLCI data from EUMETSAT. <u>https://www.epa.gov/water-research/cyanobacteria-assessment-network-mobile-application-cyan-app</u>
