# MEMORANDUM

**DATE:** June 26, 2019

SUBJECT: Weekly Environmental Conditions for Systems Operations

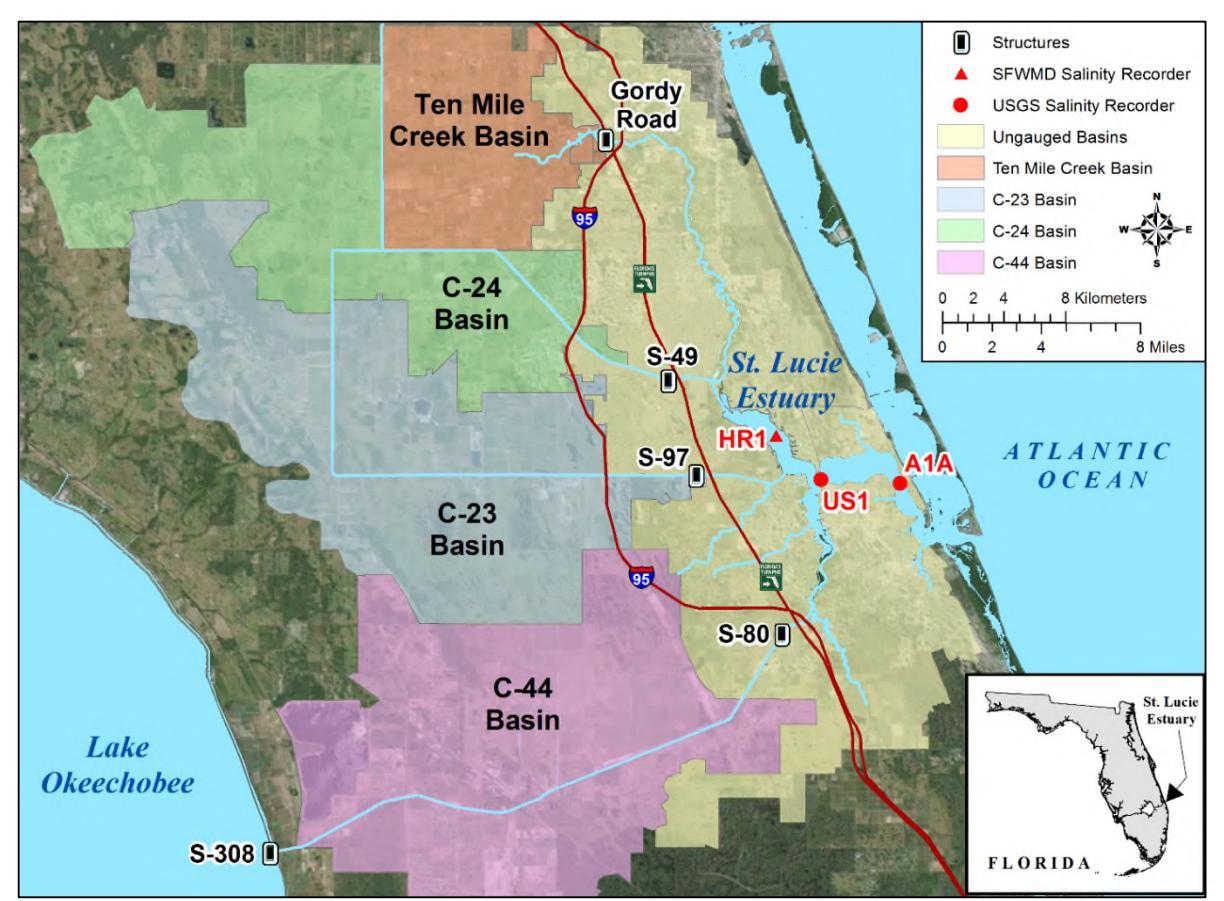
Figure 1. Basins, water control structures, and salinity monitoring for the St. Lucie Estuary.

Last week total inflow to the St. Lucie Estuary averaged approximately 494 cfs (Figures 1 and 2) and last month inflow averaged about 534 cfs. Last week's provisional averaged inflows from the tidal basin and the structures are shown in Table 1.

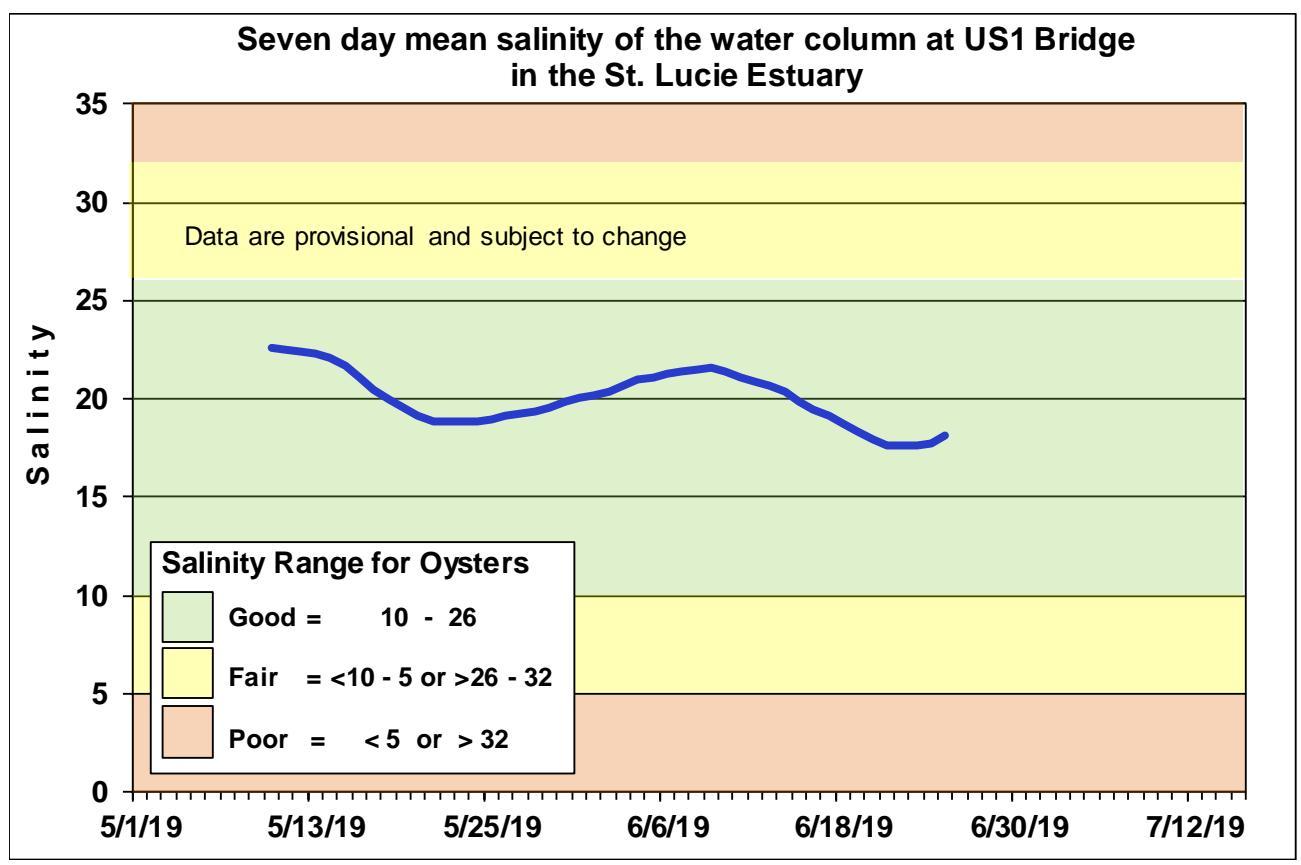
Figure 3. Seven-day mean salinity of the water column at the US1 Bridge.

Over the past week, salinity decreased throughout the estuary (Table 2, Figures 3 and 4). The seven-day moving average of the water column (an average of the surface and bottom salinity) at the US1 Bridge is estimated to be 18.1. Salinity conditions in the middle estuary are within the good range for adult eastern oysters (Figure 3).

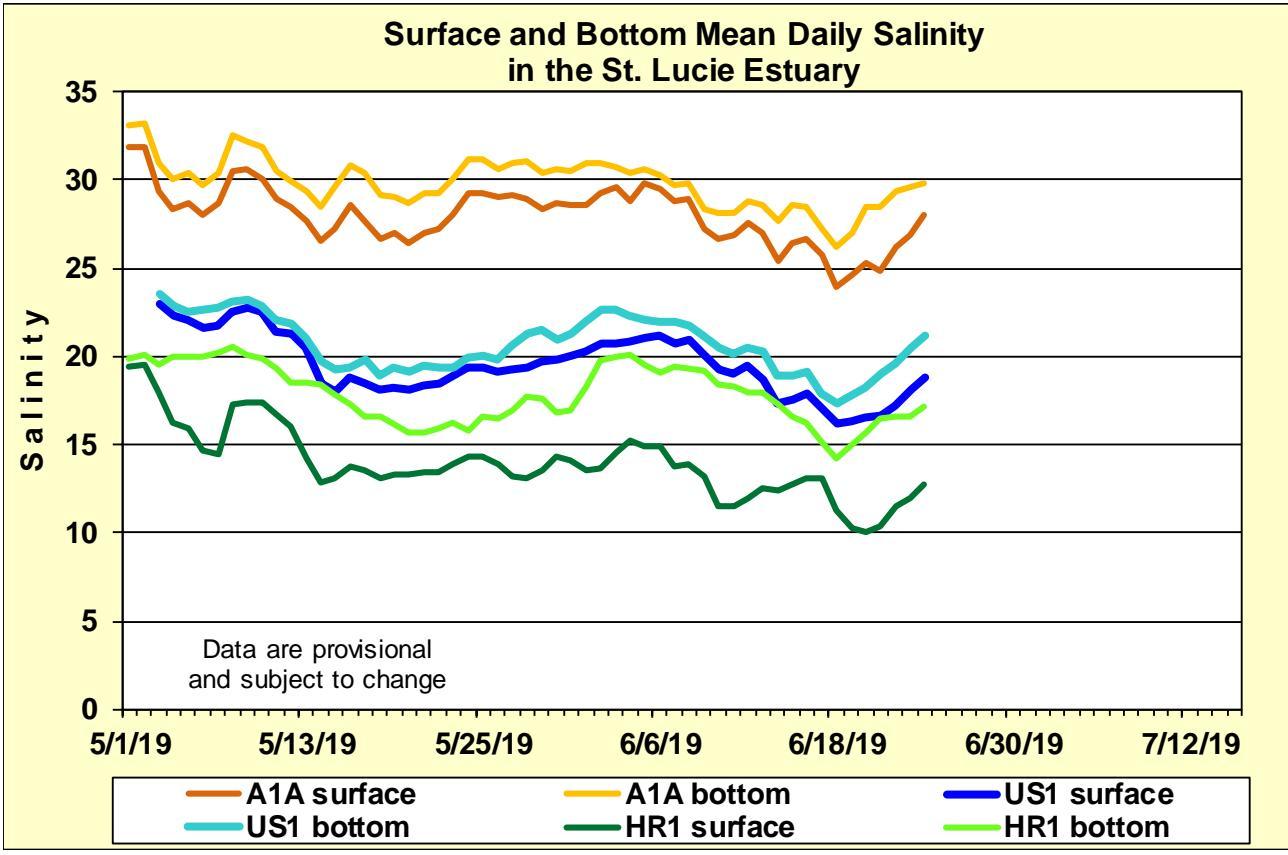
Figure 4. Daily mean salinity at the A1A, US1 and estimated HR1 stations.

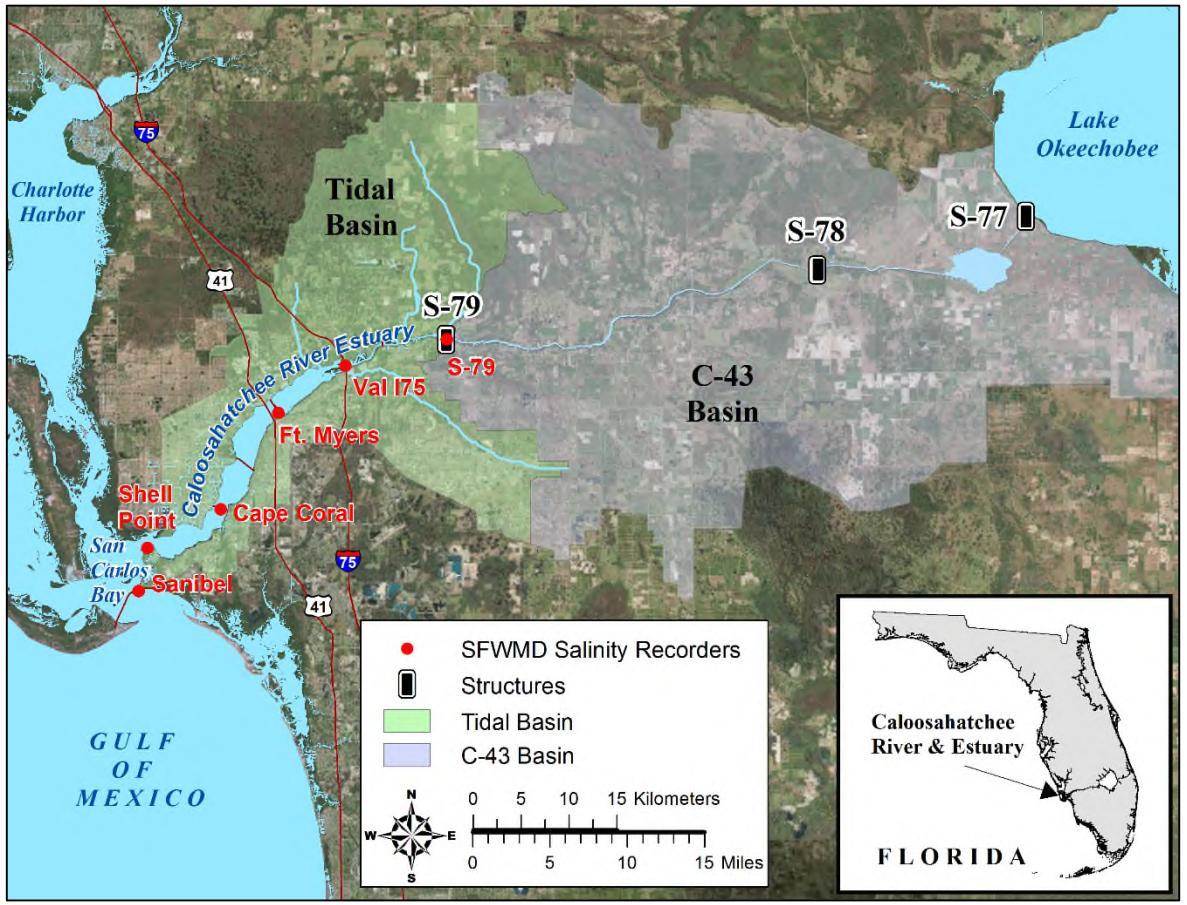
Figure 5. Basins, water control structures, and salinity monitoring for the Caloosahatchee Estuary.

Last week total inflow to the Caloosahatchee Estuary averaged approximately 3255 cfs (Figures 5 and 6) and last month inflow averaged about 1814 cfs. Last week's provisional averaged inflows from the structures are shown in Table 3.

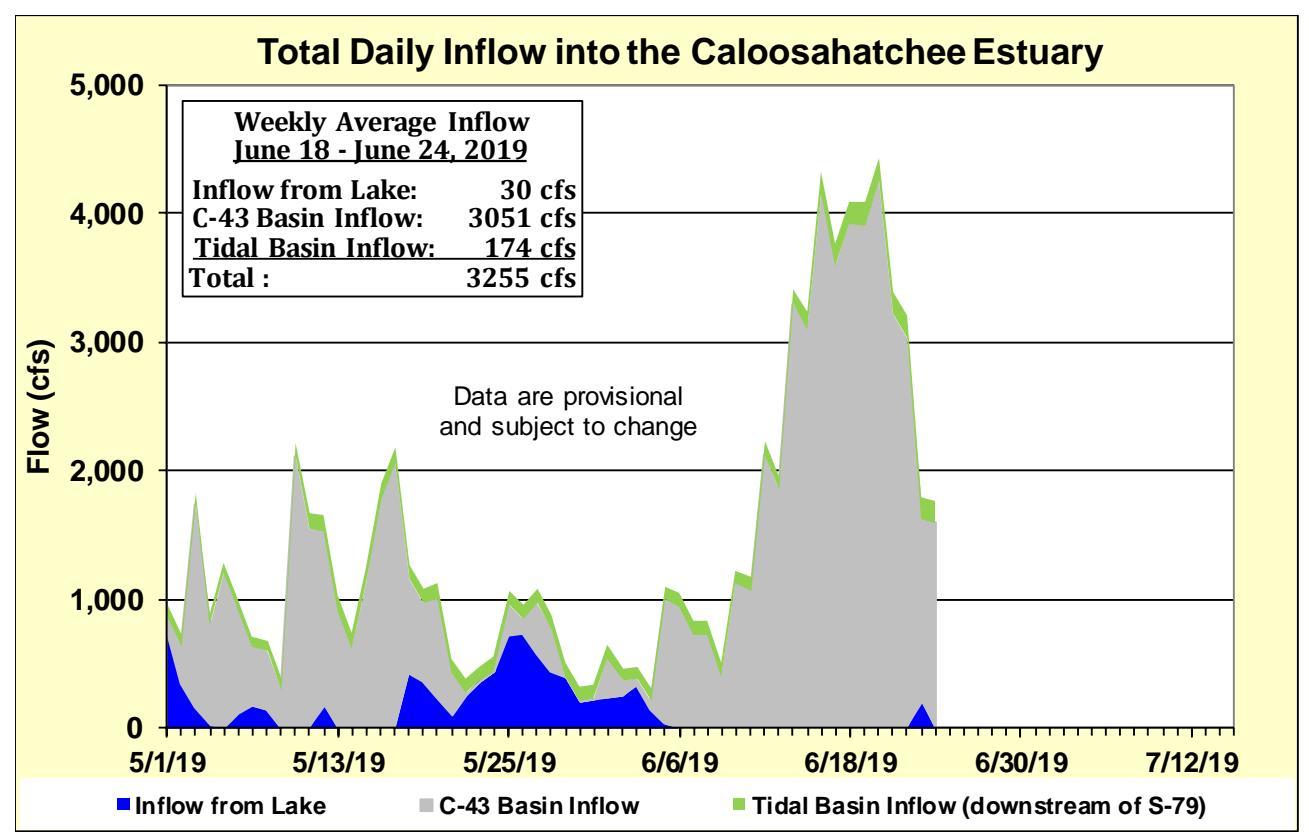
**Figure 6.** Total daily inflows from Lake Okeechobee, runoff from the C-43 basin, and tributaries in the tidal basin into the Caloosahatchee River Estuary.

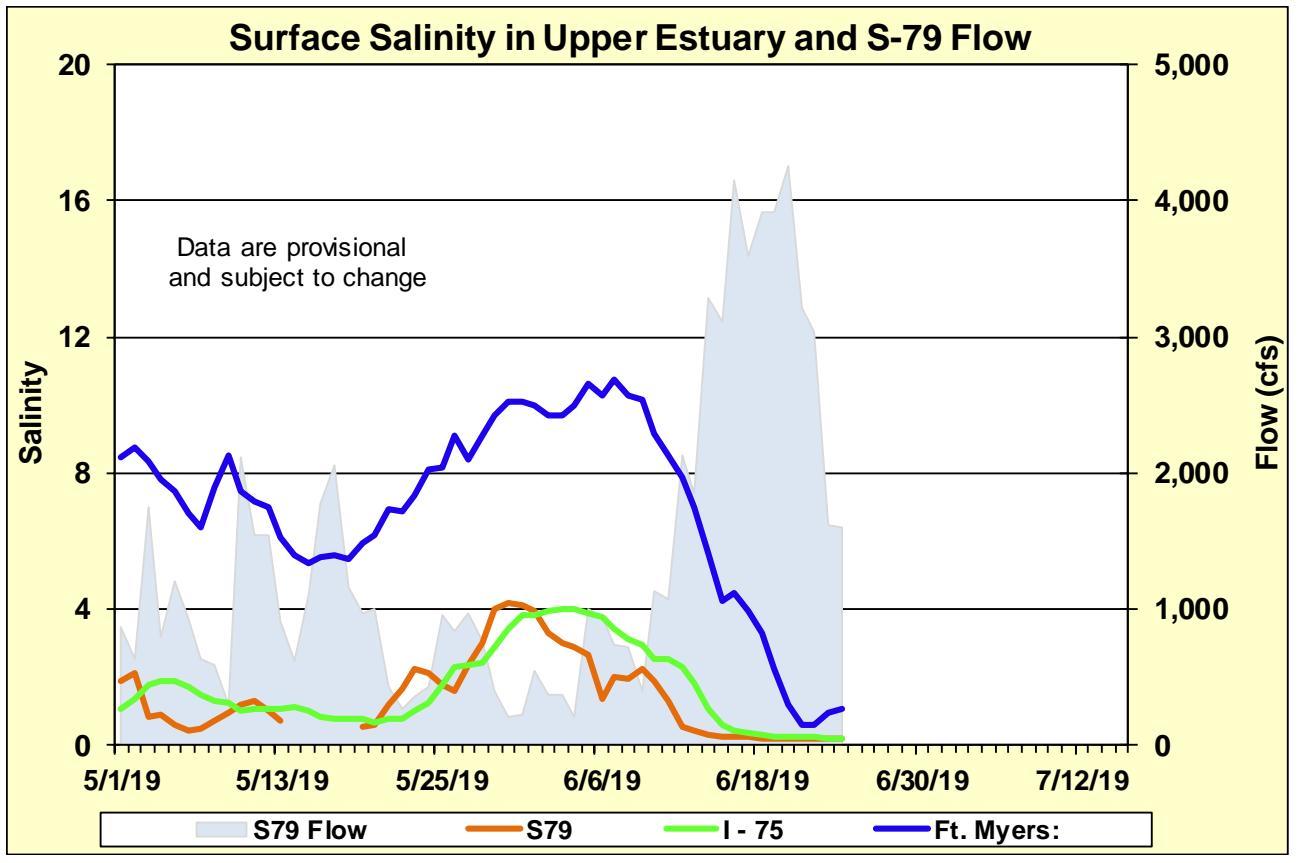
**Figure 7.** Daily mean flows at S-79 and salinity at upper estuary monitoring stations.

Over the past week, salinity decreased throughout the estuary (Table 4, Figures 7 & 8). The seven-day average salinity values are estimated to be within the good range for adult eastern oysters at Cape Coral, Shell Point and Sanibel (Figure 9). The 30-day moving average surface salinity is 2.1 at Val I-75 and 7.0 at Ft. Myers. Salinity conditions between Val I-75 and Ft. Myers are good for tape grass.

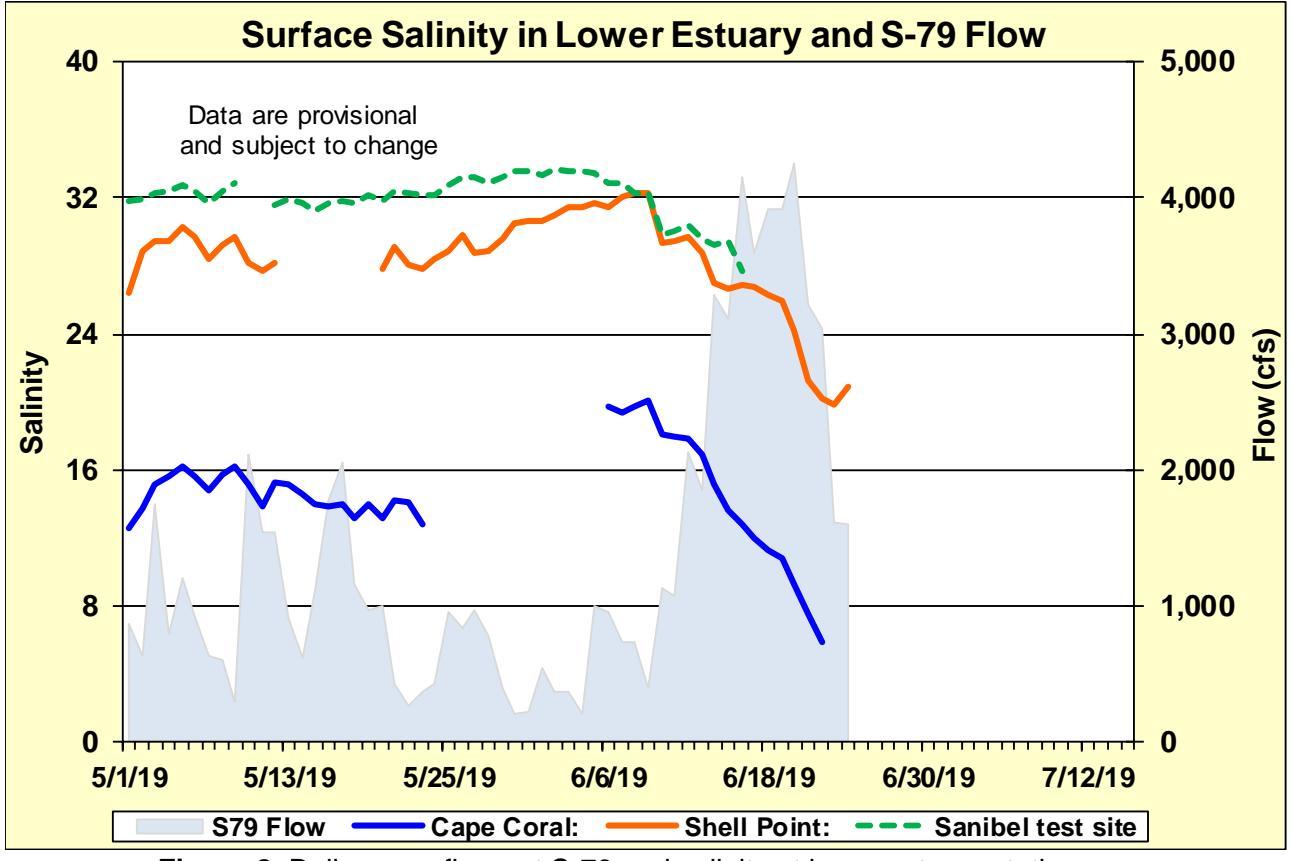
Figure 8. Daily mean flows at S-79 and salinity at lower estuary stations.

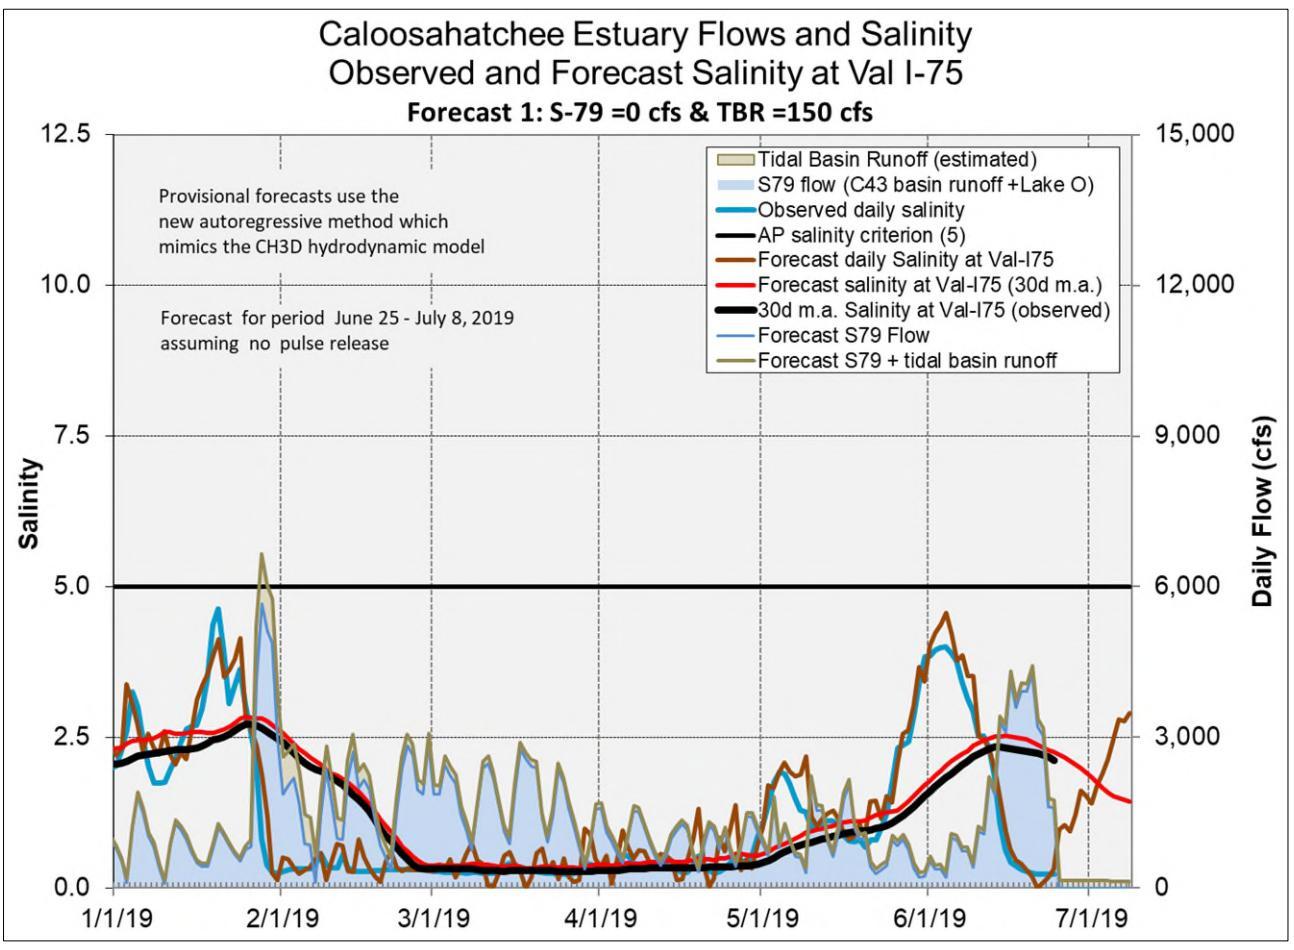
Figure 10. Forecasted Val I-75 surface salinity assuming no pulse release at S79.

Forecast of surface salinity (Table 5 and Figure 10) at Val I-75 for the next two weeks using the autoregression model (Qiu and Wan, 2013) coupled with a linear reservoir model for the tidal basin predicts daily salinity ranging from 0.7 to 2.9 at the end of the next two weeks for pulse release at S-79 ranging from 0 to 800 cfs and Tidal Basin inflows of 150 cfs.

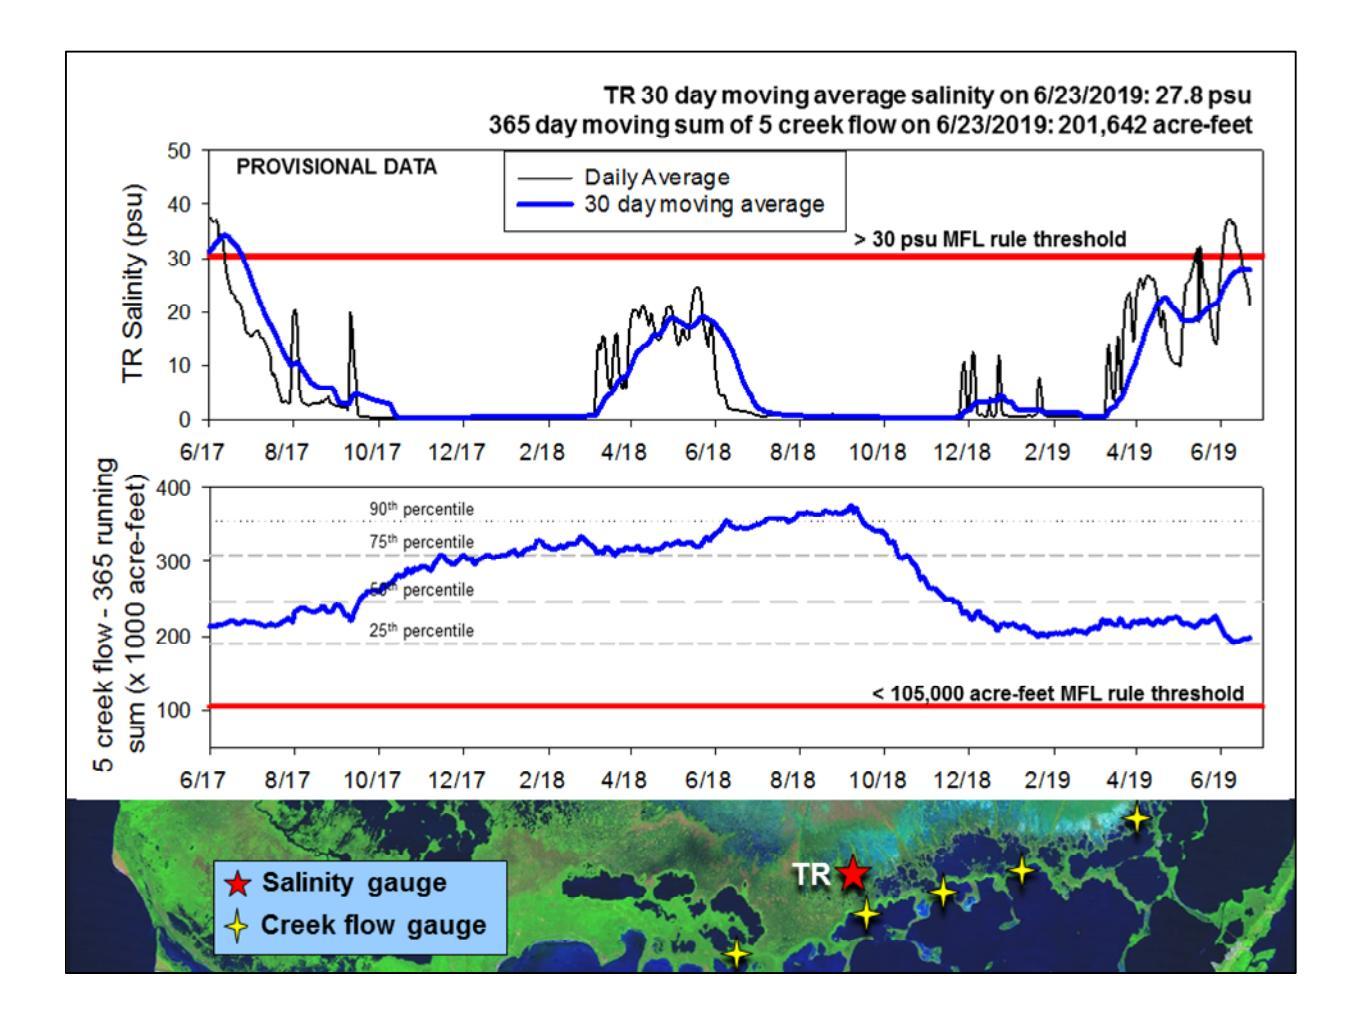
Florida Bay MFL: Salinity at the TR station in the mangrove zone (tracked for the Florida Bay MFL) continued to decrease this past week ending at 18 psu. The 30-day moving average continued to increase to 27.8 psu. If salinities remain below 20 psu, the 30-day moving average salinity will not increase further. The weekly flow from the 5 creeks feeding Florida Bay was 9,500 acre-feet. The 365-day moving sum of flow from the five creeks (tracked as part of the Florida Bay MFL criteria) increased to 201,642 which is less than the long-term average of 257,628 acre-feet but slightly above the 25th percentile (190,165 acre-feet). Creek flow is provisional data from the USGS and is highly variable.
