MEMORANDUM

DATE: April 7, 2021

SUBJECT: Weekly Environmental Conditions for Systems Operations

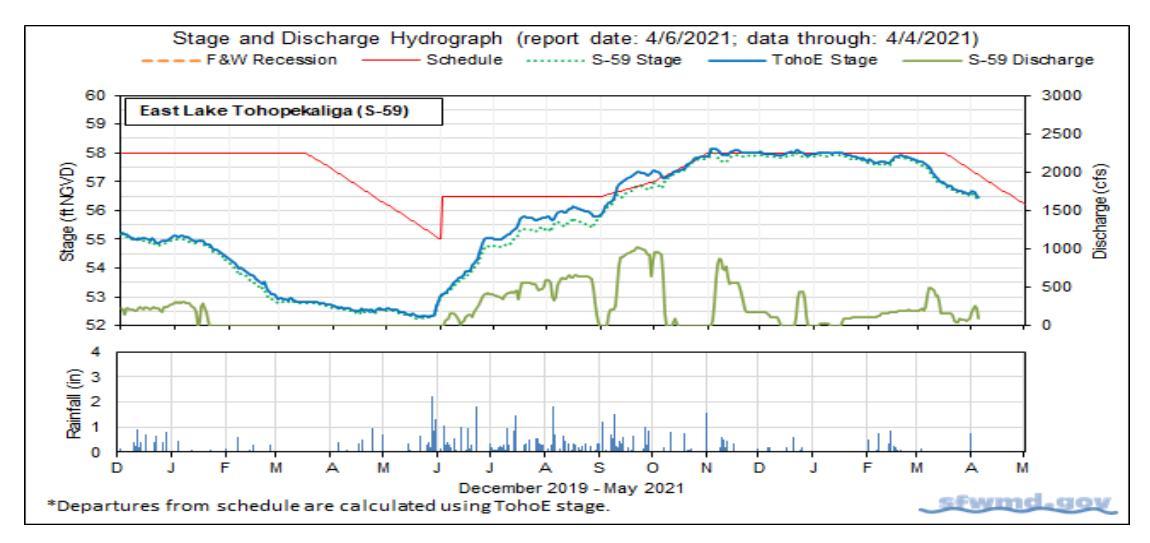
Figure 1. East Lake Toho regulation schedule, stage, discharge and rainfall.

Table 1 lists stage and discharge for several Kissimmee Chain of Lakes (KCL) water bodies using data from lake outfall structures. KCL stage hydrographs with respective regulation schedules and rainfall are shown in **Figures 1-3**.

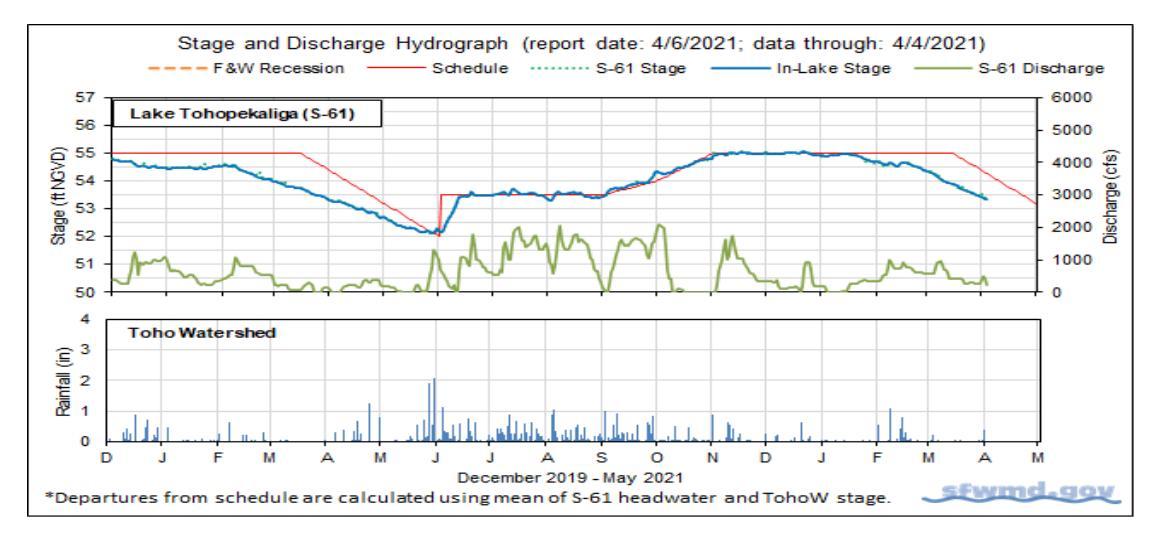
Figure 2. Lake Toho regulation schedule, stage, discharge and rainfall.

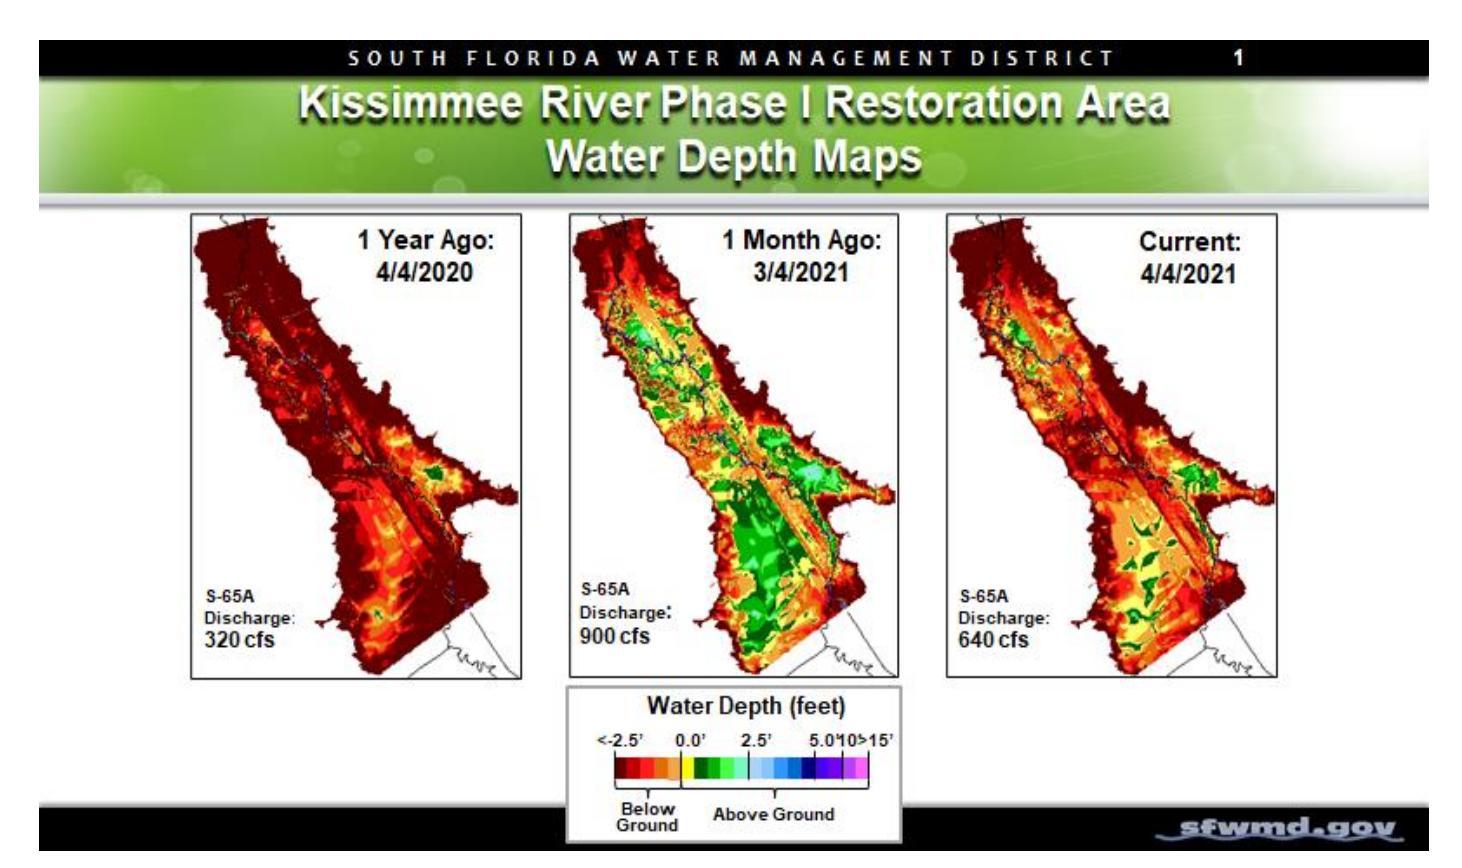
Figure 4. Phase I area floodplain water depths (from left to right) one year ago, one month ago and current. Color-coding has been modified to accommodate greater water depths; these maps are not directly comparable to Kissimmee Basin WDAT maps published prior to January 16, 2012.

Discharges at lower basin structures are shown in **Table 2**. **Figure 4** compares floodplain inundation depths from one year and one month ago with current inundation depths in the Phase I restored area of the Kissimmee River. **Figure 5** shows dissolved oxygen concentration along with S-65A discharge, water temperature and rainfall. **Figures 6-8** are included for reference: **Figure 6** is the current guide for operation of S-65 and S-65A, called the "Preferred Discharge Plan IS-14-50.0". This is developed collaboratively each year between ecologists and SFWMD water managers based on prevailing ecological and hydrologic conditions. A preferred discharge plan and the interim regulation schedule (**Figure 7**) will be used until the Headwaters Lakes Revitalization regulation schedule is implemented. **Figure 8** is a map of the Kissimmee Basin showing Central and Southern Florida (C&SF) flood control project structures and color-coded watersheds.

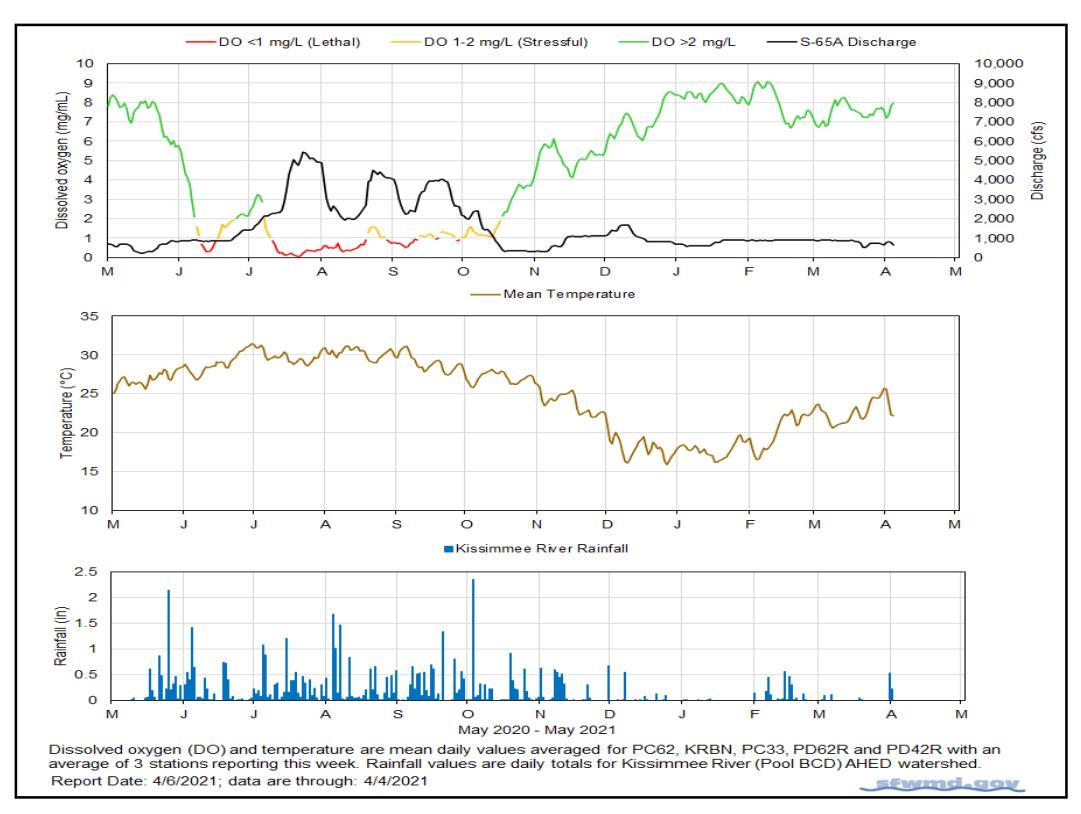
Figure 5. Restored Kissimmee river channel mean daily dissolved oxygen concentration (mg/L), S-65A discharge (cfs), temperature (°C) and rainfall (inches)

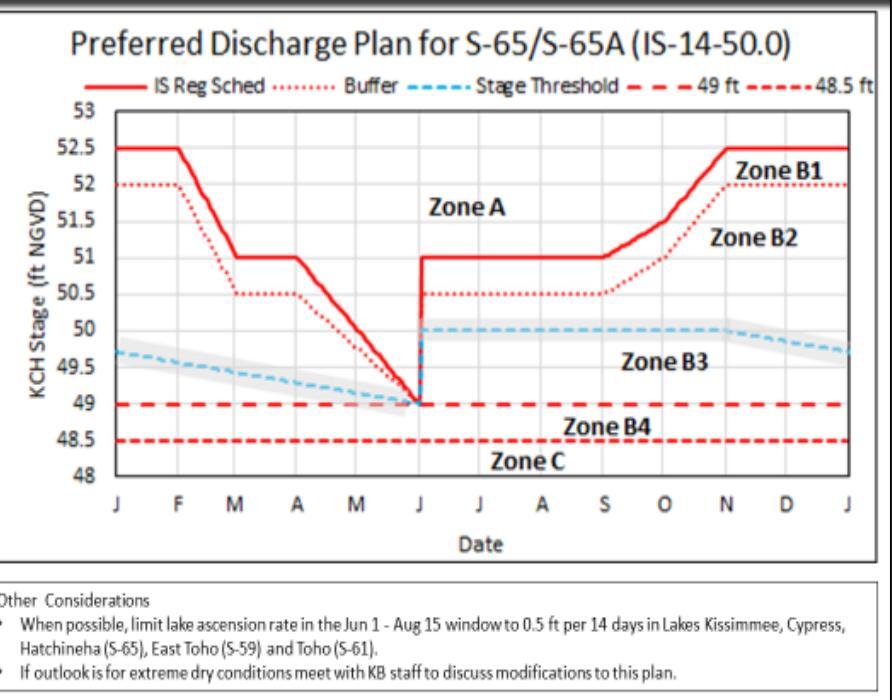
Figure 6. The 2019-2020 Discharge Plan for S-65/S-65A.

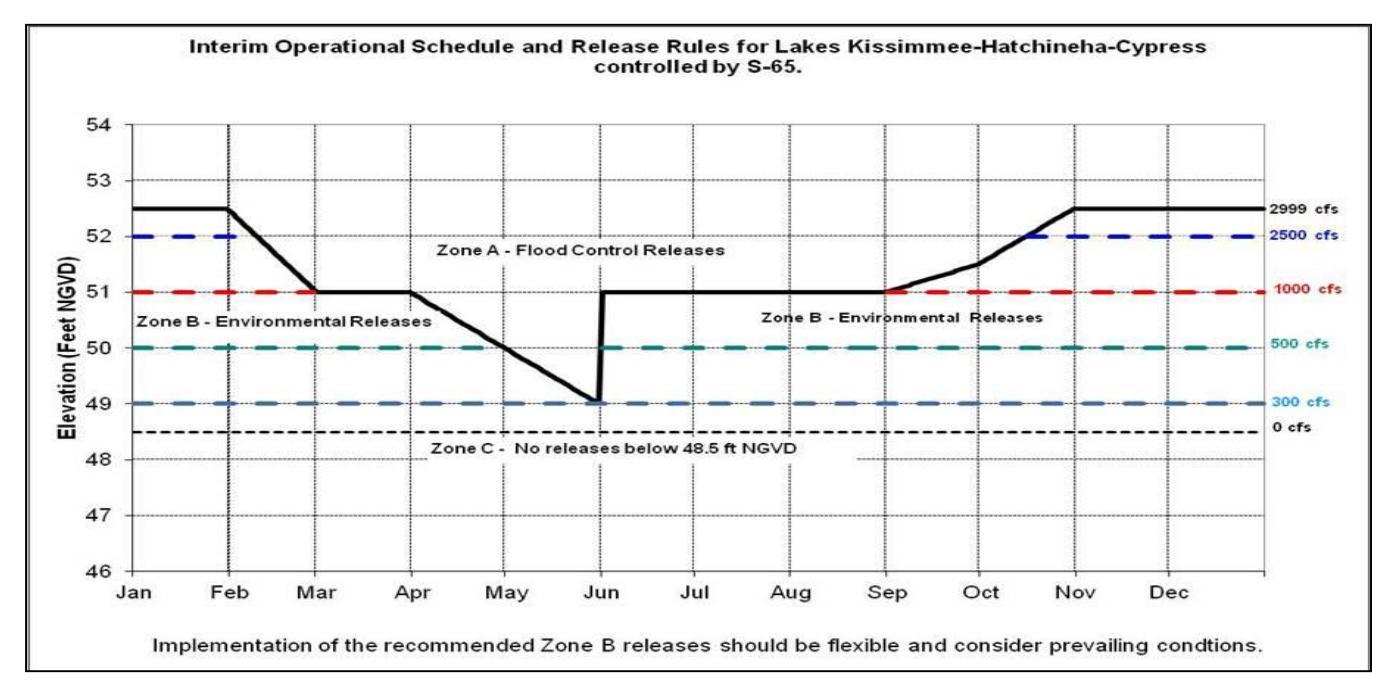
Figure 7. Interim operations schedule for S-65 (solid black line). The discharge schedule shown to the right has not been used in recent years.

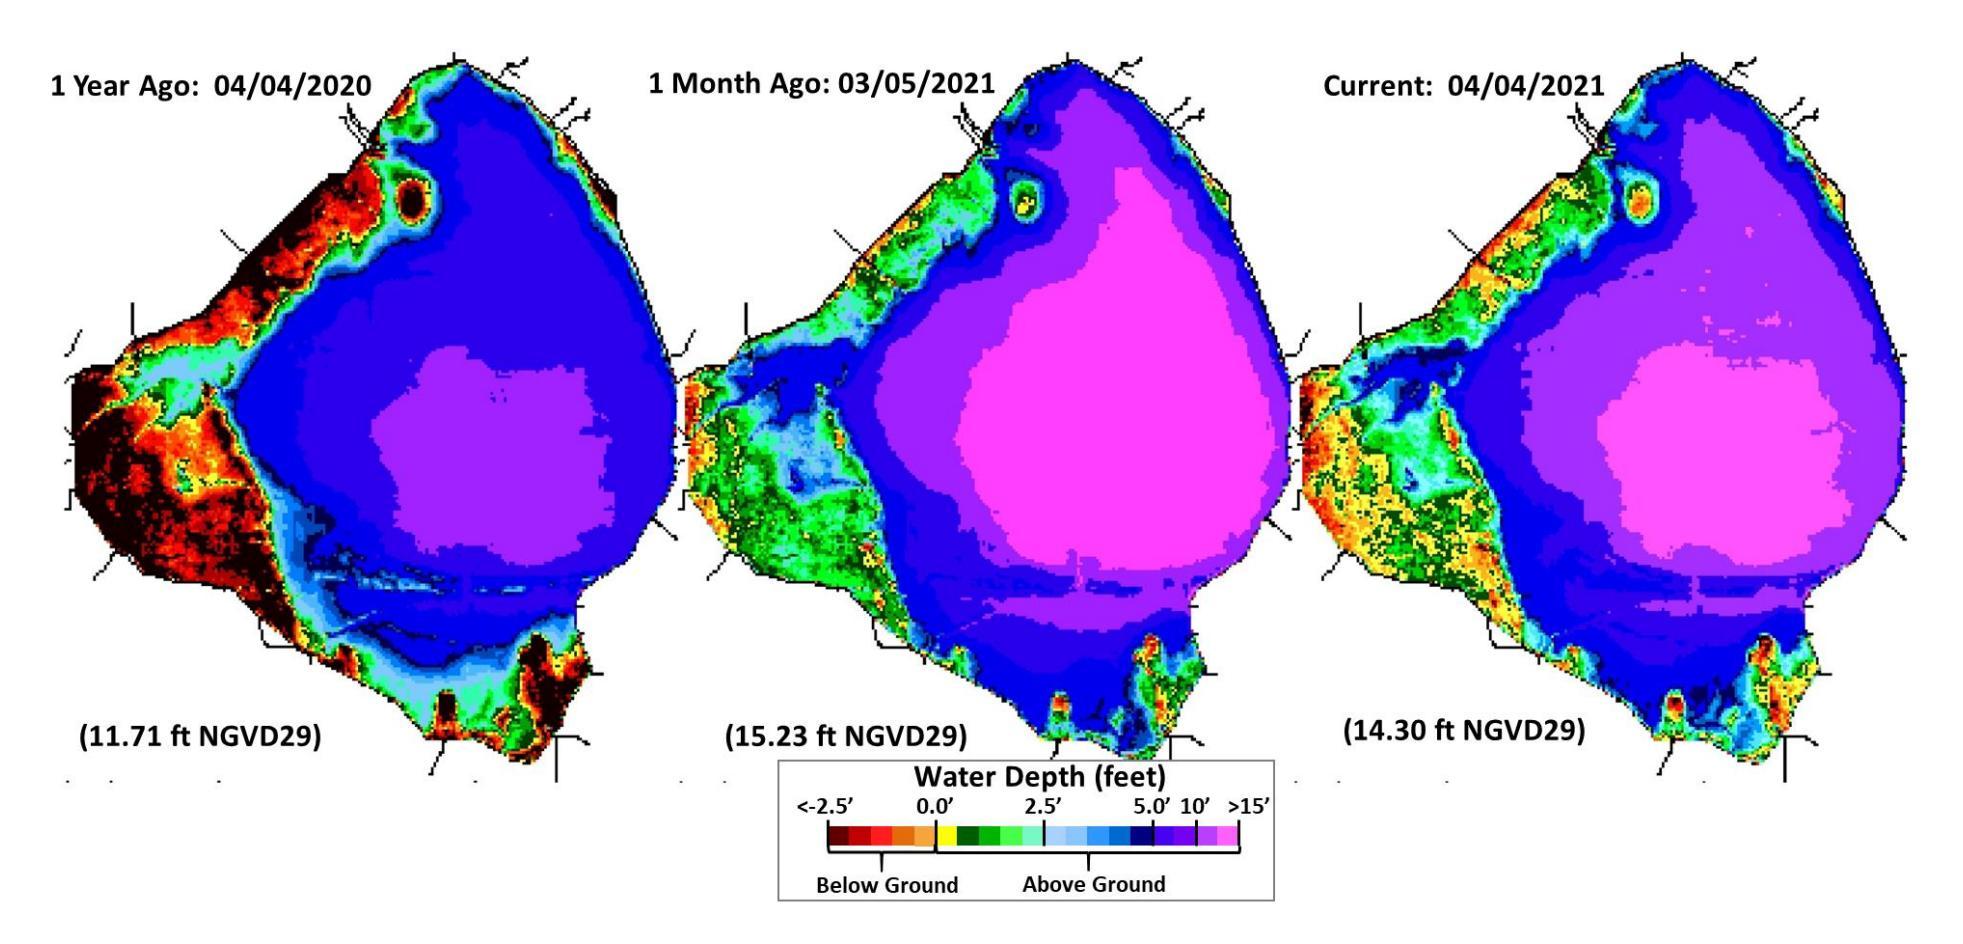
Figure 1. Water depth estimates on Lake Okeechobee based on the South Florida Water Depth Assessment Tool.

Lake Okeechobee stage was 14.30 feet NGVD on April 4, 2021, 0.93 feet lower than a month ago, and 2.59 feet higher than one year ago (Figure 1). Lake stages rose into the lower portion of the preferred ecological envelope on June 2, 2020 (Figure 2) and had been above the envelope since August 1, 2020. Lake stage reentered the envelope this week and is still in the Low sub-band. Lake stage reached a low of 10.99 feet on May 17 and a high of 16.45 feet on November 12 (post Tropical Storm Eta), a difference of 5.5 feet (Figure 3). Lake stage declined slowly from mid-November through mid-February, but recession rate has increased over the past several weeks. According to NEXRAD, 0.69 inches of rain fell directly on the Lake; some northern regions received more than 1.5 inches of rain, while less than 0.25 fell in most southern portions. The district-wide average was 0.43 inches (Figure 4).

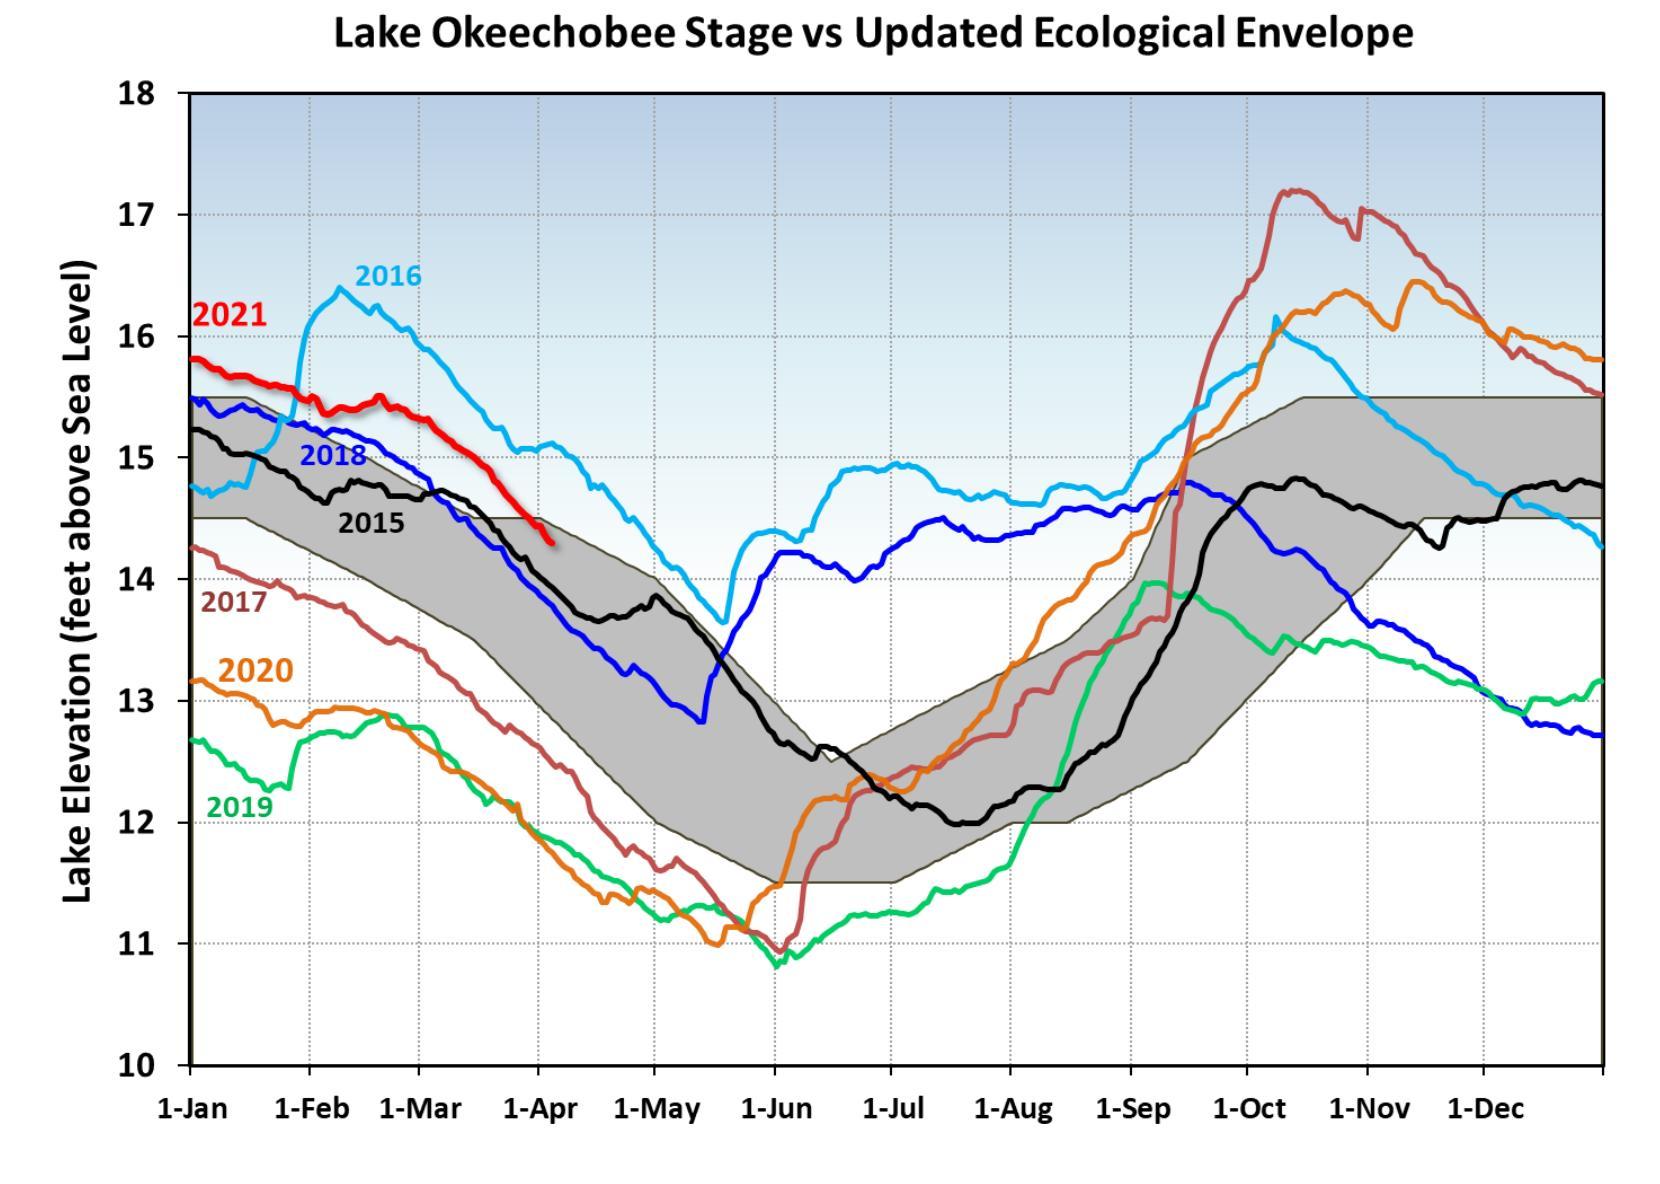
Figure 2. Select annual stage hydrographs for Lake Okeechobee in comparison to the updated Ecological Envelope.

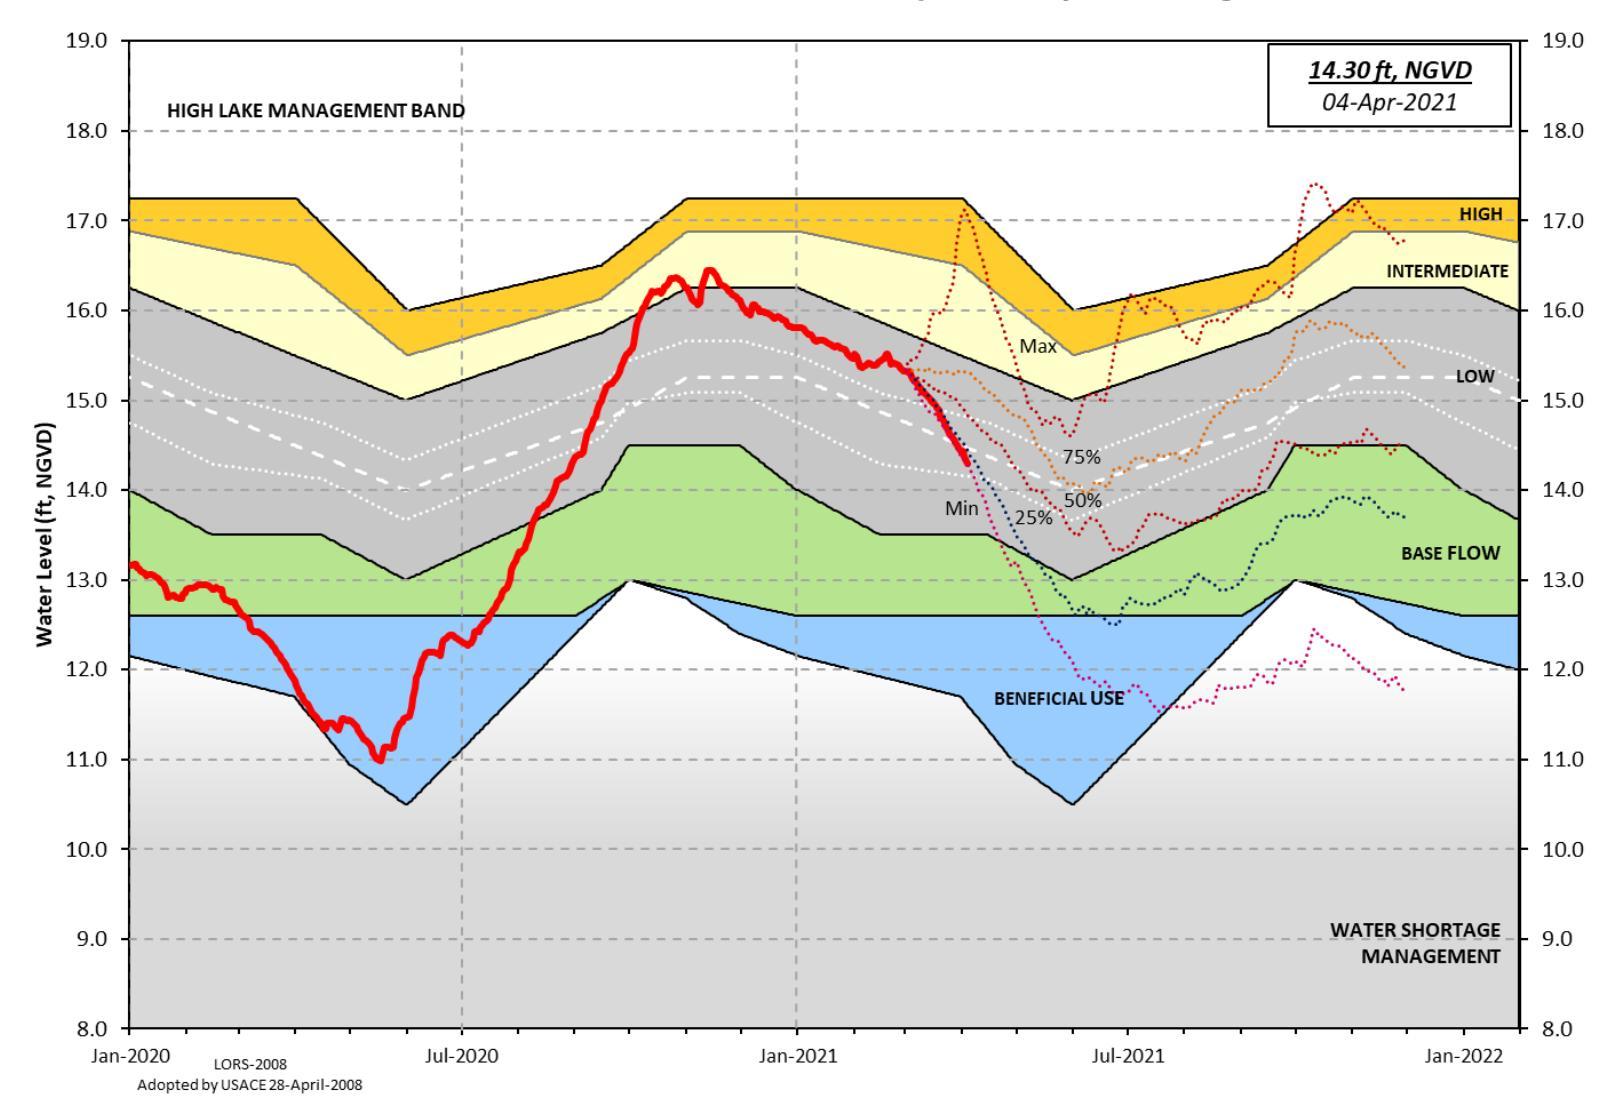
Figure 3. Recent Lake Okeechobee stages and releases, with projected stages based on a dynamic position analysis.

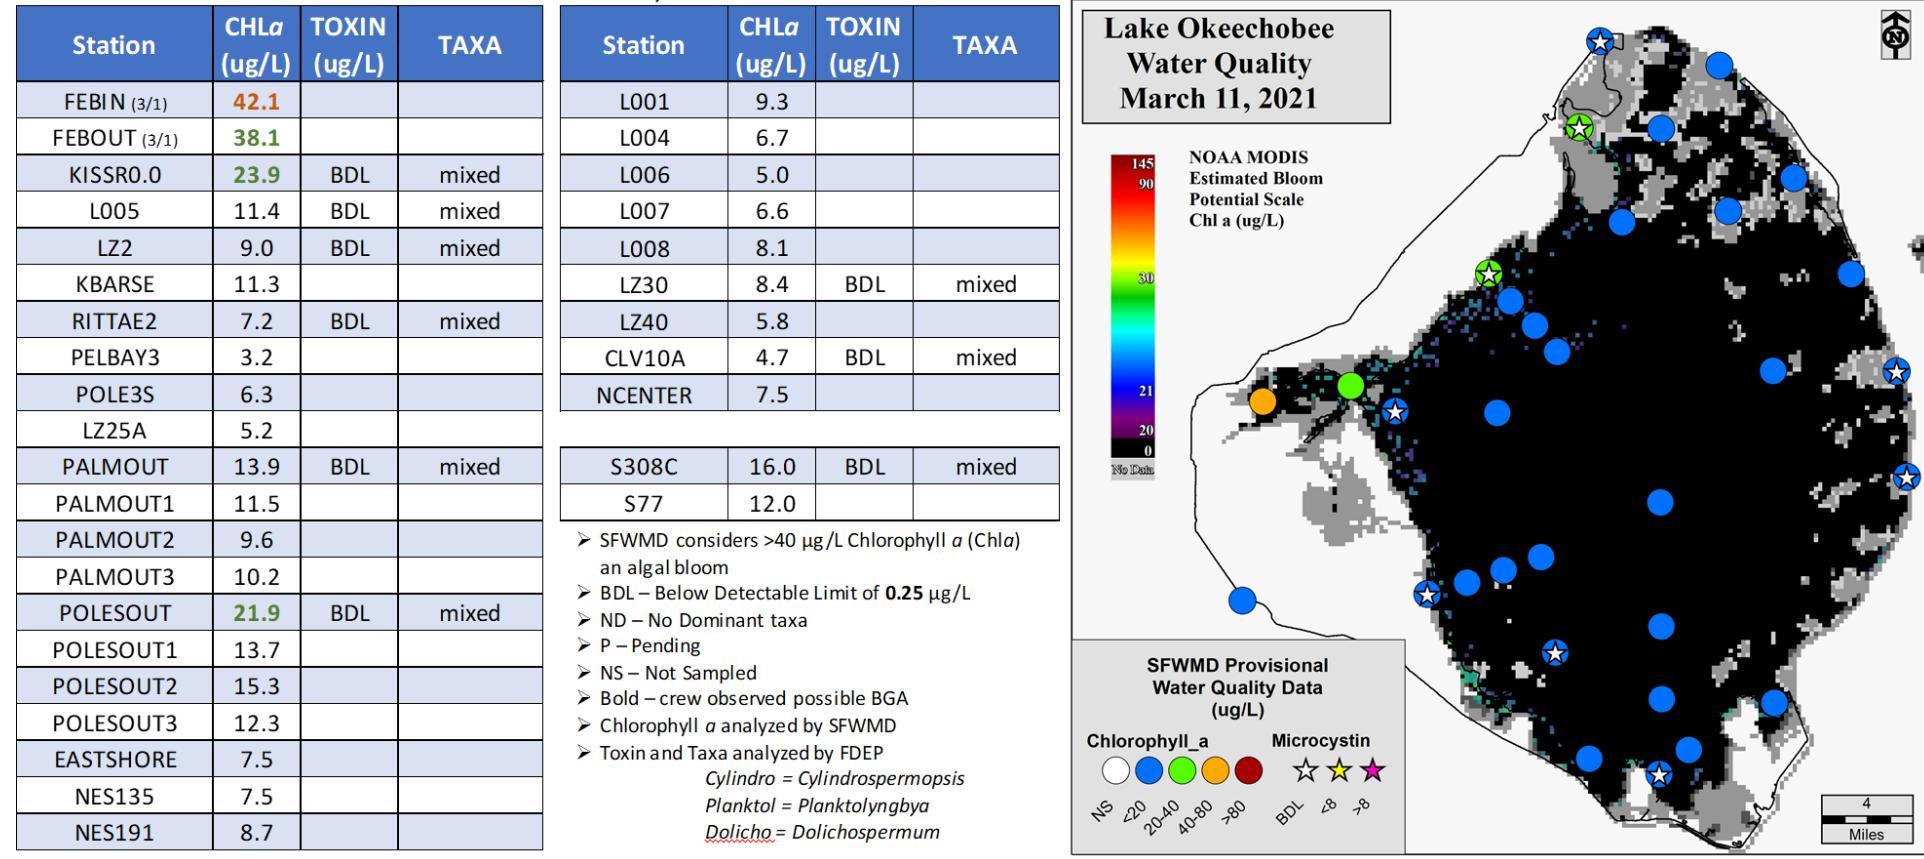
Figure 6. Provisional results from the expanded monitoring sampling trips March 9 - 11, 2021.

Water quality sampling is now on the non-bloom season schedule (November – April), occurring once monthly at 32 stations for chlorophyll *a*, and at 9 stations for taxonomic identification and toxin analyses. Most of the March sampling occurred on the 10th and 11th. None of the samples from the nine algal ID stations had detectable levels of cyanotoxins, and all algal communities were described as mixed, i.e. no dominant cyanobacteria taxa. For the chlorophyll *a* results, four sites exhibited values above 20 μ g/L, one of which (FEBIN) was over 40 μ g/L (Figure 6).

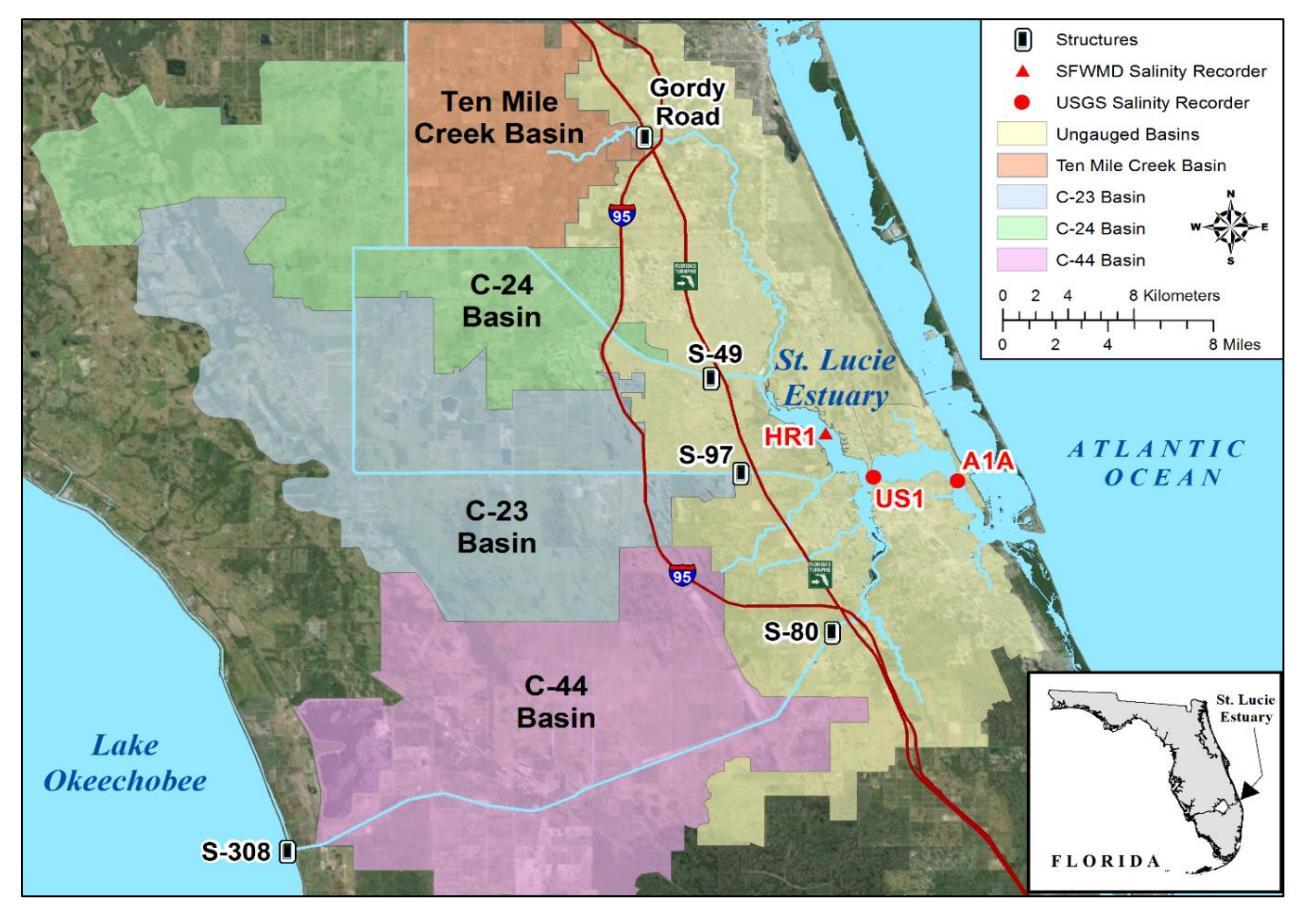
Figure 1. Basins, water control structures, and salinity monitoring for the St. Lucie Estuary.

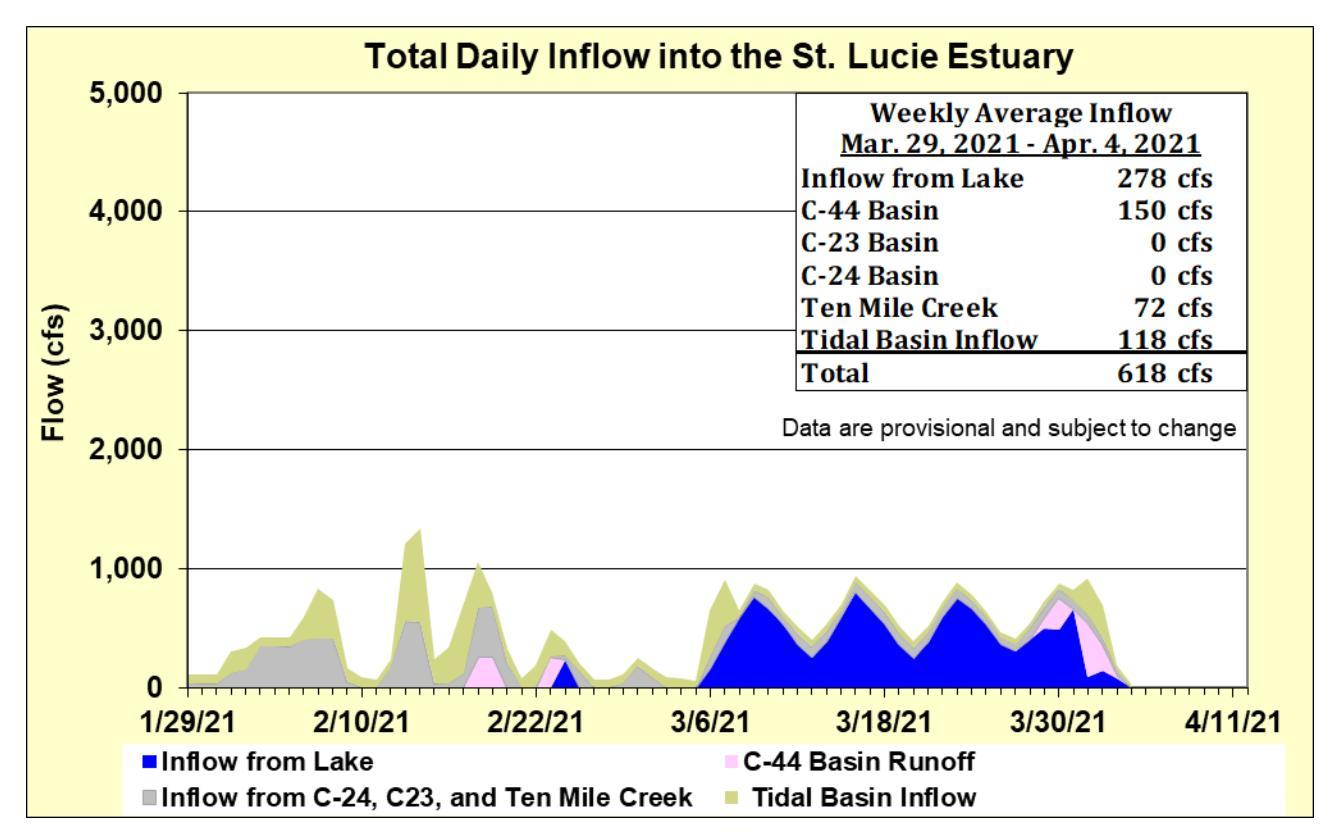
Figure 2. Total daily inflows from Lake Okeechobee and runoff from the C-44, C-23, C-24, Ten Mile Creek, and tidal basin into the St. Lucie Estuary. Note: C-23 Basin inflows were estimated using S-48.

Last week total inflow to the St. Lucie Estuary averaged approximately 618 cfs (Figures 1 and 2) and the previous 30-day inflow averaged about 643 cfs. Last week's provisional averaged inflows from the tidal basin and the structures are shown in Table 1.

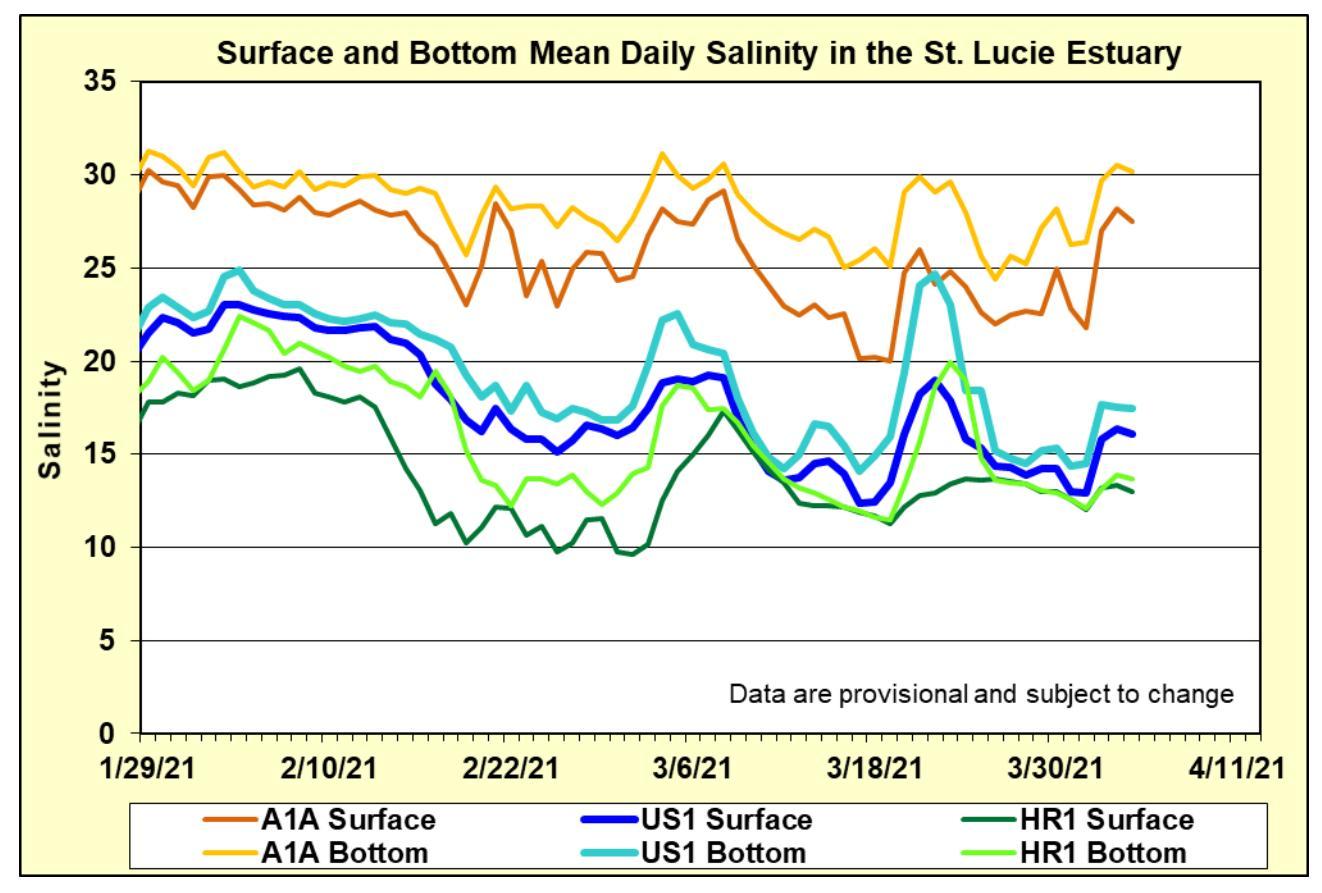
Figure 3. Daily mean salinity at the A1A, US1, and HR1 stations.

Over the past week, salinity decreased at the HR1 and US1 Bridge sites but increased at the A1A Bridge site (Table 2, Figures 3 and 4). The seven-day moving average of the water column (an average of the surface and bottom salinity) at the US1 Bridge was 15.3. Salinity conditions in the middle estuary are estimated to be within the good range for adult eastern oysters (Figure 4).

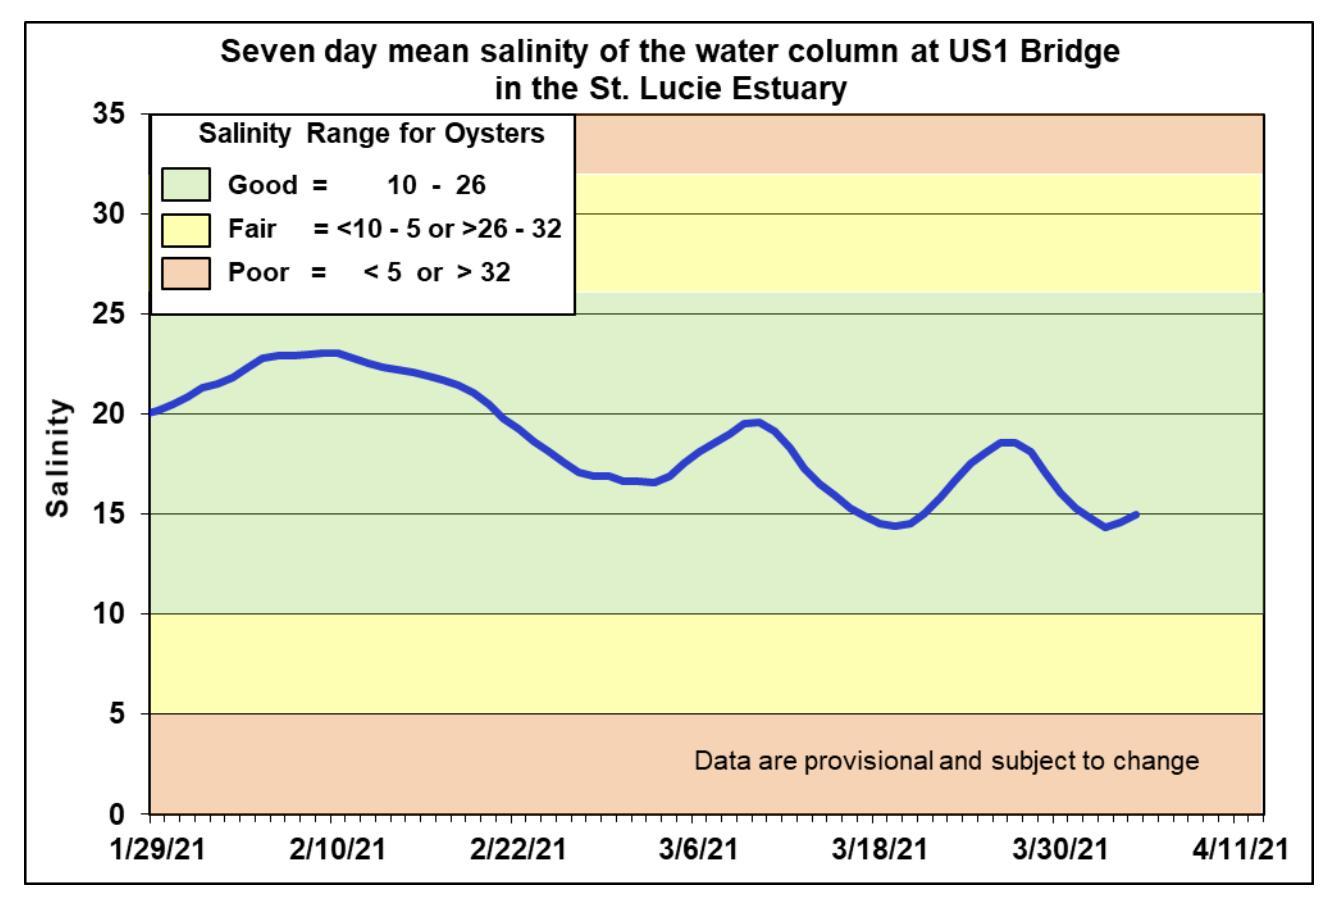
Figure 4. Seven-day mean salinity of the water column at the US1 Bridge.

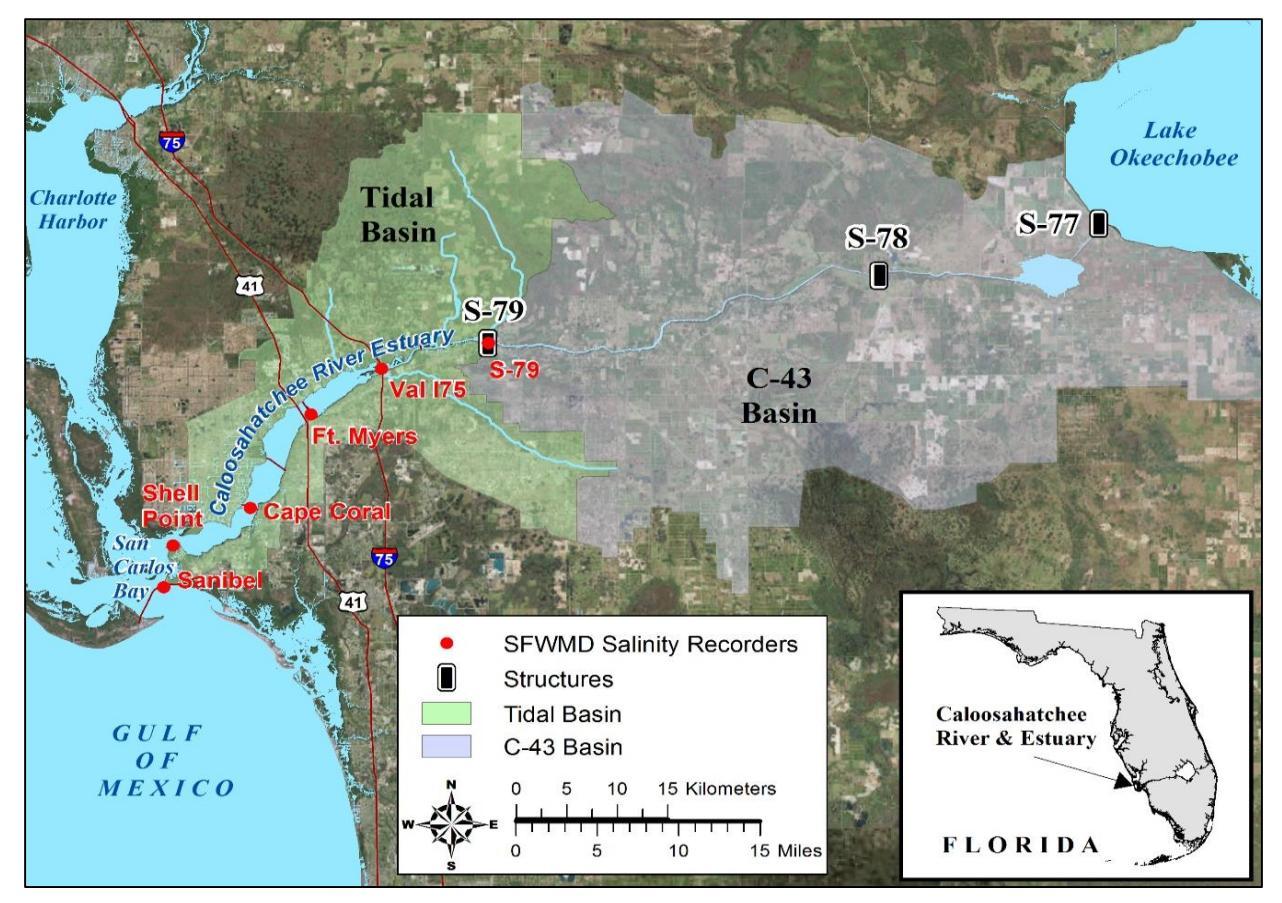
Figure 5. Basins, water control structures, and salinity monitoring for the Caloosahatchee Estuary.

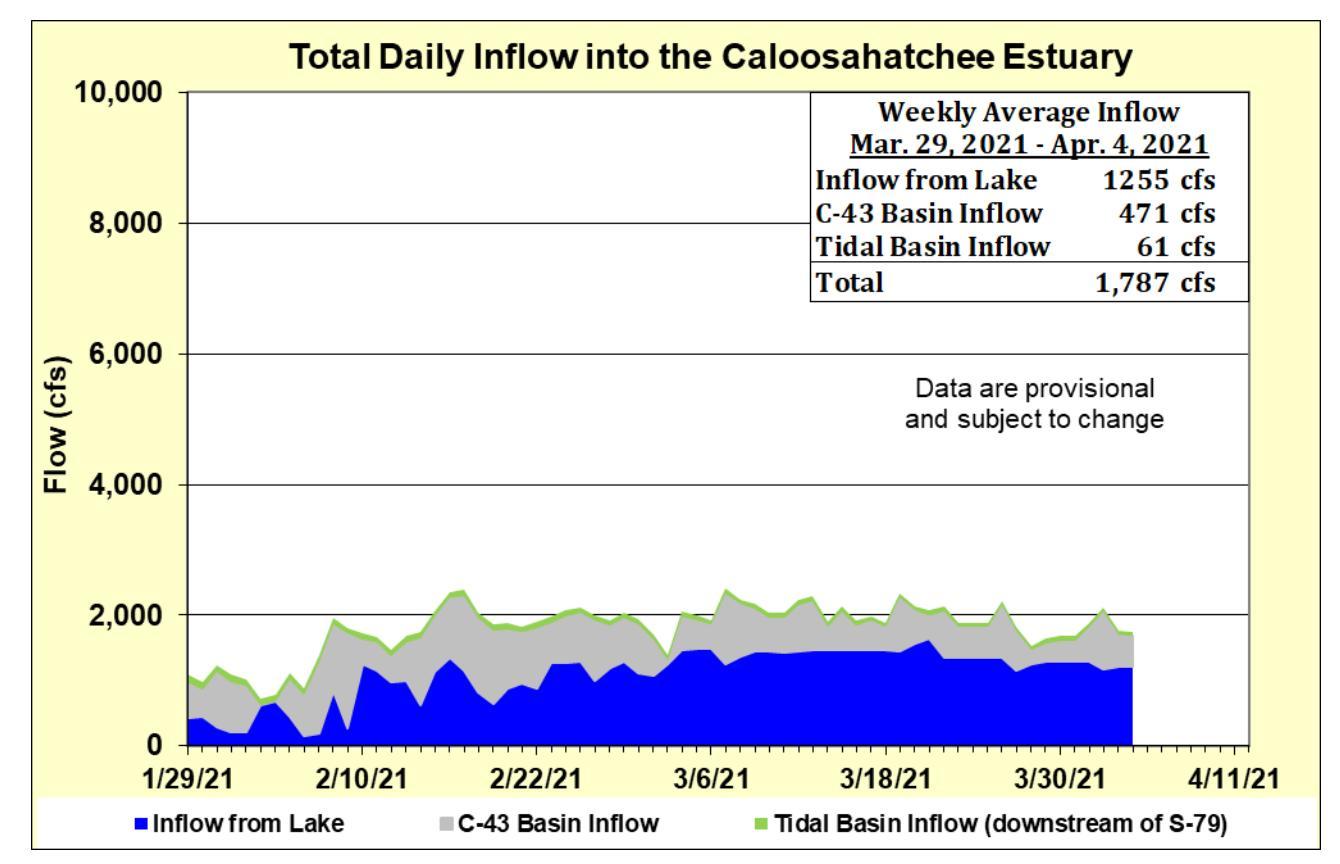
Figure 6. Total daily inflows from Lake Okeechobee, runoff from the C-43 basin and tributaries in the tidal basin into the Caloosahatchee River Estuary.

Last week total inflow to the Caloosahatchee Estuary averaged approximately 1,787 cfs (Figures 5 and 6) and the previous 30-day inflow averaged approximately 1,986 cfs. Last week's provisional averaged inflows from the structures and the tidal basin are shown in Table 3.

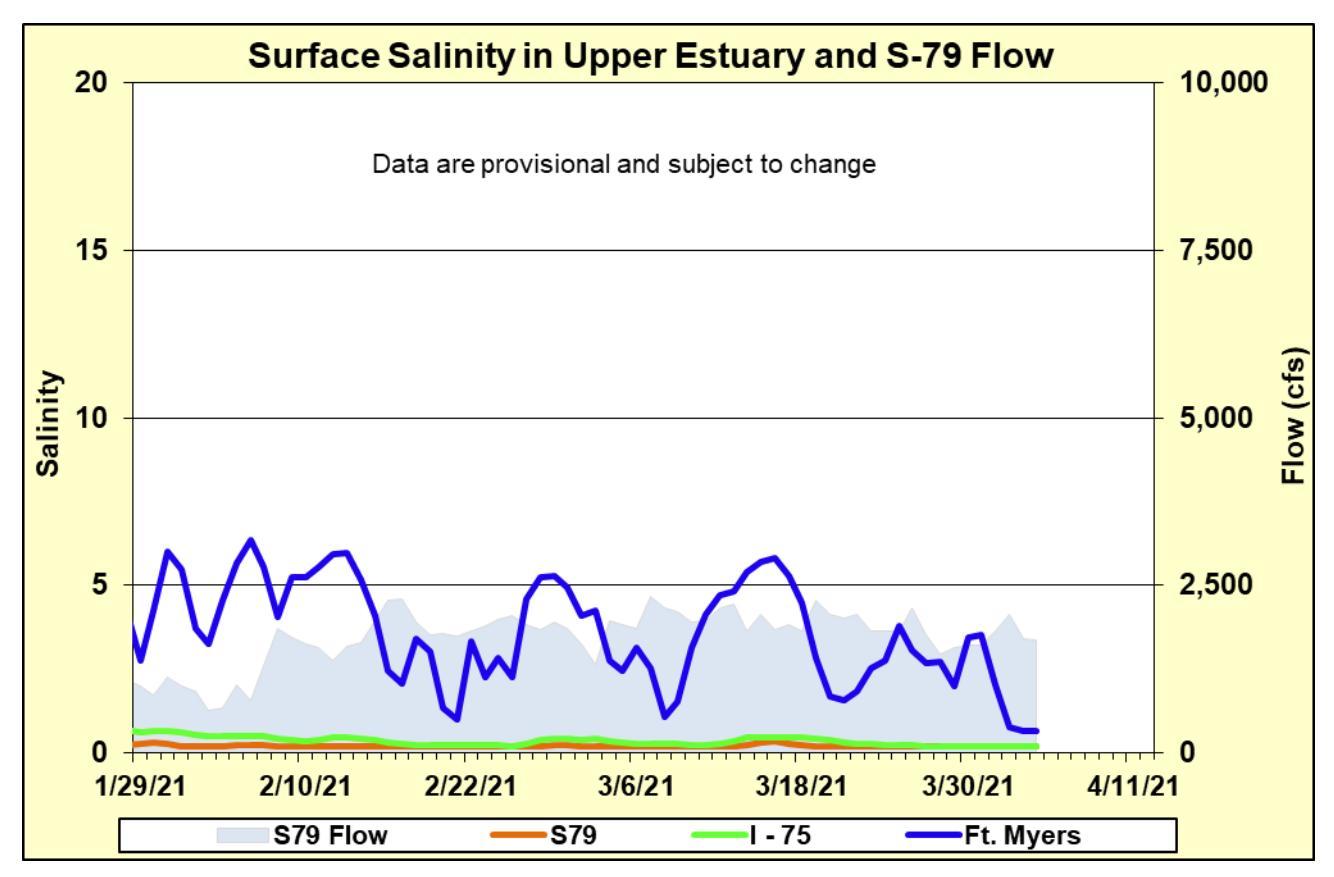
Figure 7. Daily mean flows at S-79 and salinity at upper estuary monitoring stations.

Over the past week, surface salinities remained the same at S-79 and Val I-75 and decreased at the remaining sites in the estuary (Table 4, Figures 7 & 8). The seven-day average salinity values were within the good range for adult eastern oysters at Cape Coral and Shell Point, and in the fair range at Sanibel (Figure 9). The seven-day average salinities (Table 4) were in the good range (0-10) for tape grass at Val I-75 and at Ft. Myers.
