MEMORANDUM

DATE: April 7, 2021

SUBJECT: Weekly Environmental Conditions for Systems Operations

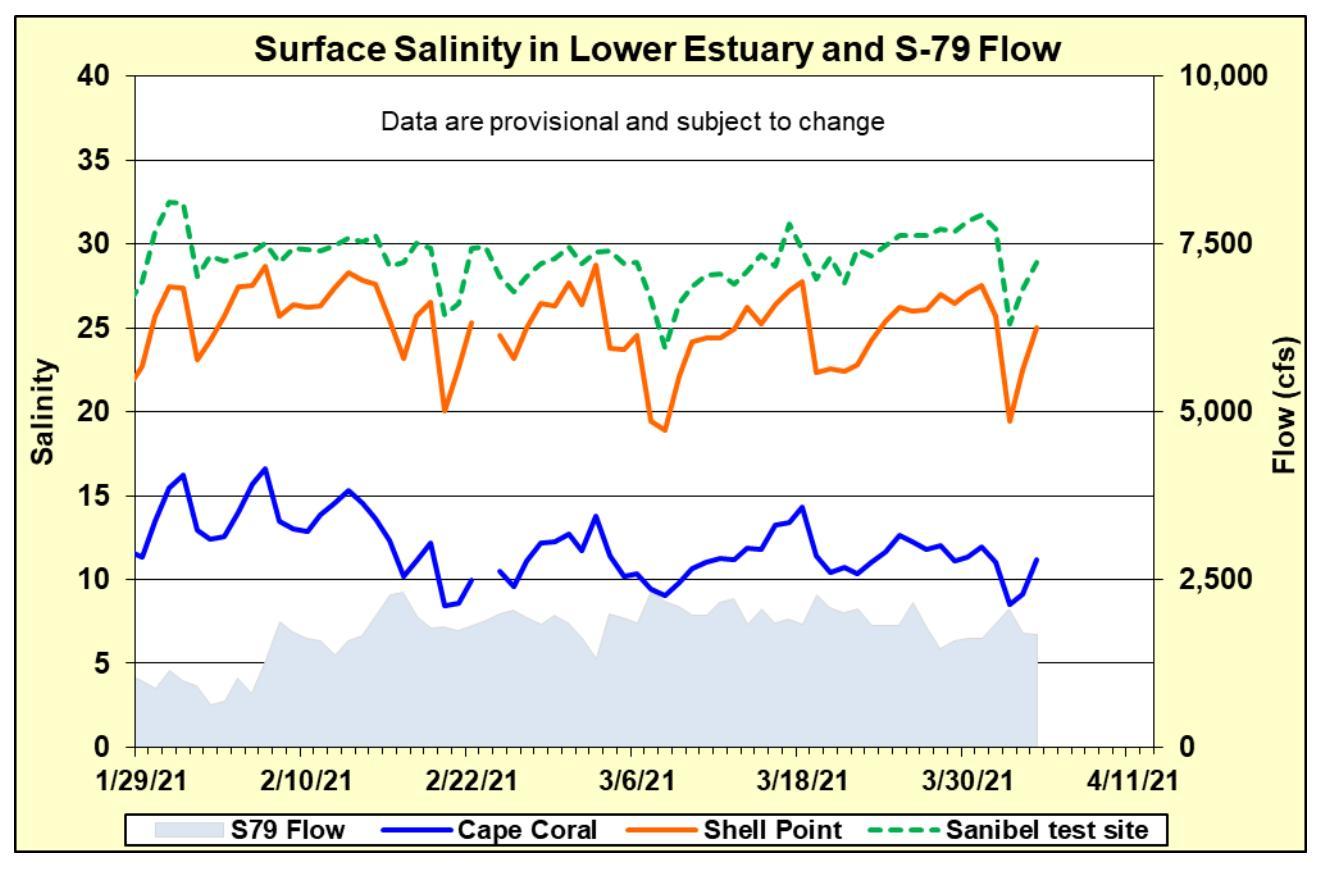
Figure 8. Daily mean flows at S-79 and salinity at lower estuary stations.

Over the past week, surface salinities remained the same at S-79 and Val I-75 and decreased at the remaining sites in the estuary (Table 4, Figures 7 & 8). The seven-day average salinity values were within the good range for adult eastern oysters at Cape Coral and Shell Point, and in the fair range at Sanibel (Figure 9). The seven-day average salinities (Table 4) were in the good range (0-10) for tape grass at Val I-75 and at Ft. Myers.

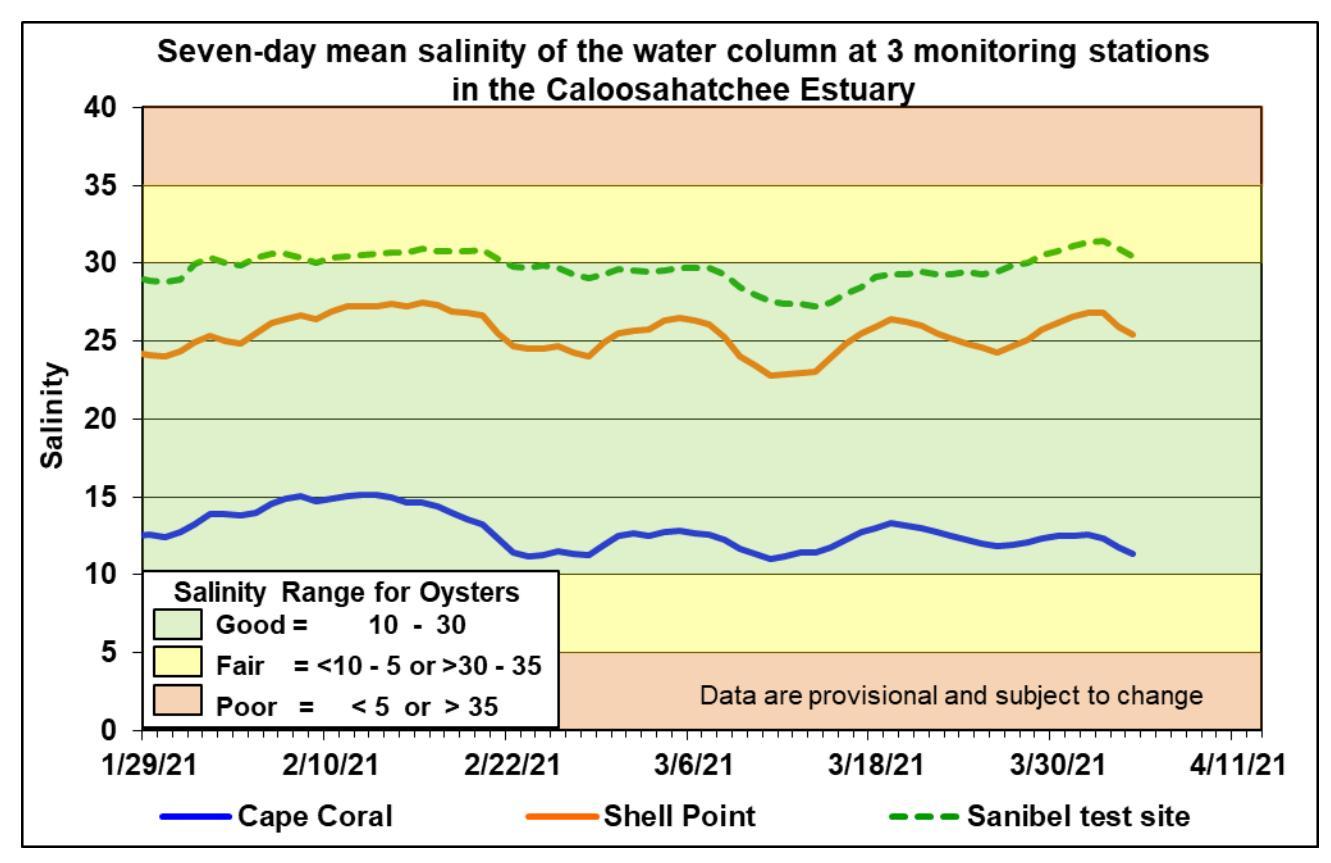
Figure 9. Seven-day mean salinity at Cape Coral, Shell Point, and Sanibel monitoring stations.

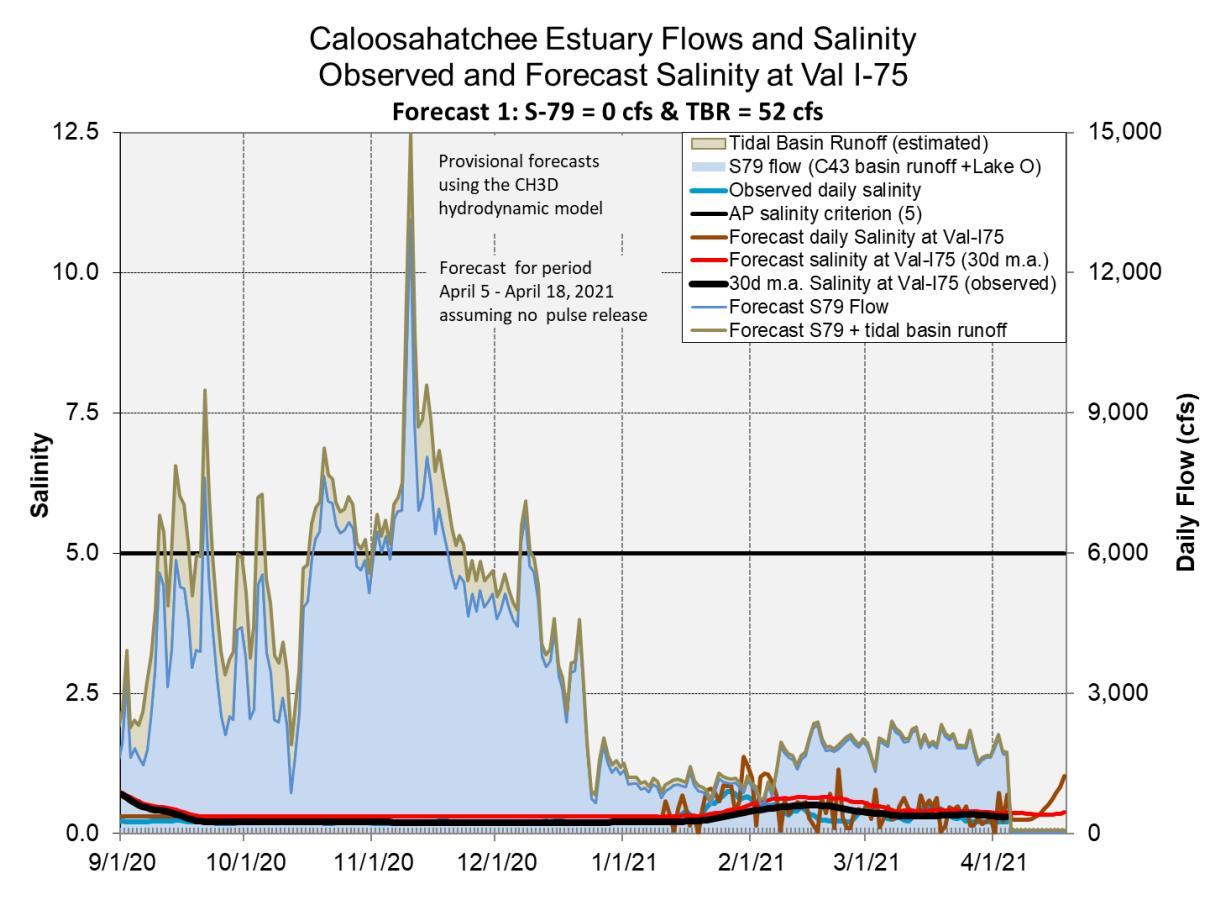
Figure 10. Forecasted Val I-75 surface salinity assuming no pulse release at S79.

Forecast of surface salinity (Table 5 and Figure 10) at Val I-75 for the next two weeks using the autoregression model (Qiu and Wan, 2013) coupled with a linear reservoir model for the tidal basin predicts daily salinity to be 1.0 or lower at the end of the two week period for pulse release at S-79 ranging from 0 to 1500 cfs and steady release at S-79 of 2000 cfs.Tidal Basin inflows are estimated to be 52 cfs. The 30-day moving average surface salinity at Val I-75 is forecast to be 0.4 or lower (Table 5). The current salinity conditions at Val I-75 are within the envelope of salinity (0.0-5.0) for this site (Table 4).

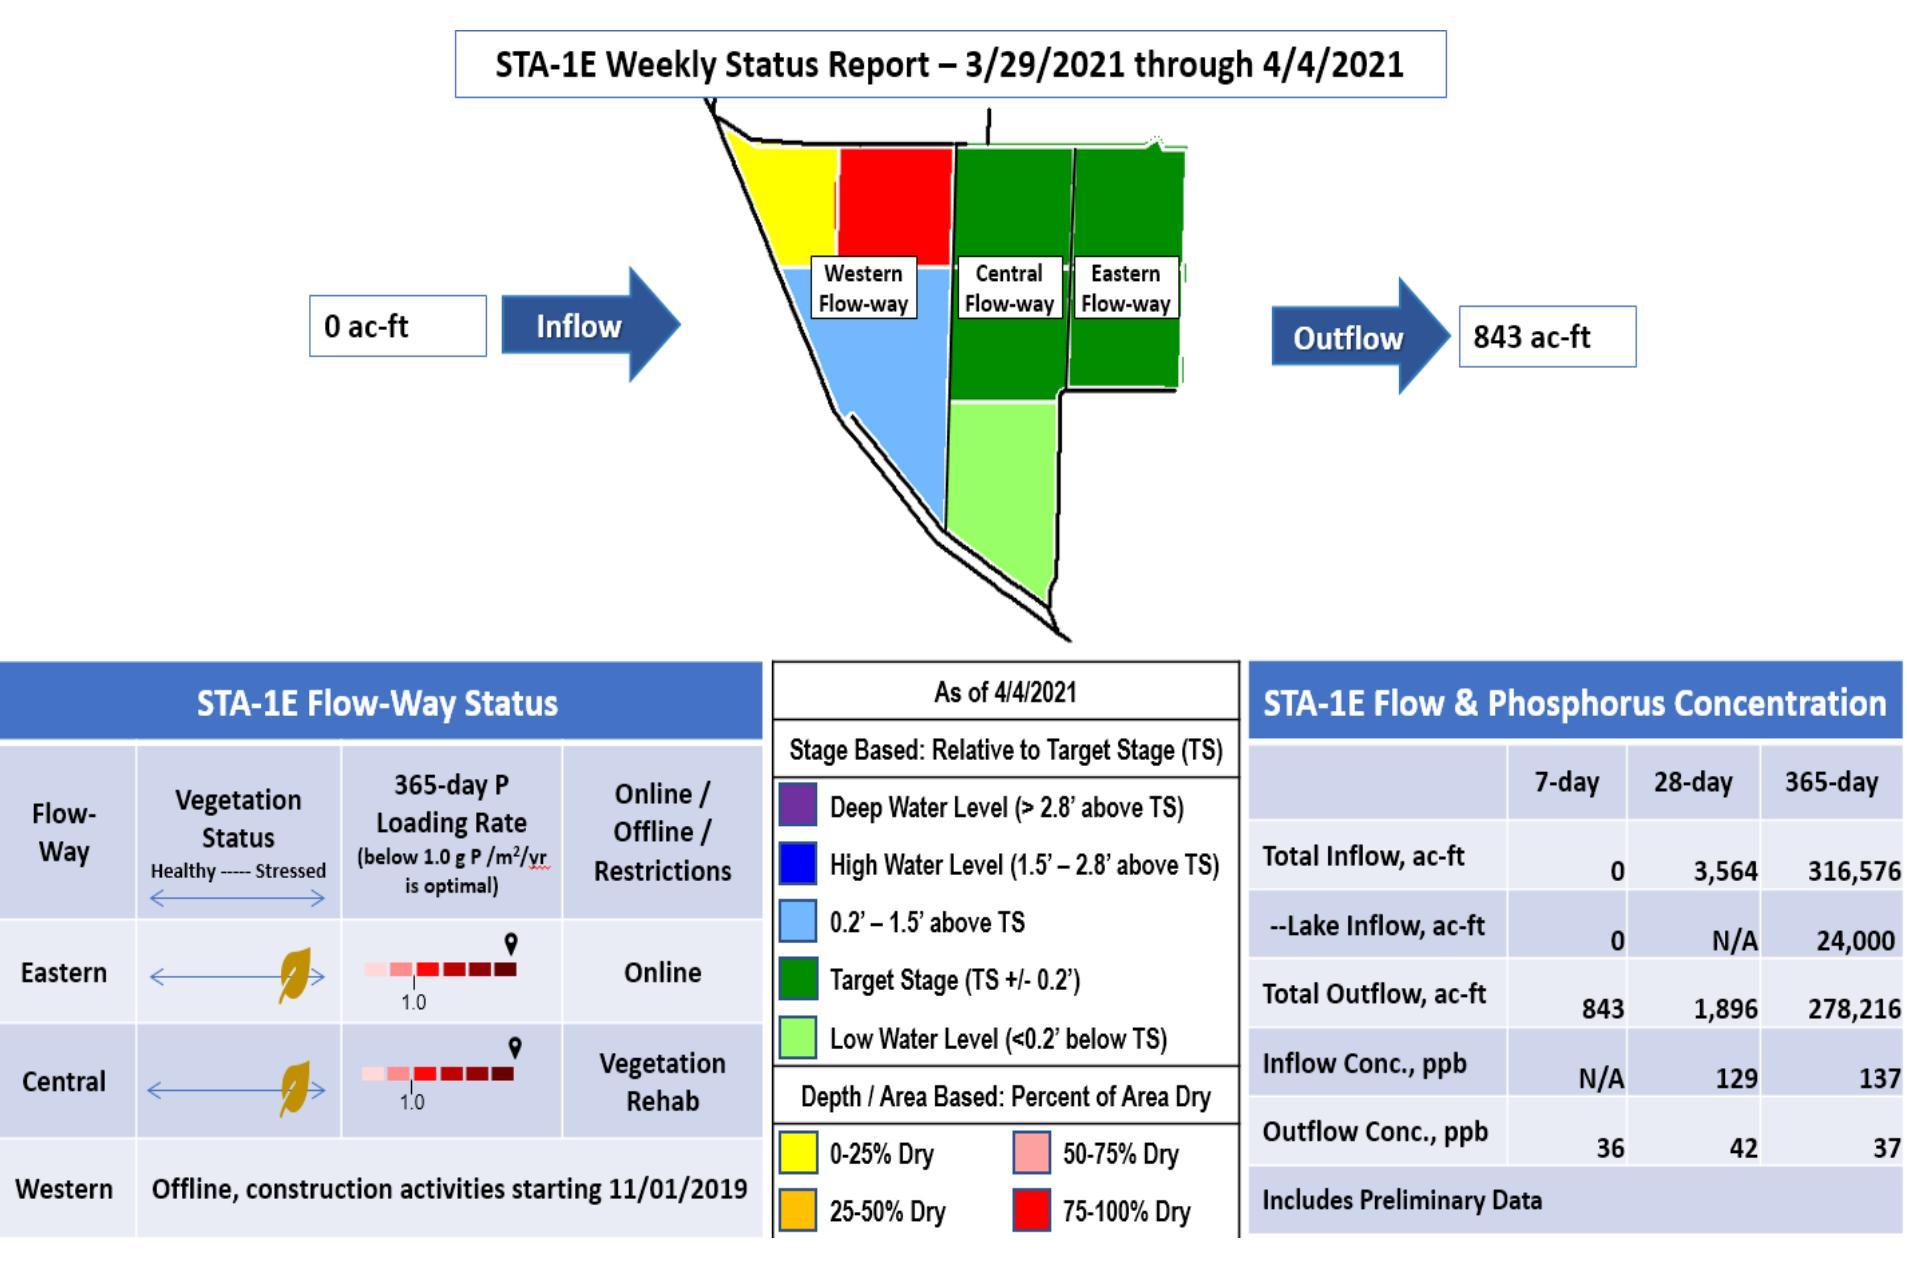
Figure 1. STA-1E Weekly Status Report

STA-1E: STA-1E Western Flow-way is offline for the Restoration Strategies project to fill and grade Cells 5 and 7. Operational restrictions are in place in STA-1E Central Flow-way for vegetation management activities. Online treatment cells are at or near target stage, vegetation in these cells is highly stressed and the 365-day phosphorus loading rates (PLR) for these flow-ways are extremely high (Figure 1).

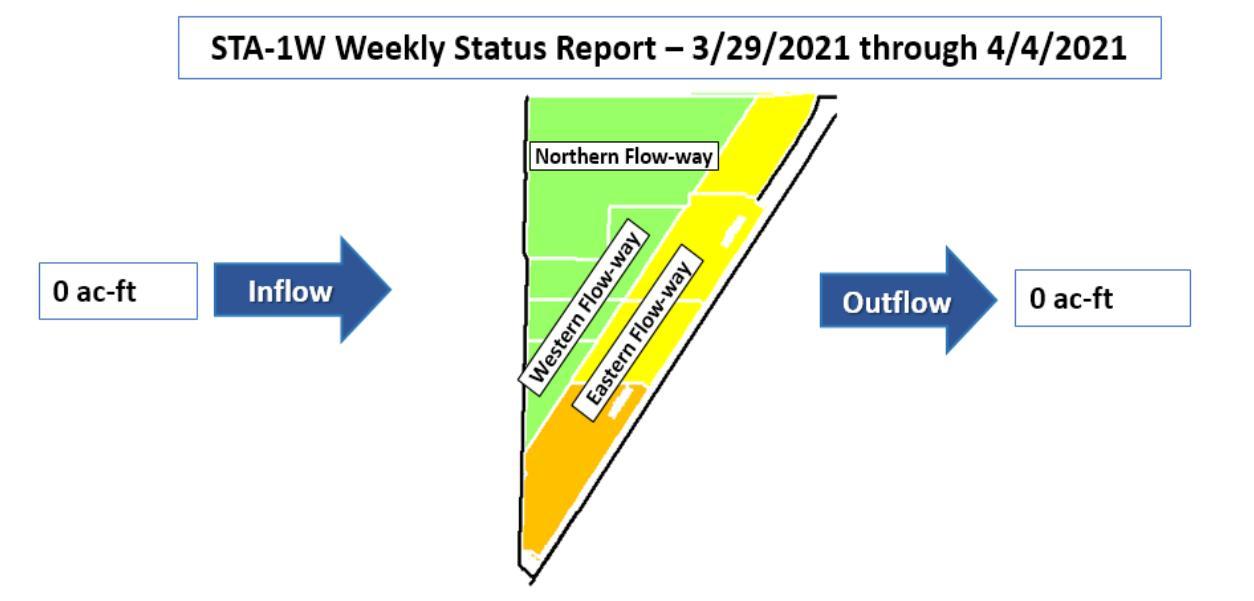
Figure 2. STA-1W Weekly Status Report

STA-1W: Operational restrictions are in place in STA-1W Western, Eastern, and Northern Flow-ways due to construction activities. All treatment cells are below target stage. Vegetation in all flow-ways is highly stressed and the 365-day PLRs for all flow-ways are high to very high (Figure 2).

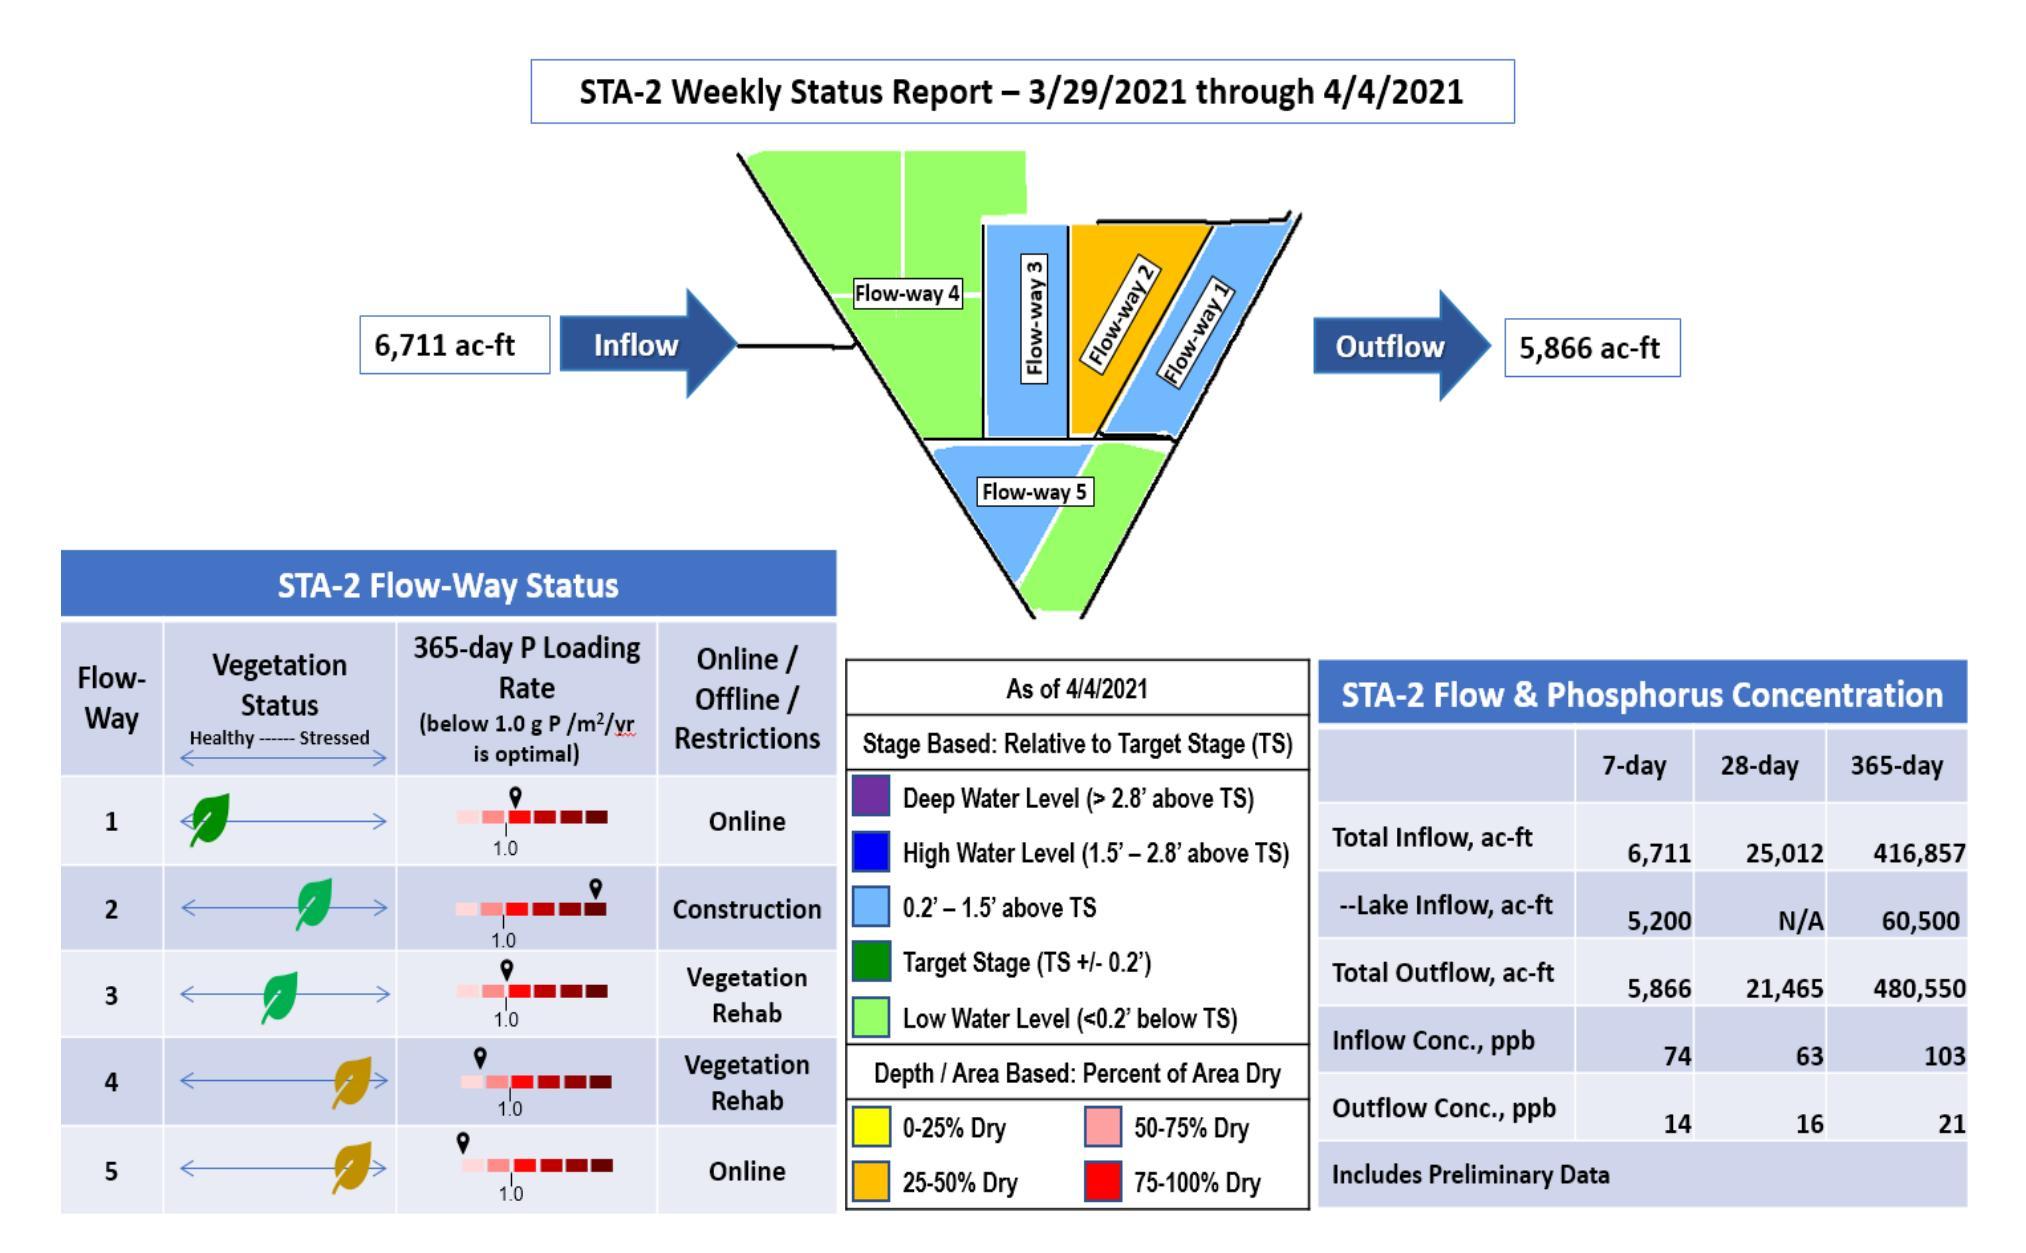
Figure 3. STA-2 Weekly Status Report

STA-2: Operational restrictions are in place in STA-2 Flow-ways 3 and 4 for vegetation management activities and in Flow-way 2 for construction activities. Treatment cells are near target stage except Flow-way 2 which is below target stage. Vegetation in Flow-way 1 is healthy, in Flow-ways 2 and 3 is stressed, and in Flow-ways 4 and 5 is highly stressed. The 365-day PLRs for all flow-ways are about 1.0 g/m²/year except Flow-way 2 which is very high (Figure 3).

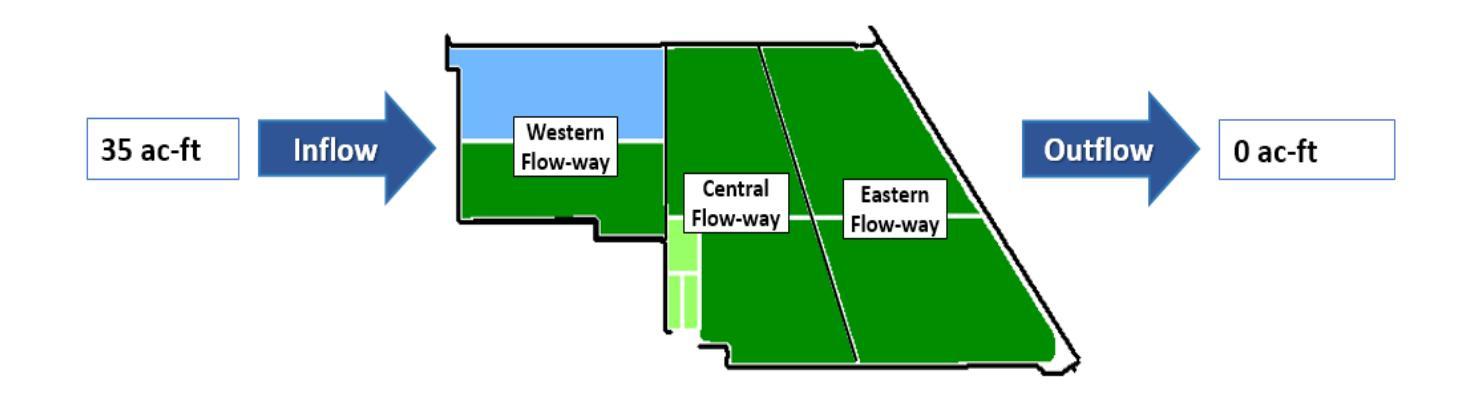
Figure 4. STA-3/4 Weekly Status Report

STA-3/4: STA-3/4 Eastern Flow-way is offline for vegetation rehabilitation/drawdown. Operational restrictions are in place in STA-3/4 Central and Western Flow-ways for vegetation management activities. All online treatment cells are at or near target stage. Vegetation in the Eastern and Central Flow-ways is highly stressed and in the Western Flow-way is stressed. The 365-day PLRs for all flow-ways are below 1.0 g/m²/year (Figure 4).

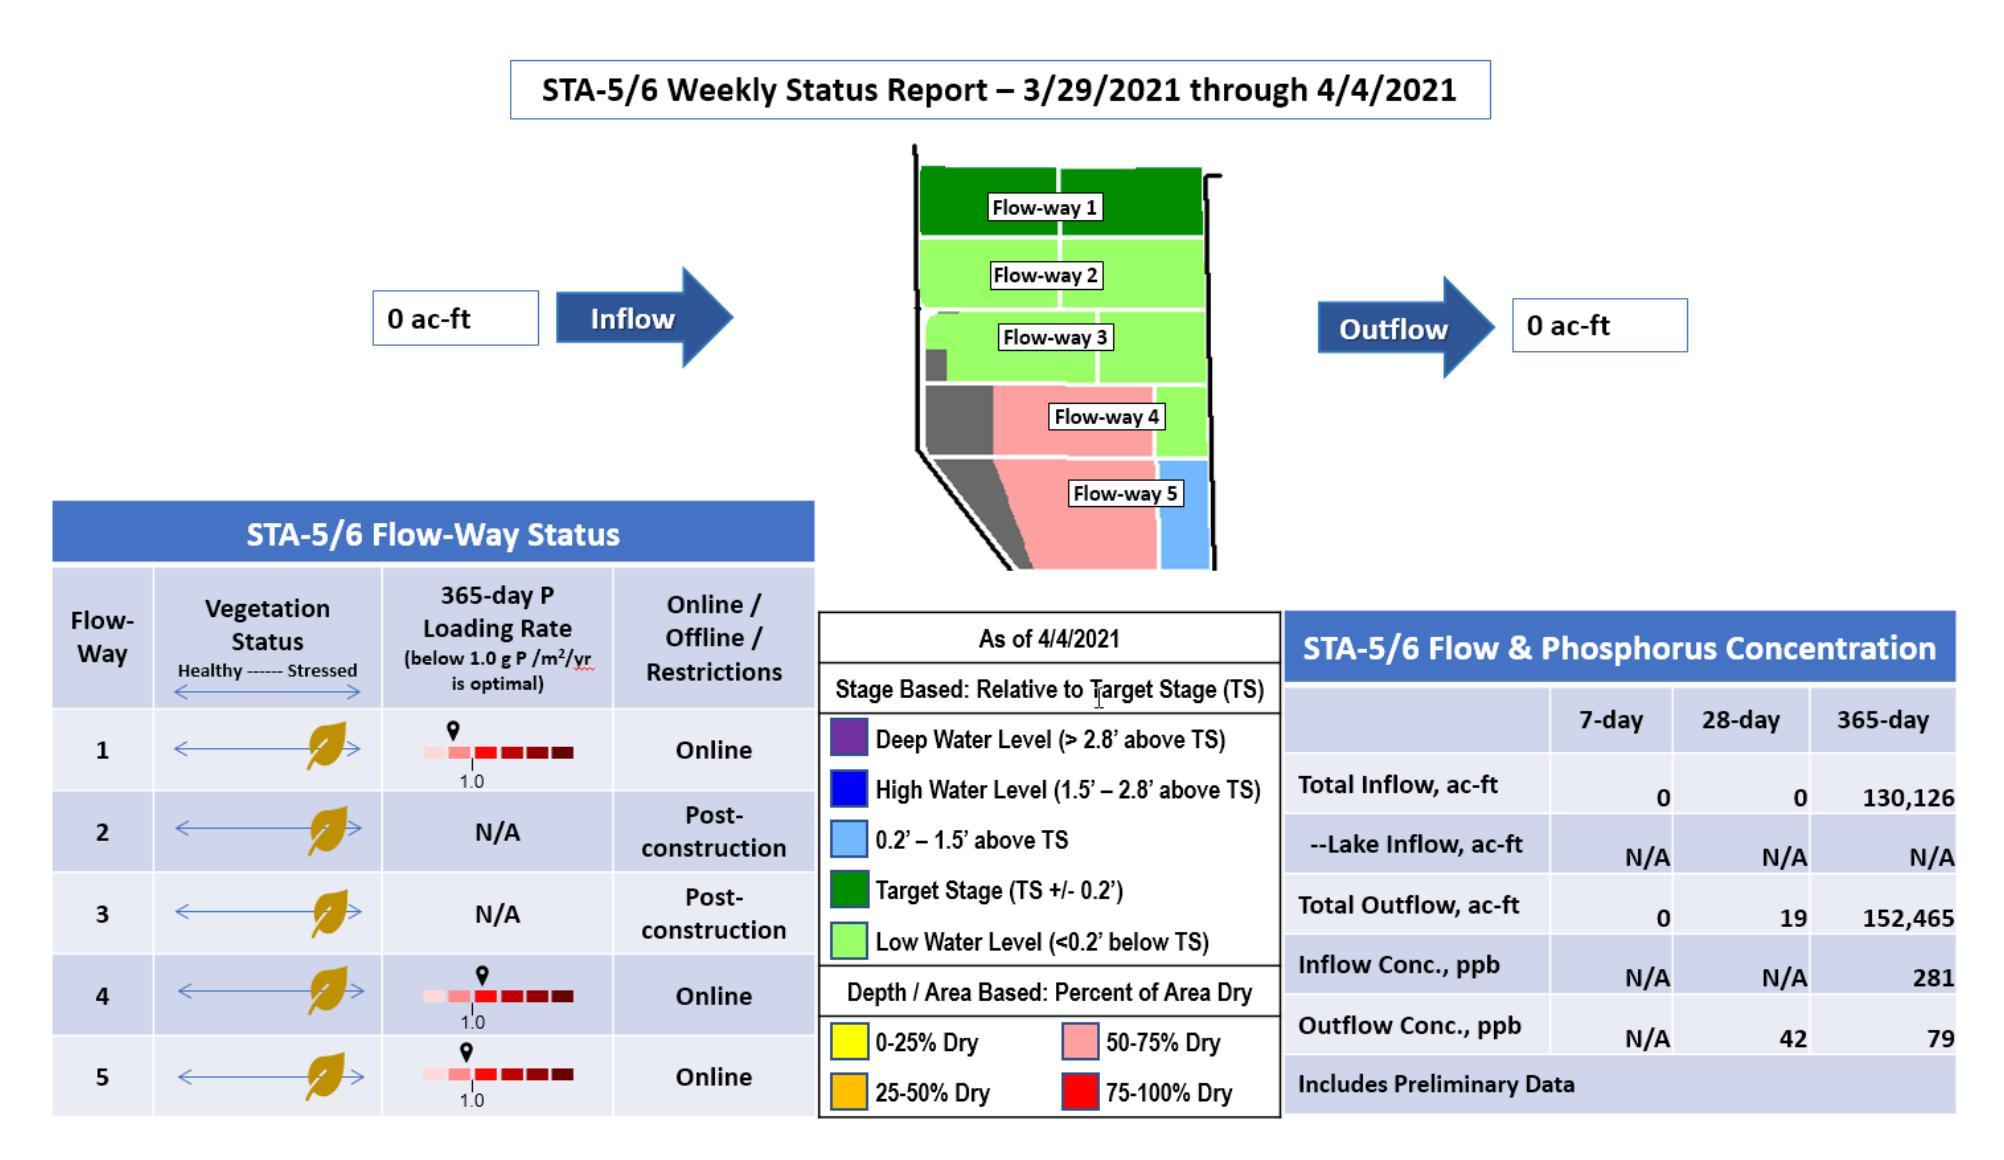
Figure 5. STA-5/6 Weekly Status Report (Flow-ways 1 – 5)

STA-5/6: Operational restrictions are in place in STA-5/6 Flow-ways 2 and 3 following the Restoration Strategies project to grade non-effective treatment areas. Some treatment cells are at or near target stage while several cells are starting to dry out. The 365-day PLRs for most flow-ways are near 1.0 g/m²/year. All treatment cells have highly stressed vegetation conditions except Flow-ways 7 and 8 which are healthy (Figure 5 and 6).
