# Reconnaissance of Hydrology and Environmental Conditions in Central Big Cypress Basin

Final Report  
February 15, 2006  
CN040927-WO01

South Florida Water  
Management District

Metcalf & Eddy  
3740 Executive Way  
Miramar, FL 33025  
T 954-450-7770  
F 954-450-5100

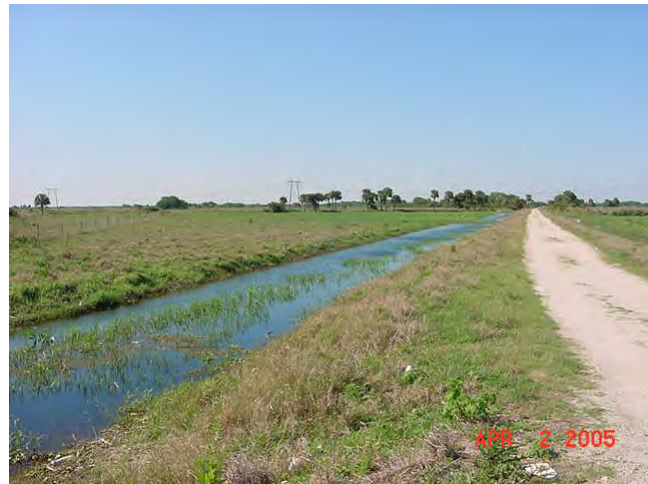
**Photo 2.1 Typical Farming Ditch along dirt road in Bear Slough; ditch acts as a basin divide**

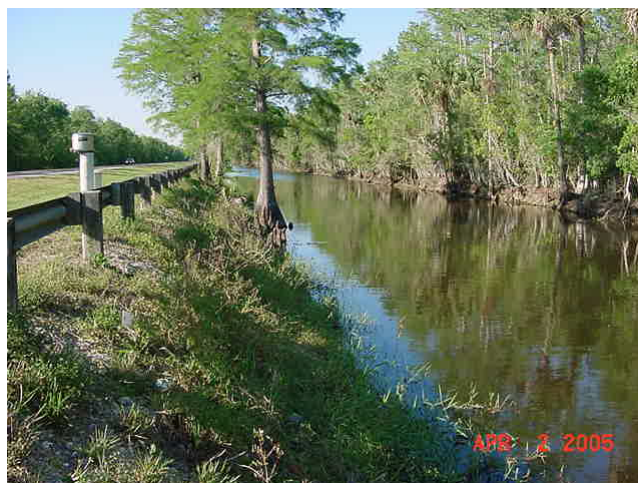
**Photo 2.2. Barron River Canal along SR 29 within the Okaloacoochee Slough Sub-Basin.**

Throughout the project study area, canals can simply be a by-product of roadway construction (i.e., providing fill materials). Such was the case for the Barron River Canal (Photo 2.2), materials used for State Road 29, and the creation of the Tamiami Canal was a by-product of the Tamiami Trail (US-41).

The first major canal was excavated in the 1920's as a result of the US 41, Tamiami Trail, construction. As a result of this road, water now moves in an east-west direction until it can exit south through bridges or water conveyance structures (Sobczak, 2005). Some of the adjacent wetland habitats get too much fresh water while other areas receive too little water. The other major roadway is I-75 which runs east-west through the project study area and like US 41, diverts water to the west until it can pass underneath the road under a bridge or culvert (Sobczak, 2005). State Route 29 parallels a major canal that drains water to the south.

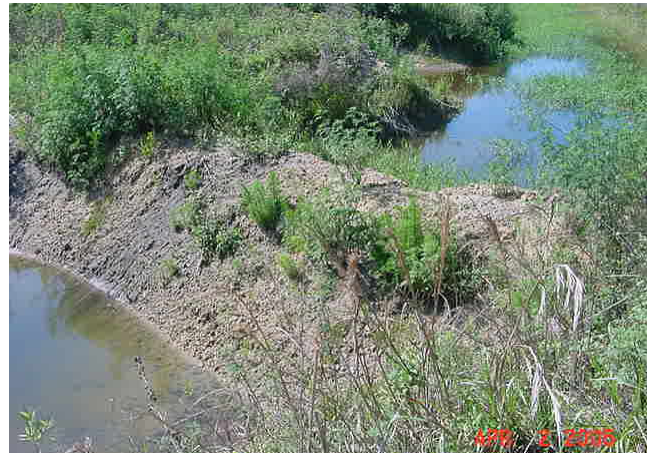
**Photo 2.5 Typical Farm Berm in Canal, Camp Keais Sub-Basin**

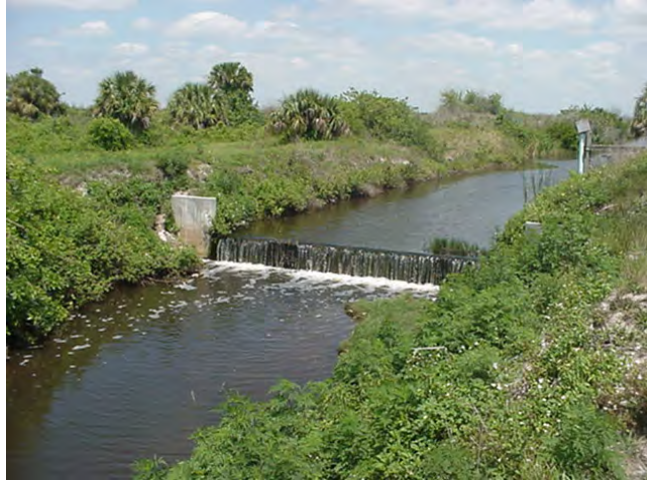
**Photo 2. 6. Fixed crest concrete weir located at entrance into CREW management center.**

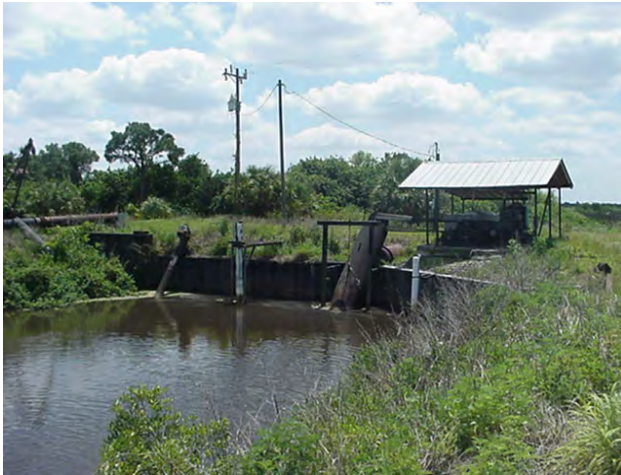
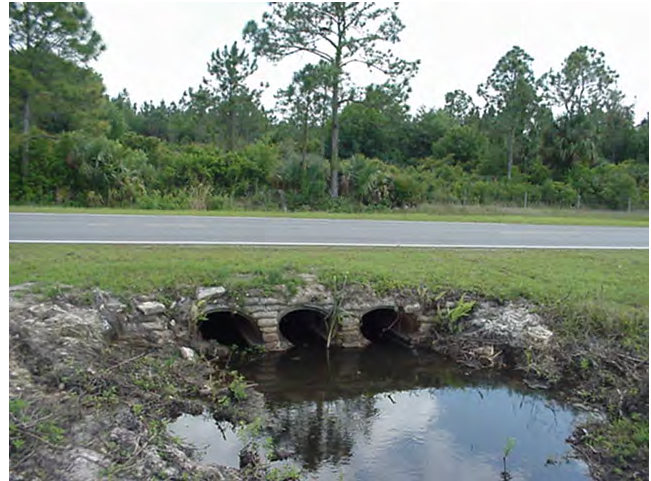
**(Left) Photo 2.7 Citrus Grove Pumping Station located at northeastern boundary of Corkscrew Marsh**  
**(Right) Photo 2.8 Concrete tri-culverts conveying agricultural runoff into Corkscrew Marsh**

1. Drainage north of Corkscrew Swamp and Wildcat Farms provides too much water to the south and may include runoff from agricultural land use – primarily citrus.

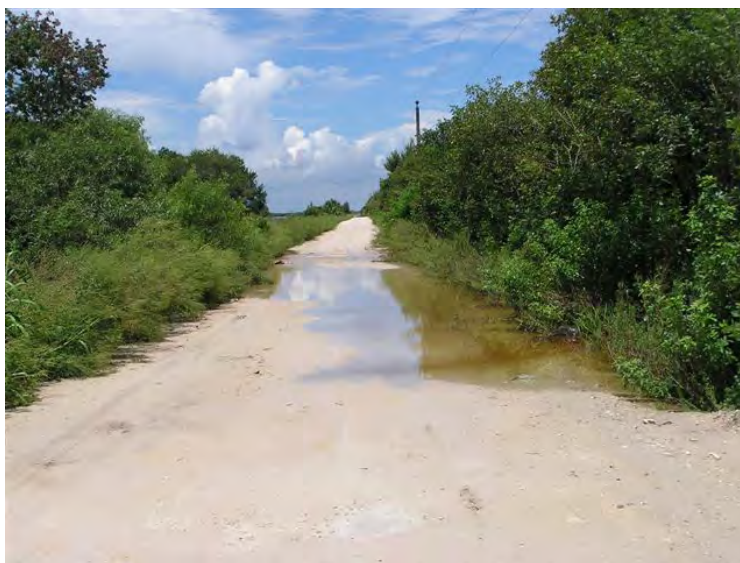
**Photo 6.1. Flooded Farm Road During a Relatively Dry Period in Bear Slough, East Collier Sub-Basin (April, 2005)**

Several portions of the project study area are subject to fluctuations in water levels that result in problems. The Bear Slough area in the Eastern Collier County Sub-Basin was identified as one area of concern because of existing hydrological conditions (Section 2.8). This largely agricultural area is subject to periodic inundation during periods of high precipitation. These conditions have been prominent again during recent wet periods in June and July, 2005.

Property owners have reported to the District that sheet flow is impeded by plugged farm ditches, blocked sloughs, and roads and farm paths that lack culverts or have blocked culverts. One such condition is shown in Photo 2.5. Conditions are severe enough that roads are covered with standing water for extended periods (Photo 6.1). Restoration of this area is discussed in Section 6.3.1.
