M E M O R A N D U M

DATE: October 31, 2017

SUBJECT: Weekly Environmental Conditions for Systems Operations

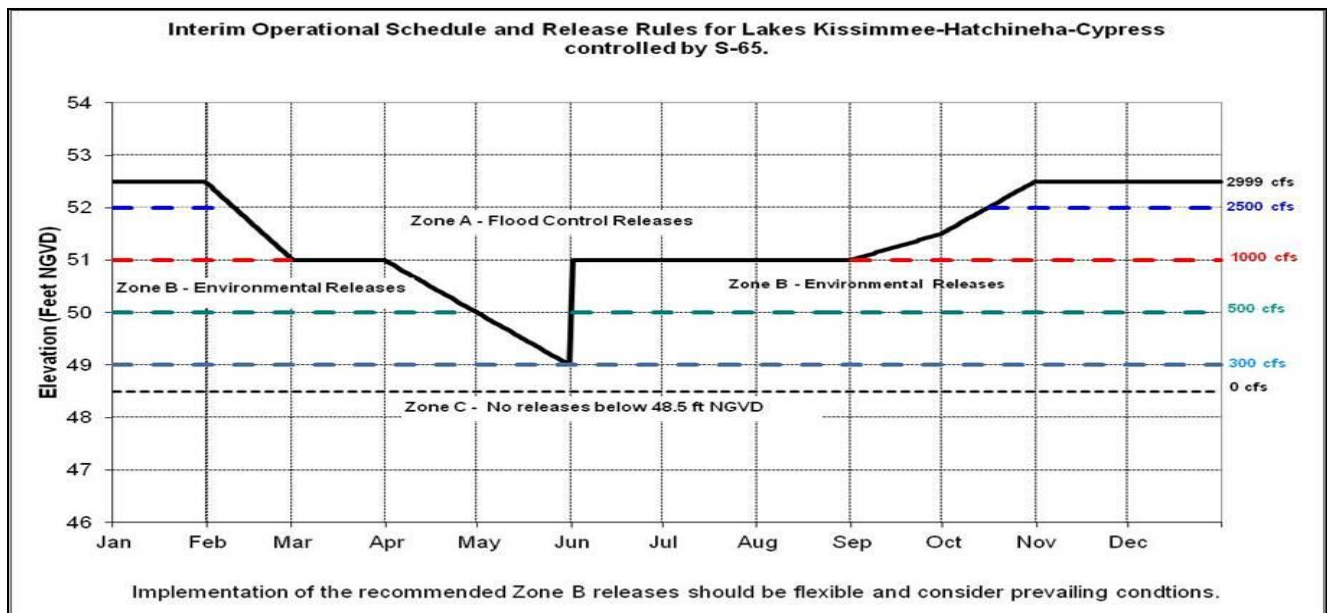
Figure 9. Interim operations schedule for S-65. The discharge schedule shown to the right has not been used in recent years.

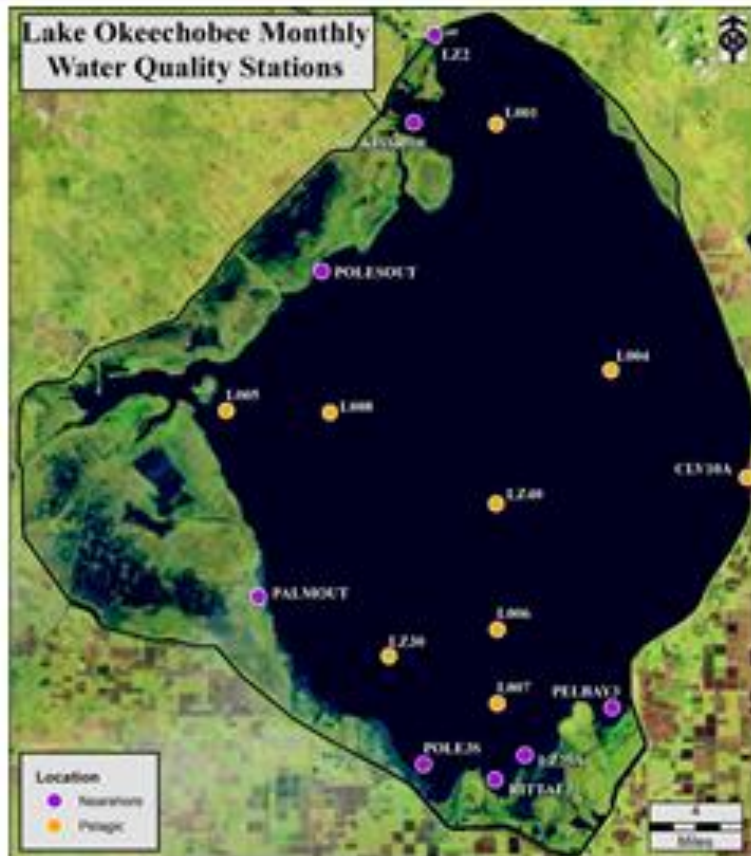
Figure 5

The high total phosphorous (TP) concentrations and amount of total suspended solids (TSS) in the water column as a result of Hurricane Irma's high inflows and high winds decreased slightly just a month later (Figure 5). TP average for the nearshore areas went from 295 ppb just after Hurricane Irma to 179 ppb in October, while the pelagic average went from 203 ppb to 181 ppb. The lake-wide average declined from 251 ppb to 180 ppb. Similarly, the TSS went from 44 ppm in the nearshore to 14 ppm, and the pelagic average went from 54 ppm to 29 ppm, bringing the lake-wide average from 49 ppm to 22 ppm. While these reductions are a good sign, lake-wide values are still well above pre-storm (August) averages of 113 ppb and 10 ppm TP and TSS, respectively, and it is too early to tell if this trend of settling will continue.

Parameter		Aug 2017	Sep 2017	Oct 2017
TP (ppb)	Nearshore	119	295	179
	Pelagic	106	203	181
	Lakewide	113	251	180
TSS (ppm)	Nearshore	6	44	14
	Pelagic	15	54	29
	Lakewide	10	49	22

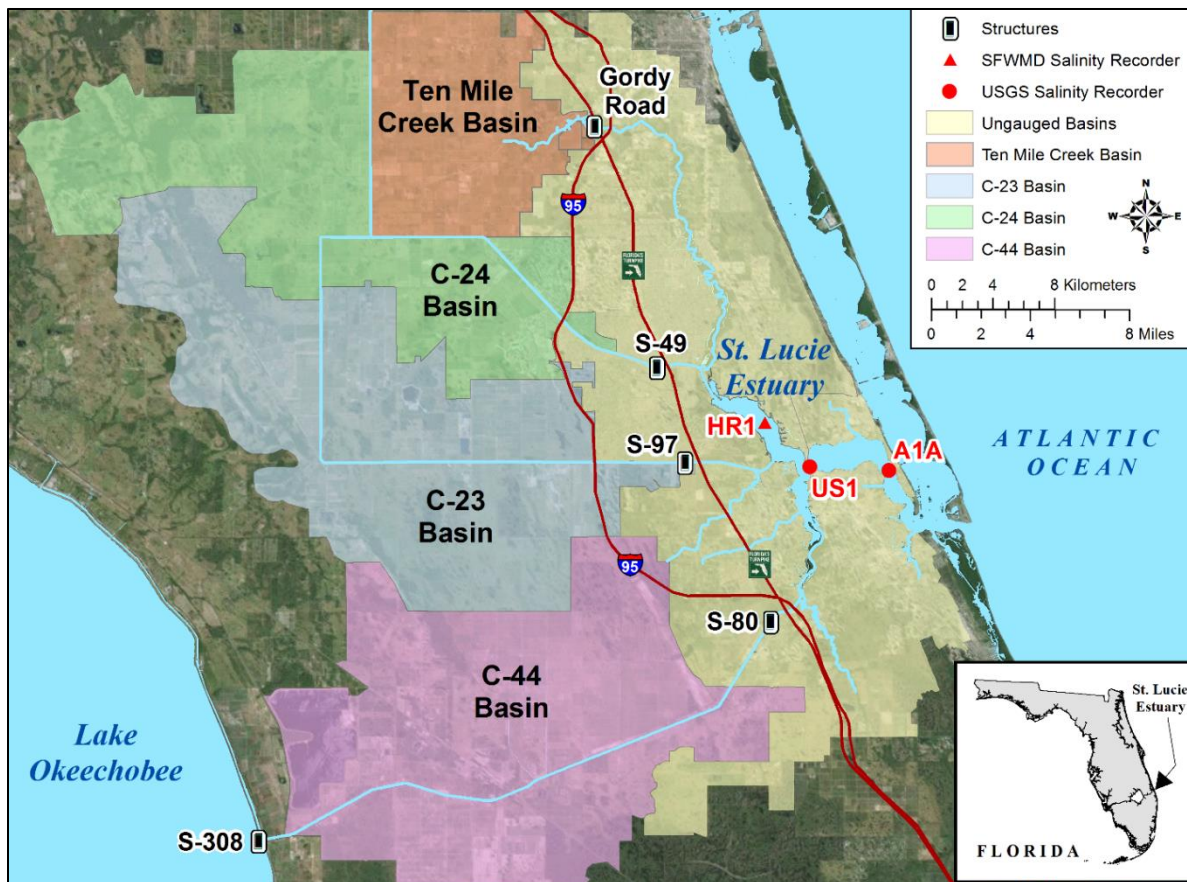
Figure 1. Basins, water control structures, and salinity monitoring for the St. Lucie Estuary.

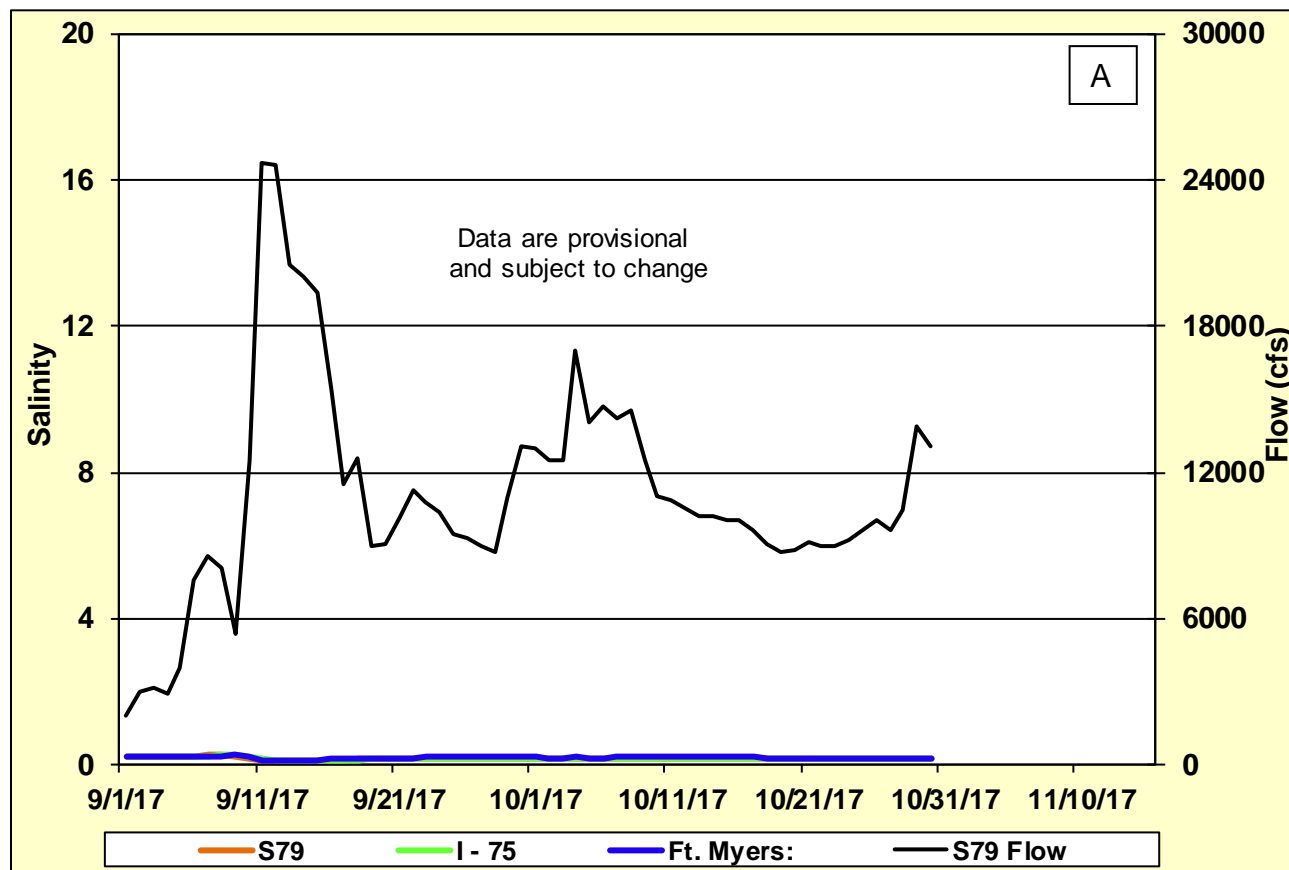
Figure 8. Daily mean flows at S-79 and salinity at upper estuary monitoring stations (A) and 30-day moving average salinity at Ft. Myers (B).

Over the past week, surface salinity decreased at and downstream of Cape Coral Bridge (Table 4, Figures 8 and 9). The seven-day average salinity values are within the poor range for adult oysters at Cape Coral and at Shell Point (Figure 10). Salinity data was not available for Sanibel. The 30-day moving average surface salinity is 0.2 at Val I-75 and Ft. Myers. Salinity conditions between Val I-75 and Ft. Myers are good for tape grass.
