# MEMORANDUM

**DATE:** March 13, 2018

**SUBJECT:** Weekly Environmental Conditions for Systems Operations

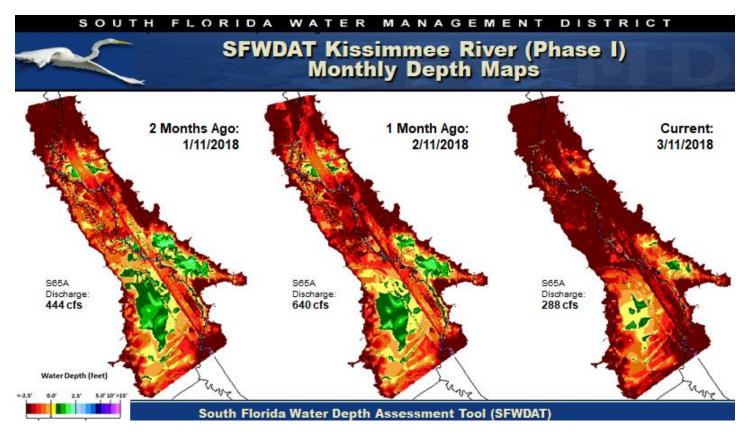
**Figure 8.** Phase I area floodplain water depths for this week, one month ago, and two months ago. Note that the WDAT color-coding has been modified to accommodate greater water depths; these maps are not directly comparable to Kissimmee Basin WDAT maps published prior to January 16, 2012.

Discharges at Lower Basin structures are shown in Table 2. SFWDAT depth maps for the Phase I restoration area are shown in Figure 8. Kissimmee River floodplain stages at selected stations are shown in Figure 9.

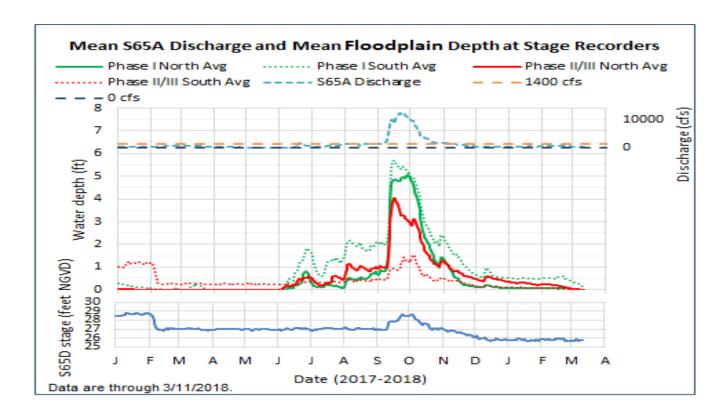
**Figure 9.** Mean water depth at stage recorders in the northern Phase I, southern Phase I, northern Phase II/III, and southern Phase II/III areas in relation to the S65A discharge and S65D headwater stage.

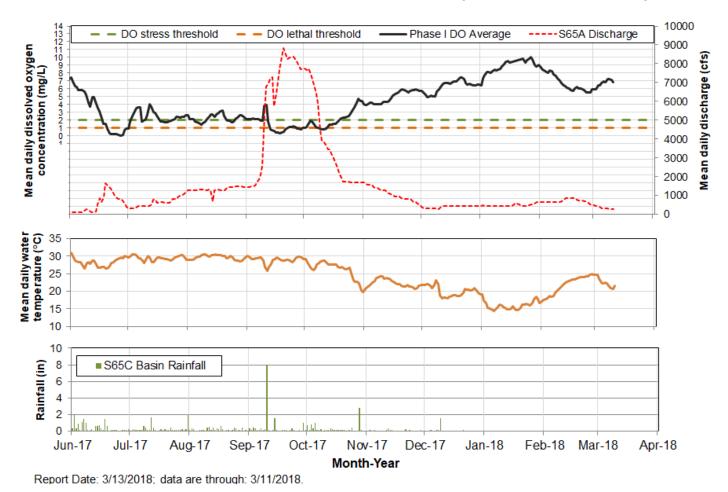
Figure 10. Mean daily dissolved oxygen, discharge, temperature and rainfall in the Phase I river channel.

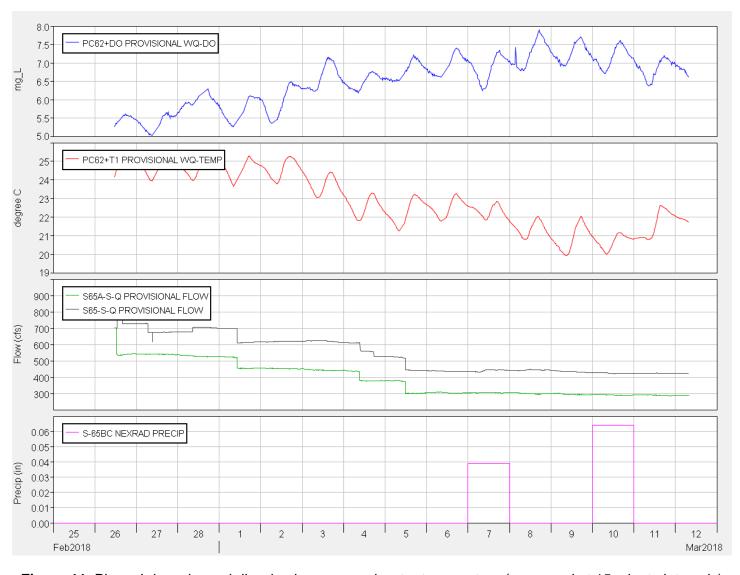
**Figure 11.** Phase I river channel dissolved oxygen and water temperature (measured at 15 minute intervals) and Pool BC daily rainfall.

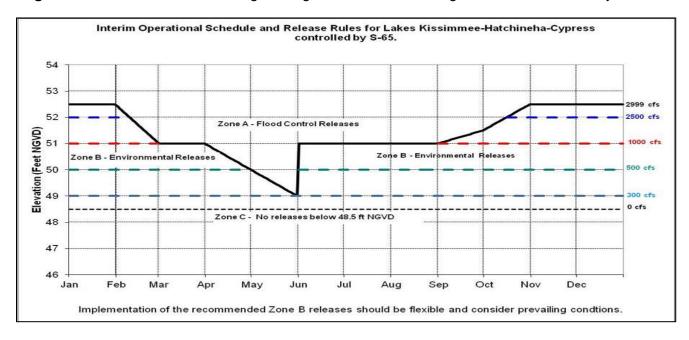
**Figure 13.** Interim operations schedule for S-65. The discharge schedule shown to the right has not been used in recent years.

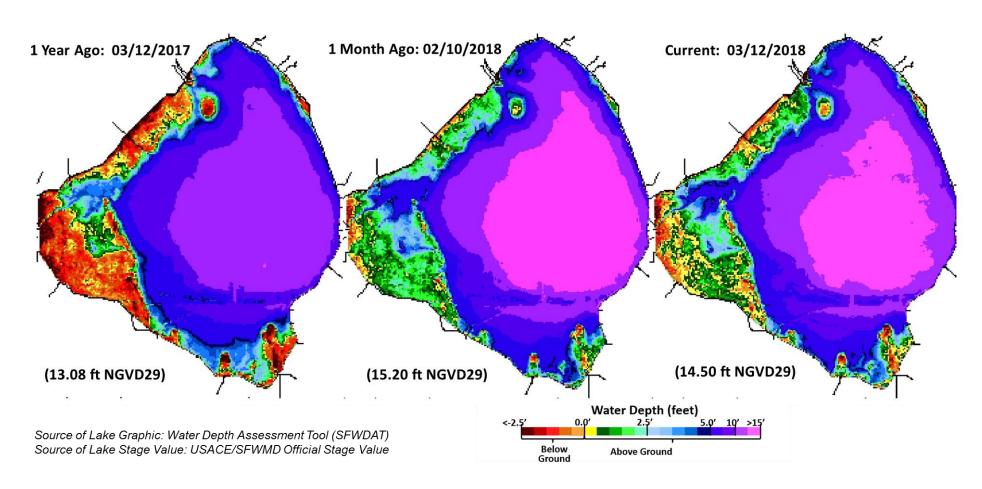
Figure 1. Water depth estimates on Lake Okeechobee based on the South Florida Water Depth Assessment Tool.

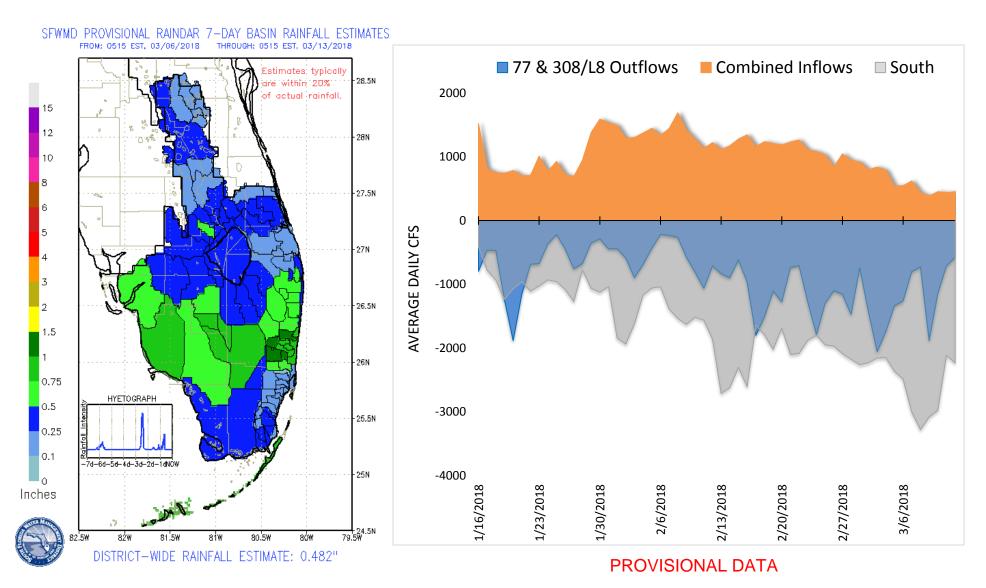
Figure 3. Rainfall estimates by basin.

According to the USACE web site, Lake Okeechobee stage is at 14.50 feet NGVD for the period ending at midnight on March 12, 2018. This value is based on the use of four interior Lake stations (L001, L005, L006 and LZ40) and four perimeter stations (S308, S352, S4 and S133). The Lake is now 0.70 feet lower than it was a month ago, 2.7 feet lower than its peak in mid-October, but still 1.42 feet higher than a year ago (Figure 1). The Lake is now in the Low sub-band (Figure 2). According to RAINDAR, 0.26 inches of rain fell over the Lake during the week March 06, 2018 – March 12, 2018 with most of the watershed receiving similar amounts (Figure 3).

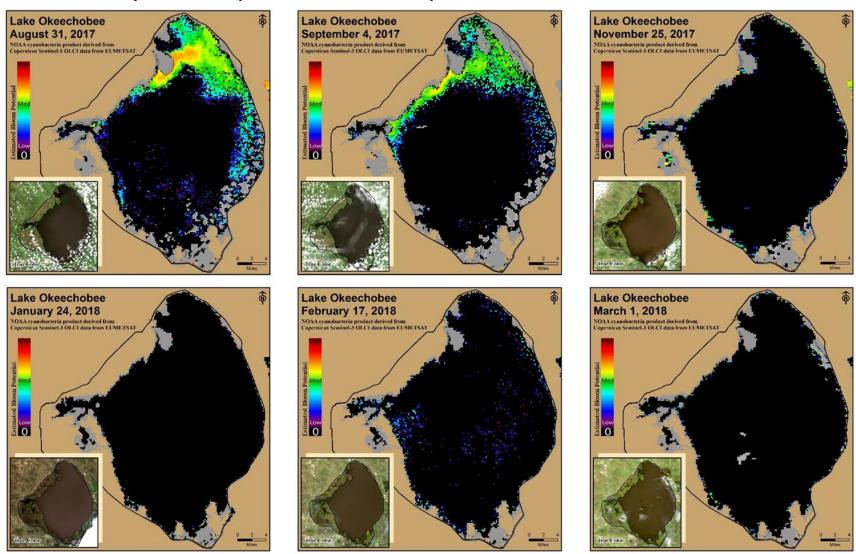
**Figure 5.** Potential for cyanobacterial blooms on Lake Okeechobee based on NOAA's harmful algal bloom monitoring system derived from Copernicus Sentinel-3 OLCI data from EUMETSAT.

The most recent satellite imagery using the cyanobacteria monitoring product derived from NOAA's OLCI satellite sensor showed cyanobacteria bloom potential has remained very low over the past five months, though there are now a few spots along the shore where the potential is moderate. The last potential for elevated cyanobacterial levels was in the northern portion of the Lake in early September 2017 (Figure 5).

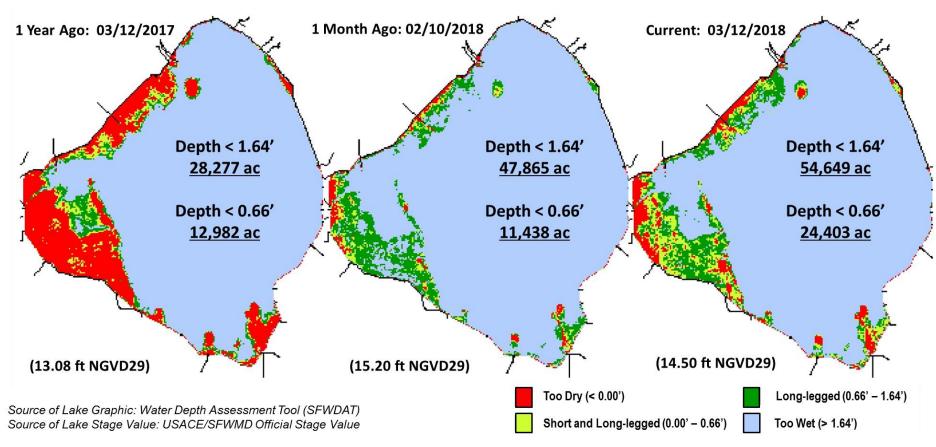
Figure 6. Wading bird habitat suitability index for Lake Okeechobee based on the South Florida Water Depth Assessment Tool.

Based on the Lake Okeechobee wading bird habitat suitability index, there was a slight decrease in habitats with suitable foraging depths for long-legged wading birds from the previous week, as Lake stage is now lower than the peak available habitat. There were approximately 55,257 acres of suitable foraging depths for long-legged wading birds the previous week, compared to 54,649 acres this past week. However, there was a slight increase in suitable foraging depths for short or long-legged wading birds, going from 21,648 acres the previous week to 24,403 acres this past week (Figure 6).

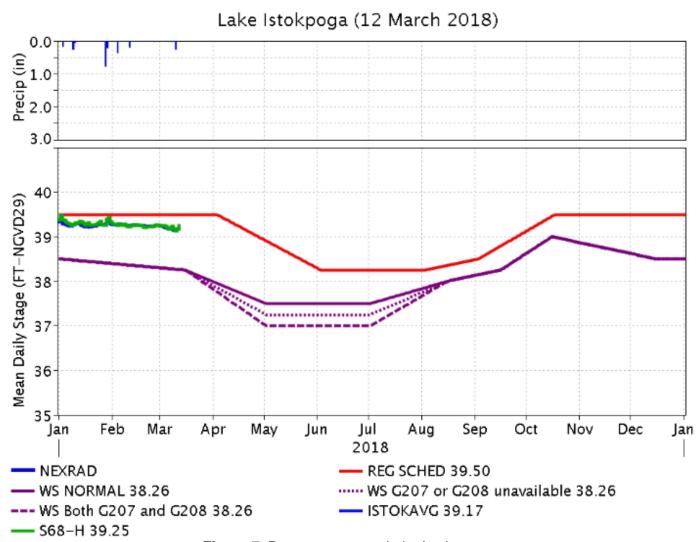
Figure 7. Recent stages on Lake Istokpoga.

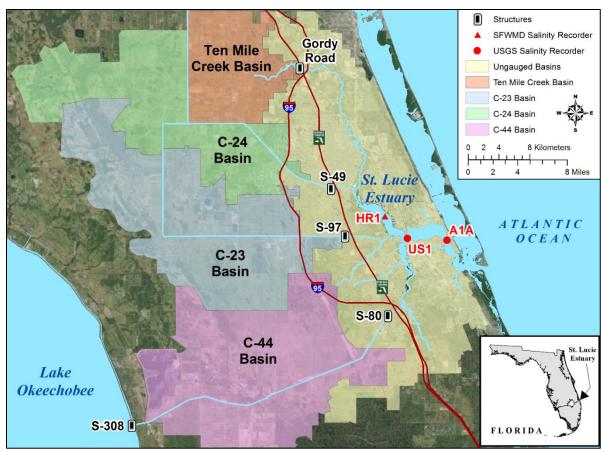
Figure 1. Basins, water control structures, and salinity monitoring for the St. Lucie Estuary.

Last week total inflow into the St. Lucie Estuary averaged about 153 cfs (Figures 1 and 2) and last month inflow averaged about 166 cfs. Last week's provisional averaged inflows from the tidal basin and the structures are shown in Table 1.

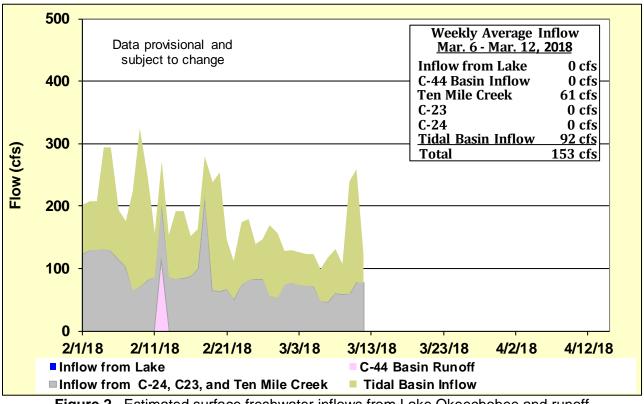
**Figure 2.** Estimated surface freshwater inflows from Lake Okeechobee and runoff from the C-44, C-23, C-24, Ten Mile Creek, and tidal basins into the St. Lucie Estuary.

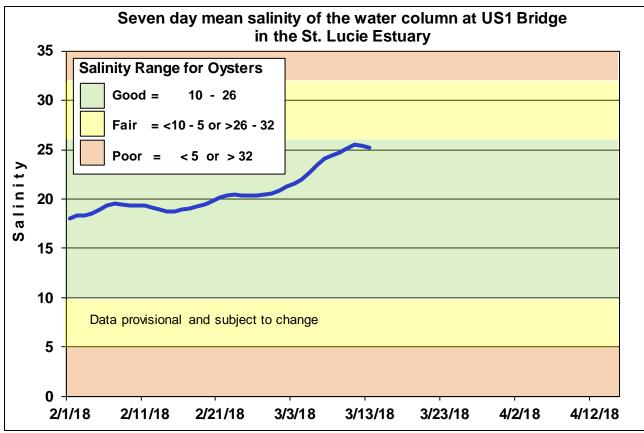
Figure 3. Seven-day mean salinity of the water column at the US1 Bridge.

Over the past week in the estuary, salinity increased upstream of the A1A Bridge and slightly decreased at and downstream of the A1A Bridge (Table 2, Figures 3 and 4). The seven-day moving average salinity of the water column (an average of the surface and bottom salinity) at the US1 Bridge is 25.2. Salinity conditions in the middle estuary are in the good range for adult eastern oysters (Figure 3).

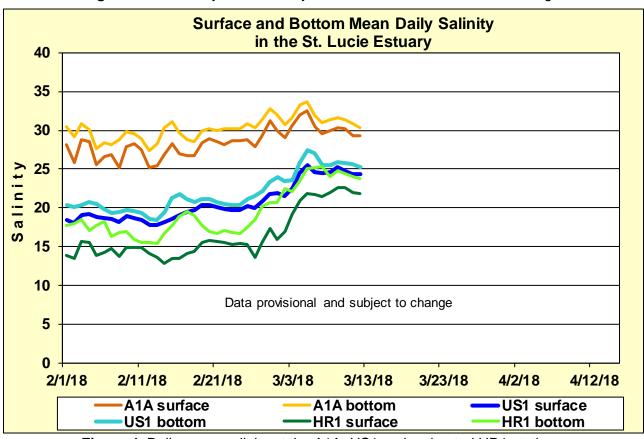
Figure 4. Daily mean salinity at the A1A, US1 and estimated HR1 stations.

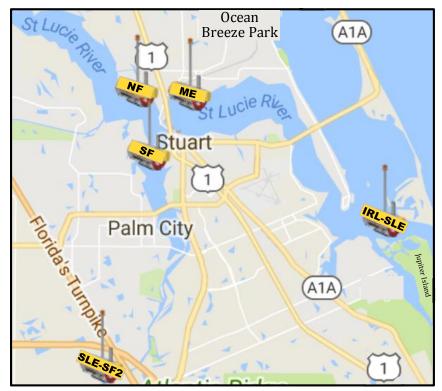
Figure 5. Location of FAU-HBOI LOBO water quality stations in the St. Lucie Estuary.

Continuous monitoring of water quality is conducted at five Land/Ocean Biogeochemical Observatory (LOBO) stations located in the St. Lucie Estuary and maintained by Florida Atlantic University/Harbor Branch Oceanographic Institute (FAU-HBOI). Data are summarized in Table 4 and station location map is shown in Figure 5.

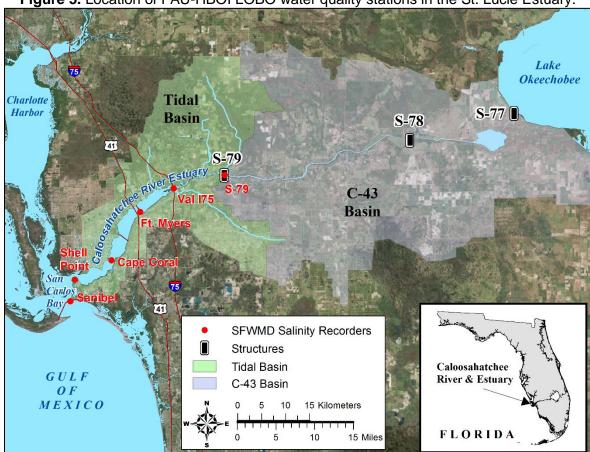
Figure 6. Basins, water control structures, and salinity monitoring for the Caloosahatchee Estuary.

Last week total inflow into the Caloosahatchee Estuary averaged about 770 cfs (Figures 6 and 7) and last month inflow averaged about 770 cfs. Last week's provisional averaged inflows from the structures are shown in Table 5.

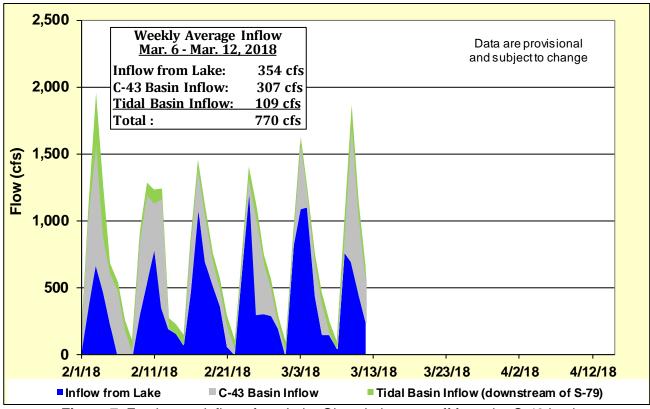
**Figure 7.** Freshwater inflows from Lake Okeechobee, runoff from the C-43 basin, and tributaries in the tidal basin into the Caloosahatchee River Estuary.

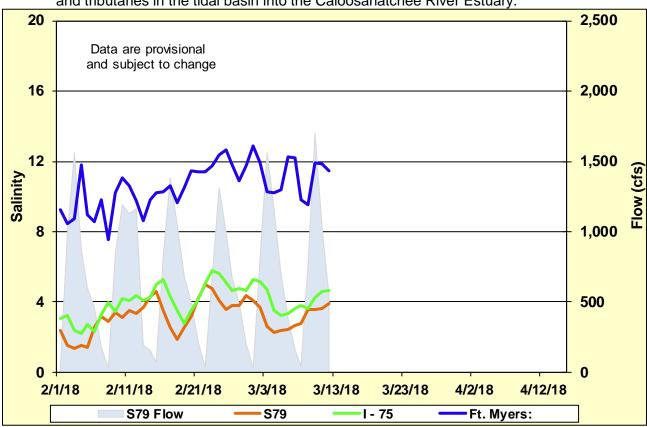
Figure 8. Daily mean flows at S-79 and salinity at upper estuary monitoring stations.

Over the past week, salinity remained about the same throughout the estuary (Table 6, Figures 8 & 9). The seven-day average salinity values are in the good range for adult eastern oysters at Cape Coral and in the fair range at Shell Point (Figure 10). Salinity data were not available at Sanibel. The 30-day moving average surface salinity is 4.4 at Val I-75 and 11.0 at Ft. Myers. With no flow through S-79, daily salinity at Val I-75 is forecast in two weeks to be 8.1, and the 30-day moving average is forecast to be 5.4 (Figure 11). Salinity conditions between Val I-75 and Ft. Myers are good for tape grass.

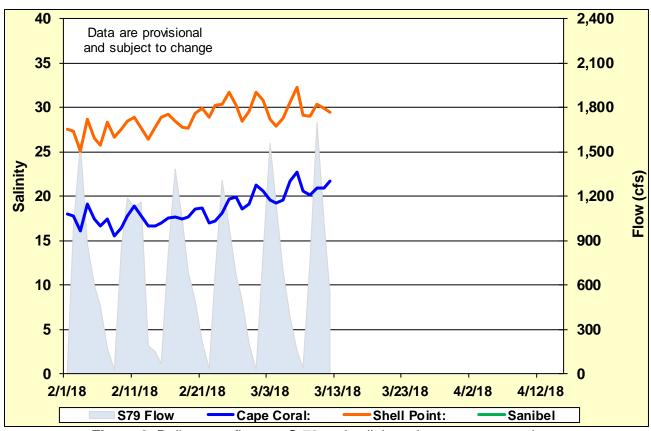
Figure 9. Daily mean flows at S-79 and salinity at lower estuary stations.

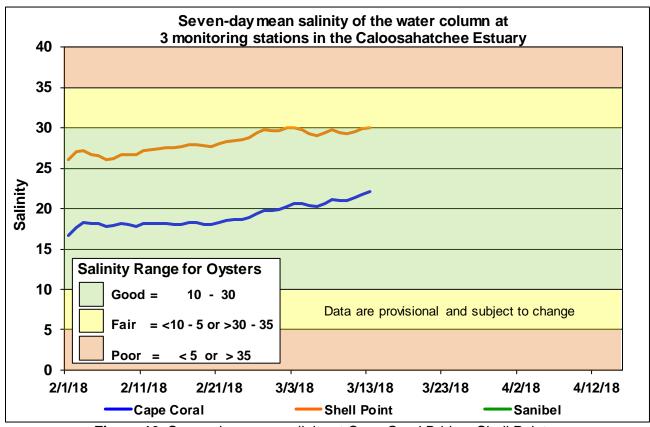
**Figure 10.** Seven-day mean salinity at Cape Coral Bridge, Shell Point, and Sanibel Bridge monitoring stations.

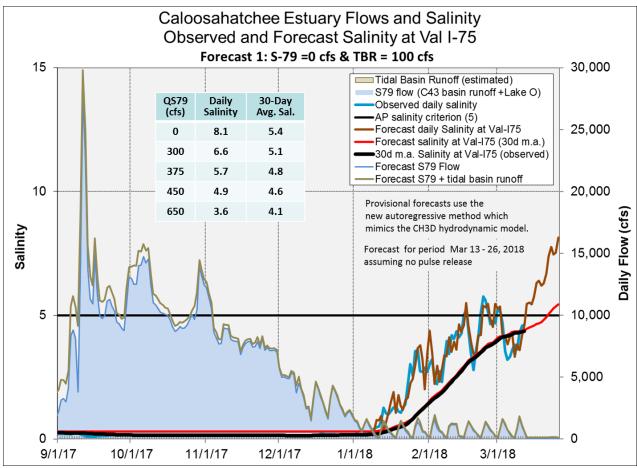
Figure 11. 14-day salinity forecast at Val I-75 assuming no releases at S-79.

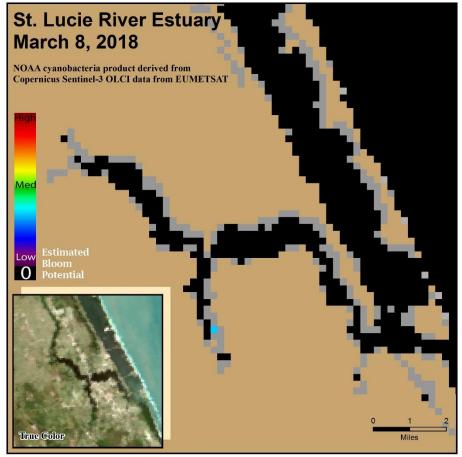
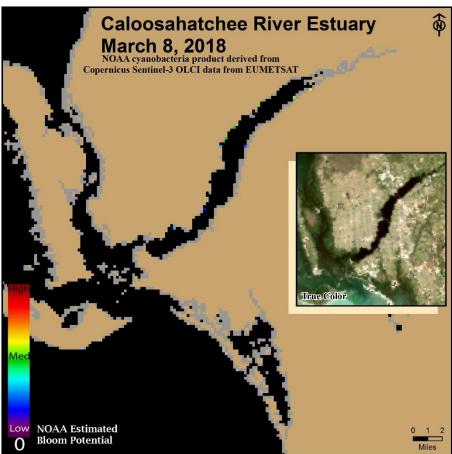
**Figure 12.** Sentinel 3a Satellite imagery provided by NOAA uses Ocean and Land Color Instrument (OLCI) to estimate cyanobacteria bloom potential in Caloosahatchee Estuary.

NOAA satellite imagery indicates no visible cyanobacteria bloom potential in the St. Lucie Estuary this week (Figure 12).

NOAA satellite imagery indicates no visible cyanobacteria bloom potential in the Caloosahatchee Estuary this week (Figure 12).
