M E M O R A N D U M

FROM: SFWMD Staff Environmental Advisory Team

DATE: October 30, 2018

SUBJECT: Weekly Environmental Conditions for Systems Operations

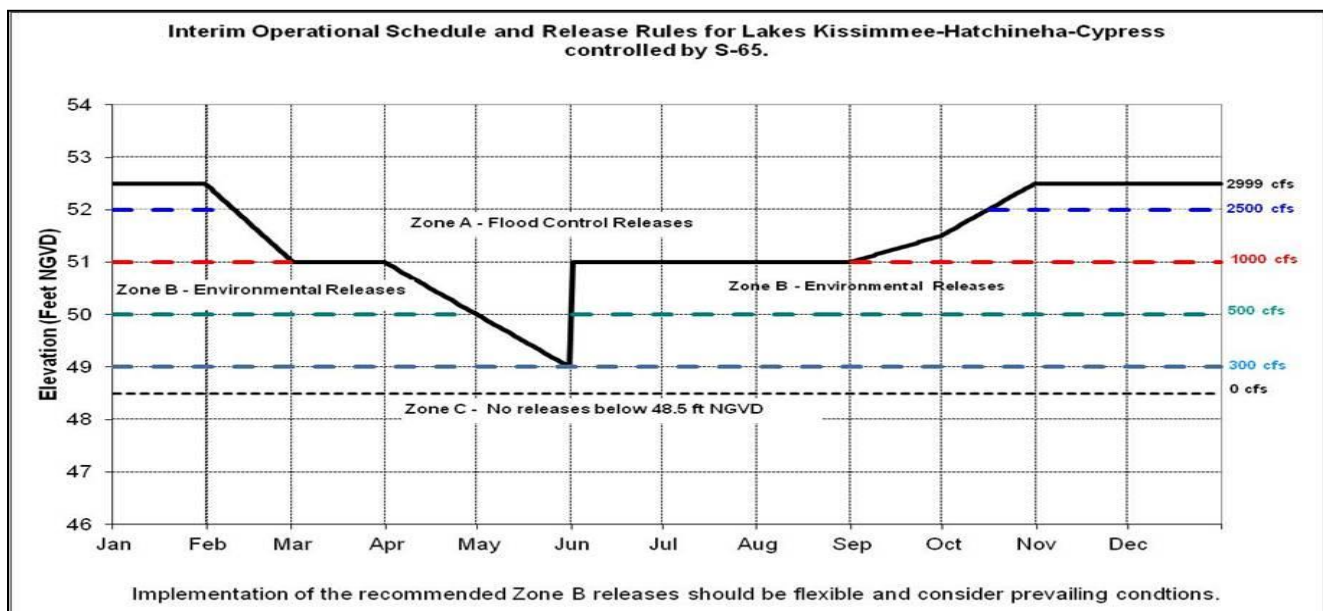
Figure 12. Interim operations schedule for S-65. The discharge schedule shown to the right has not been used in recent years.
