**SOUTH FLORIDA WATER MANAGEMENT DISTRICT**

**Hydrogeologic Assessment of  
CROOKS AND GOLDEN OX RANCHES  
Hendry County, Florida**

Technical Publication WS-28

August 2009

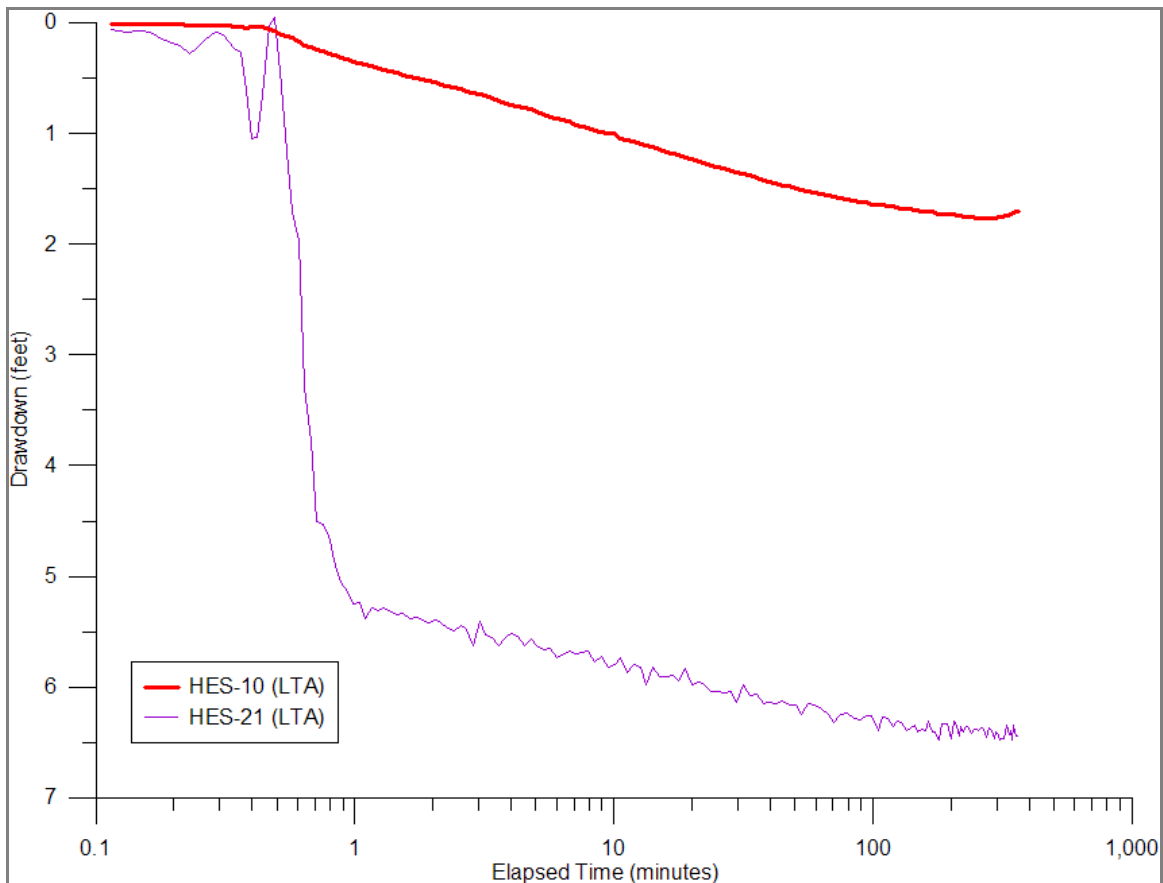
**Figure 25** presents the drawdown data in both the pumped well (HES-21) and corresponding monitor well (HES-10) in the LTA. The steep drawdown seen in the first minute of HES-21 indicates the removal of stored water in the well casing before drawdown begins in the aquifer. The maximum drawdown in HES-21 and HES-10 was approximately 6.5 feet and 1.7 feet, respectively.

Figure 25. Site 4, Water levels in LTA pumping well (HES-21) and LTA monitor well (HES-10) during the pumping phase of the APT.

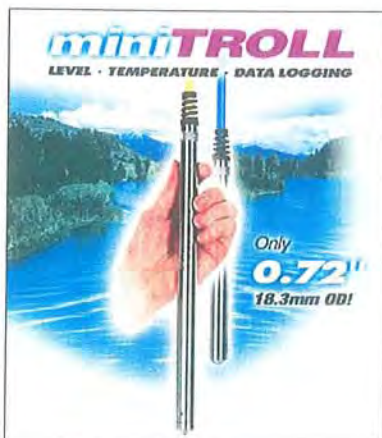
For this project, In-situ miniTrolls were selected based on their accuracy, stability, and long-term reliability.

The miniTroll Monitoring Data Loggers feature:

- Automatic Barometric Compensation
- Automatic Temperature Compensation
- Fluid Density Correction
- Gravitational Acceleration Correction
- Liquid Density Correction
- NIST-Traceable Calibration

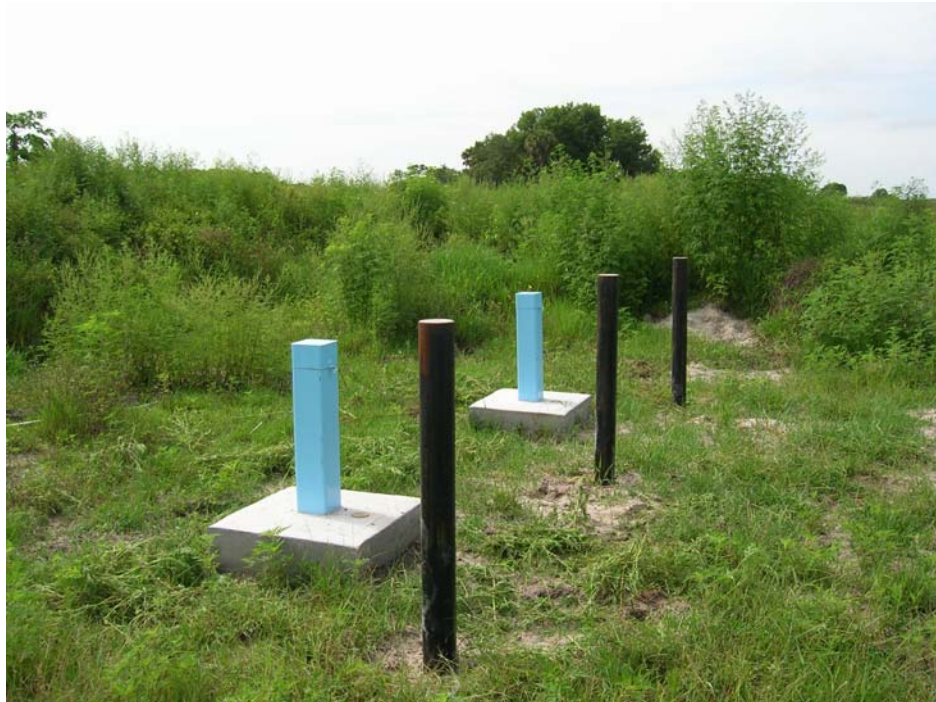
Stations HES1 and HES-2

Analysis: HES-1 is a shallow well that taps the surficial aquifer system. The benchmark and reference elevations are consistent with water-level data collected at the site, and appear to be accurate. The well was surveyed on June 29, 2005 (Scott, Jones, PE, Johnson-Prewitt and Associates, Inc., written commun., 2008). The land-surface elevation was not surveyed, but was calculated by subtracting the pad height (0.417 ft) from the benchmark elevation. A photograph of HES-1 and adjacent well HES-2 is shown below. No revisions were necessary, other than converting elevations from NAVD 88 to NGVD 29.

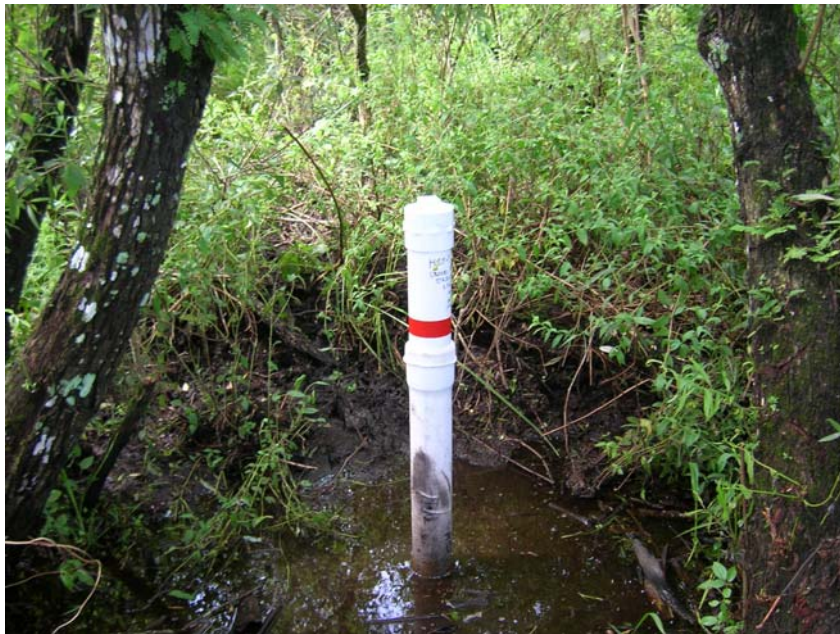
Station HES-3

Analysis: HES-3 is a stilling well that monitors the water level in a wetland. The benchmark and reference elevations are consistent with water-level data collected at the site, and appear to be accurate. The well was surveyed on June 29, 2005 (Scott, Jones, PE, Johnson-Prewitt and Associates, Inc., written commun., 2008). The median water level in the well is less than the land-surface elevation (calculated), which indicates the site was only seasonally inundated. A photograph of HES-3 is shown below. No revisions were necessary, other than converting elevations from NAVD 88 to NGVD 29.

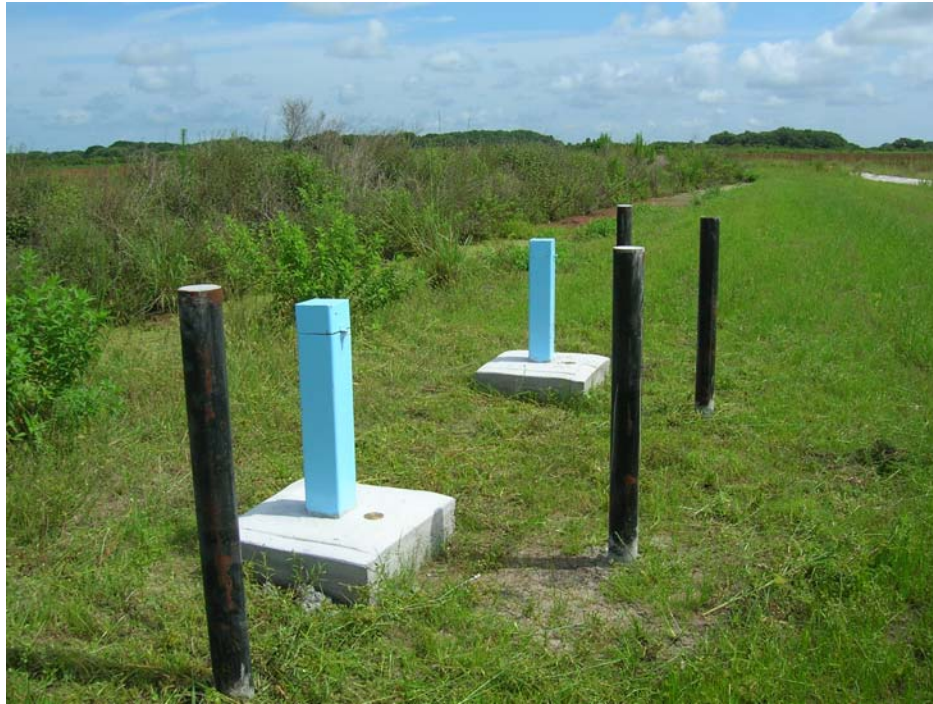
Stations HES-4 and HES-5

Analysis: HES-4 is a shallow well that taps the surficial aquifer system. The benchmark and reference elevations are consistent with water-level data collected at the site, and appear to be accurate. The well was surveyed on June 29, 2005 (Scott, Jones, PE, Johnson-Prewitt and Associates, Inc., written commun., 2008). The land-surface elevation was not surveyed, but was calculated by subtracting the pad height (0.417 ft) from the benchmark elevation. A photograph of HES-4 and adjacent well HES-5 is shown below. No revisions were necessary, other than converting elevations from NAVD 88 to NGVD 29.

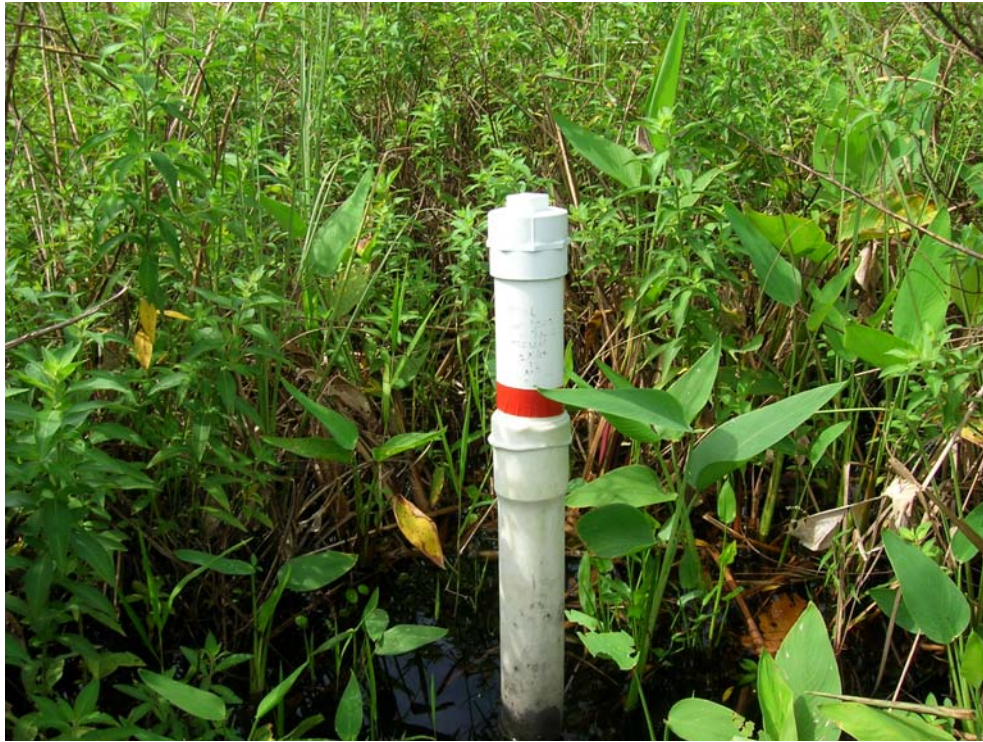
Analysis: HES-6 is a stilling well that monitors the water level in a wetland. The benchmark and reference elevations are consistent with water-level data collected at the site, and appear to be accurate. The well was surveyed on June 29, 2005 (Scott, Jones, PE, Johnson-Prewitt and Associates, Inc., written commun., 2008). The median water level in the well is less than the land-surface elevation (calculated), which indicates the site was only seasonally inundated. A photograph of HES-6 is shown below. No revisions were necessary, other than converting elevations from NAVD 88 to NGVD 29.

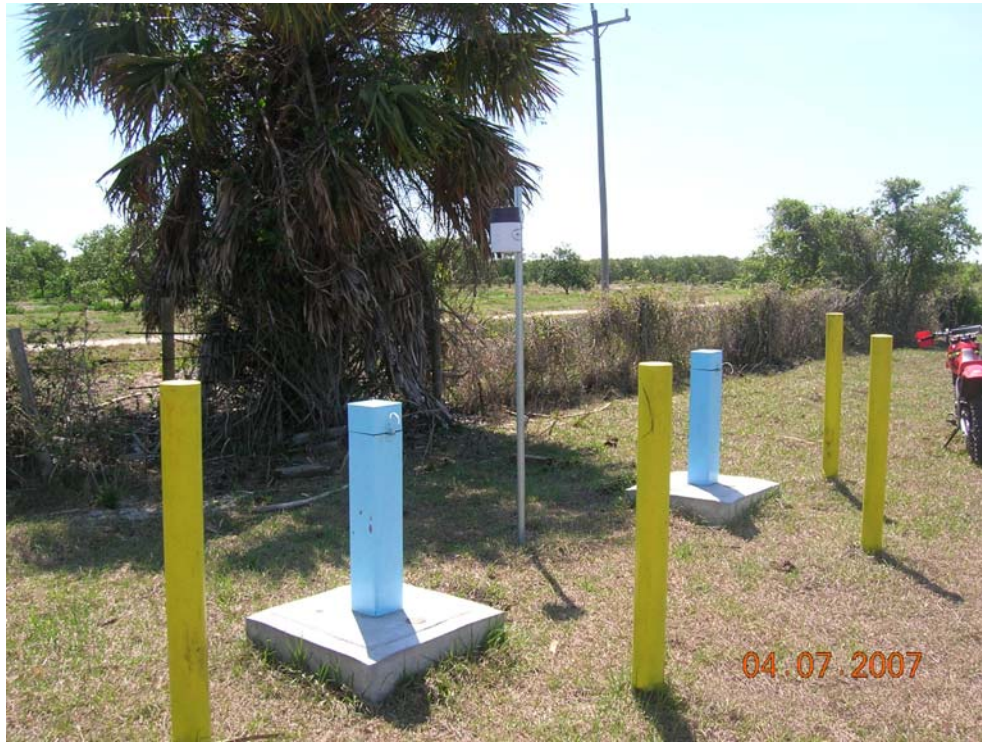
Stations HES-7 and HES-8

Analysis: HES-7 is a shallow well that taps the surficial aquifer system. The benchmark and reference elevations are consistent with water-level data collected at the site, and appear to be accurate. The well was surveyed on June 30, 2005 (Scott, Jones,

PE, Johnson-Prewitt and Associates, Inc., written commun., 2008). The land-surface elevation was not surveyed, but was calculated by subtracting the pad height (0.417 ft) from the benchmark elevation. A photograph of HES-7 and adjacent well HES-8 is shown below. No revisions were necessary, other than converting elevations from NAVD 88 to NGVD 29.

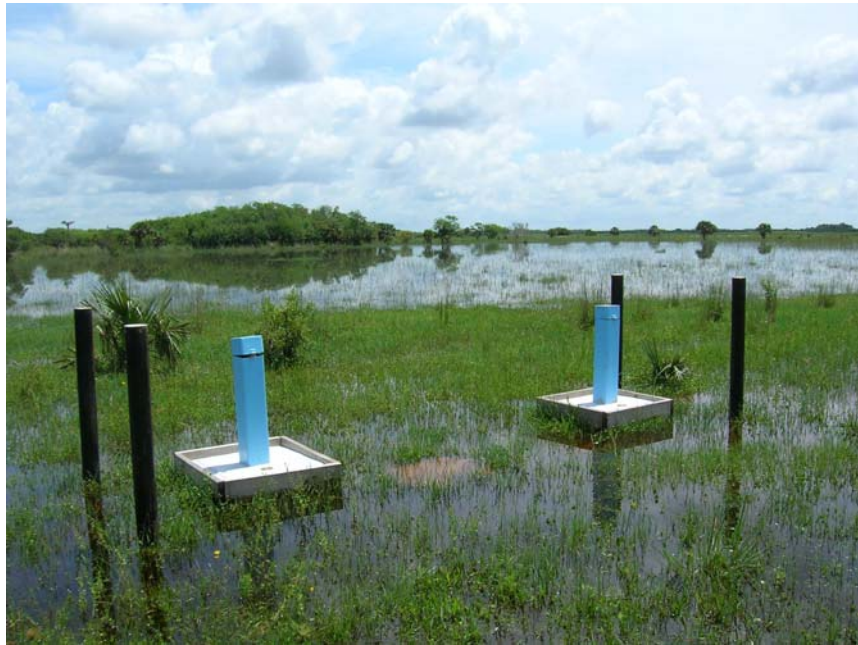
Stations HES-9 and HES-10

Analysis: HES-9 is a shallow well that taps the surficial aquifer system. The benchmark and reference elevations are consistent with water-level data collected at the site, and appear to be accurate. The well was surveyed on June 30, 2005 (Scott, Jones, PE, Johnson-Prewitt and Associates, Inc., written commun., 2008). The land-surface elevation was not surveyed, but was calculated by subtracting the pad height (0.417 ft) from the benchmark elevation. The maximum water level in the well is slightly higher than the land-surface elevation, indicating the site is periodically inundated. A photograph of HES-9 and adjacent well HES-10 (below) shows the site with standing water. No revisions were necessary, other than converting elevations from NAVD 88 to NGVD 29.

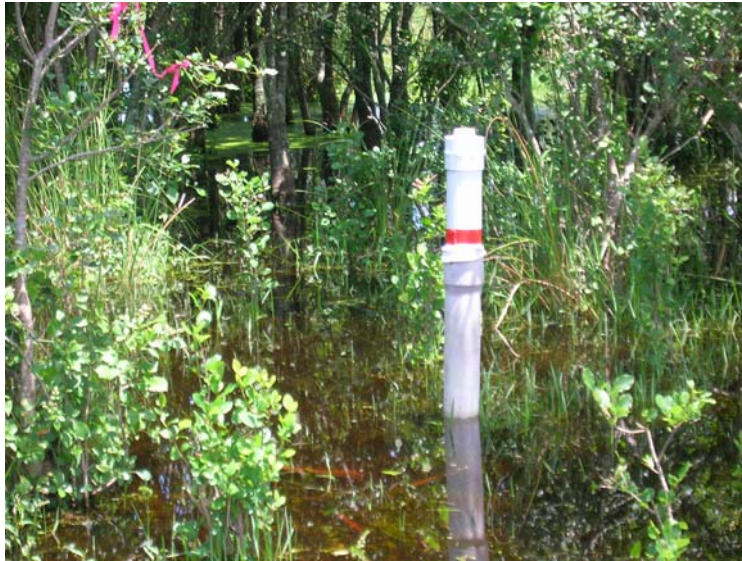
Station HES-11

Analysis: HES-11 is a stilling well that monitors the water level in a wetland. The benchmark and reference elevations are consistent with water-level data collected at the site, and appear to be accurate. The well was surveyed on June 30, 2005 (Scott, Jones, PE, Johnson-Prewitt and Associates, Inc., written commun., 2008). The median water level in the well is less than the land-surface elevation (calculated), which indicates the site was only seasonally inundated. A photograph of HES-11 is shown below. No revisions were necessary, other than converting elevations from NAVD 88 to NGVD 29.

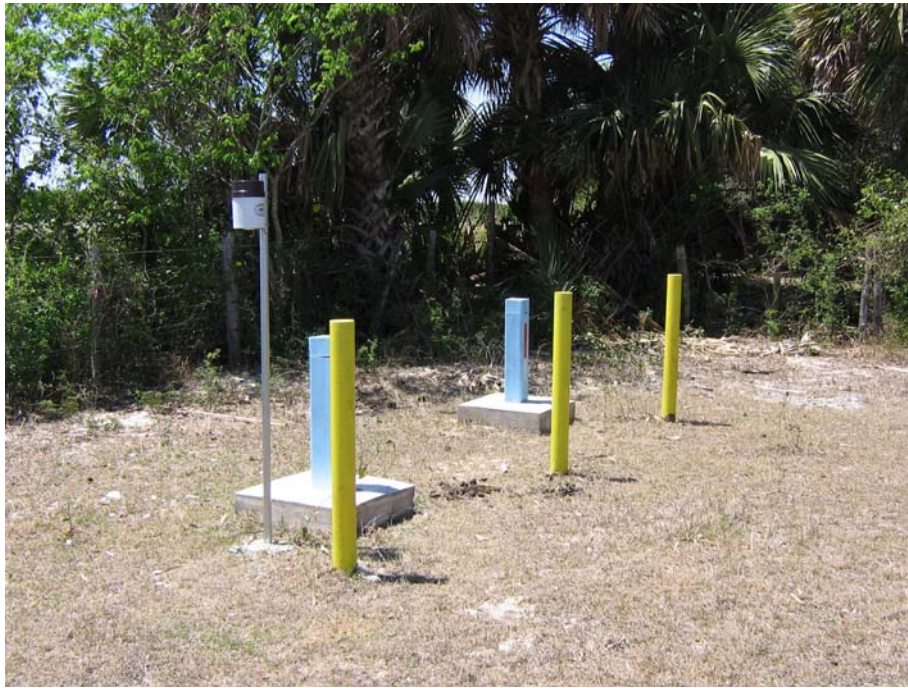
Stations HES-12 and HES-13

Analysis: HES-12 is a shallow well that taps the surficial aquifer system. The benchmark and reference elevations are consistent with water-level data collected at the site, and appear to be accurate. The well was surveyed on June 30, 2005 (Scott, Jones, PE, Johnson-Prewitt and Associates, Inc., written commun., 2008). The land-surface elevation was not surveyed, but was calculated by subtracting the pad height (0.417 ft) from the benchmark elevation. The maximum water level in the well is slightly higher than the land-surface elevation, indicating the site is periodically inundated. A photograph of HES-12 and adjacent well HES-13 is shown below. No revisions were necessary, other than converting elevations from NAVD 88 to NGVD 29.

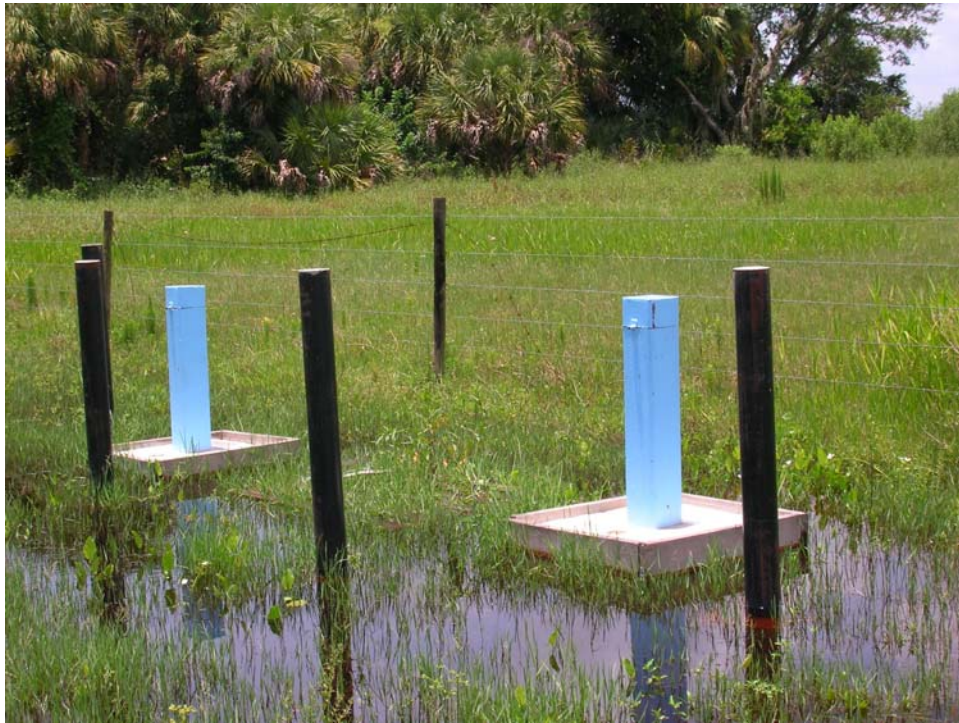
Stations HES-14 and HES-15

Analysis: HES-14 is a shallow well that taps the surficial aquifer system. The benchmark and reference elevations are consistent with water-level data collected at the site, and appear to be accurate. The well was surveyed on June 30, 2005 (Scott, Jones, PE, Johnson-Prewitt and Associates, Inc., written commun., 2008). The land-surface elevation was not surveyed, but was calculated by subtracting the pad height (0.417 ft) from the benchmark elevation. The maximum water level in the well is higher than the land-surface elevation, indicating the site is periodically inundated. A photograph of HES-14 and adjacent well HES-15 (below) shows the site inundated with water. No revisions were necessary, other than converting elevations from NAVD 88 to NGVD 29.

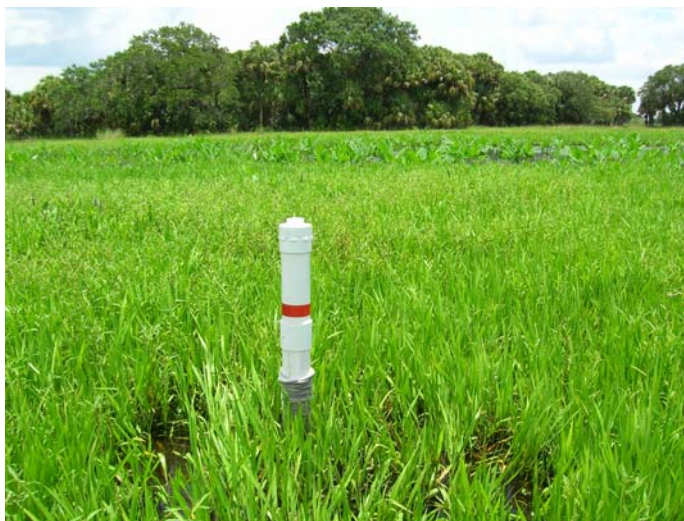
Station HES-16

Analysis: HES-16 is a stilling well that monitors the water level in a wetland. The benchmark and reference elevations are consistent with water-level data collected at the site, and appear to be accurate. The well was surveyed on July 1, 2005 (Scott, Jones, PE, Johnson-Prewitt and Associates, Inc., written commun., 2008). The median water level in the well is less than the land-surface elevation (calculated), which indicates the site was only seasonally inundated. A photograph of HES-16 is shown below. No revisions were necessary, other than converting elevations from NAVD 88 to NGVD 29.

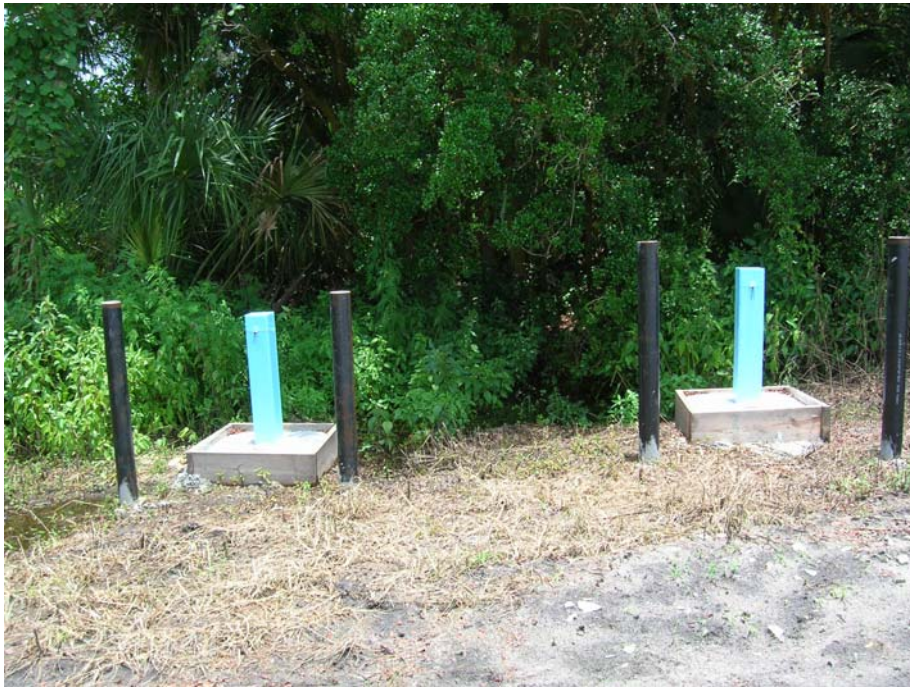
Stations HES-17 and HES-18

Analysis: HES-17 is a shallow well that taps the surficial aquifer system. The benchmark and reference elevations are consistent with water-level data collected at the site, and appear to be accurate. The well was surveyed on June 30, 2005 (Scott, Jones, PE, Johnson-Prewitt and Associates, Inc., written commun., 2008). The land-surface elevation was not surveyed, but was calculated by subtracting the pad height (0.417 ft) from the benchmark elevation. A photograph of HES-17 and adjacent well HES-18 is shown below. No revisions were necessary, other than converting elevations from NAVD 88 to NGVD 29.

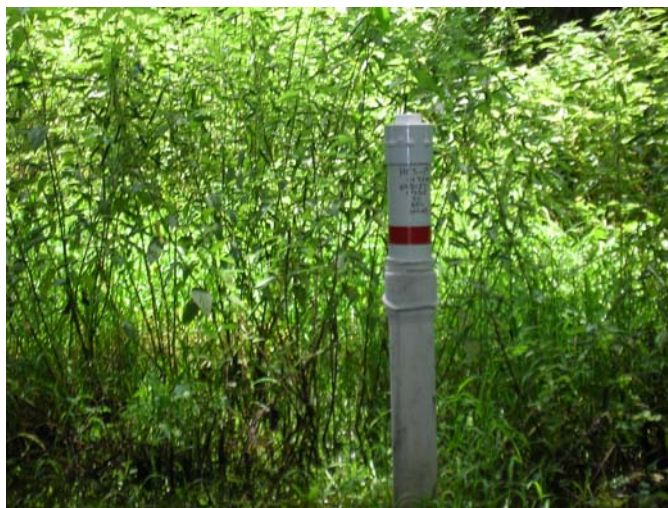
Station HES-19

Analysis: HES-19 is a stilling well that monitors the water level in a wetland. The benchmark and reference elevations are consistent with water-level data collected at the site, and appear to be accurate. The well was surveyed on June 30, 2005 (Scott, Jones, PE, Johnson-Prewitt and Associates, Inc., written commun., 2008). The median water level in the well is less than the land-surface elevation (calculated), which indicates the site was only seasonally inundated. A photograph of HES-19 is shown below. No revisions were necessary, other than converting elevations from NAVD 88 to NGVD 29.

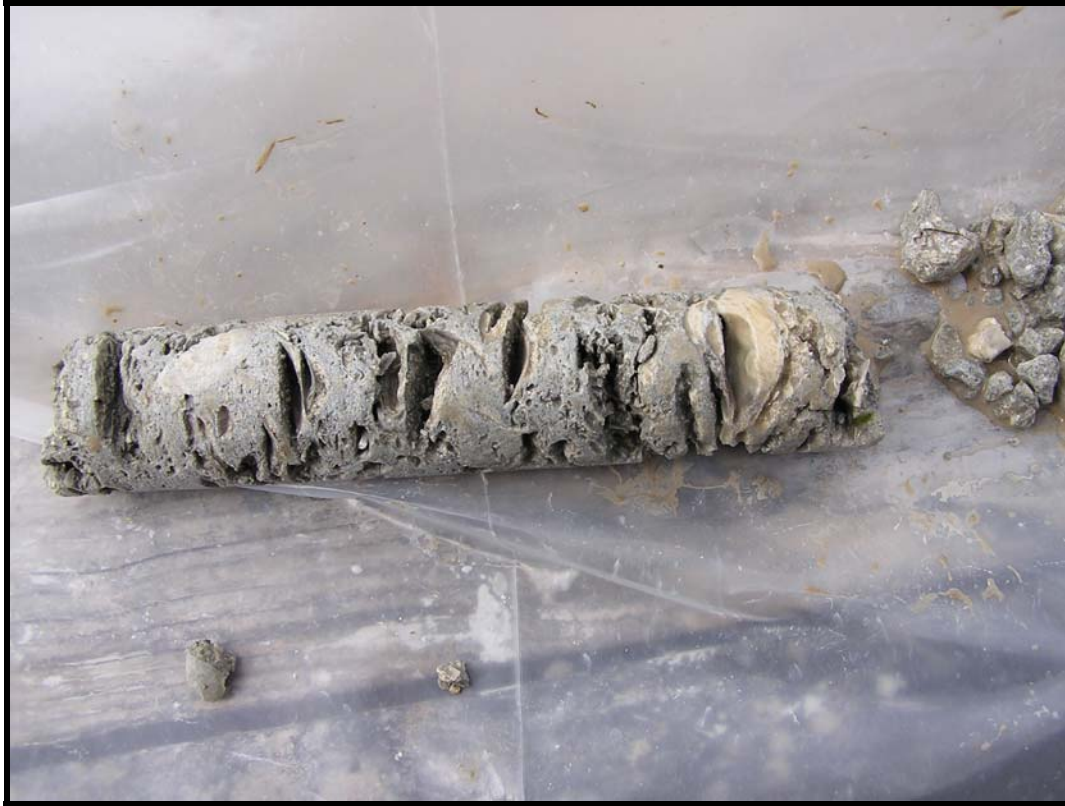
Golden Ox Ranch, Site 6, HES-20, 58-60 feet bls (Lower Tamiami aquifer)
